State of California – The Resources Agency
DEPARTMENT OF PARKS AND RECREATION
PRIMARY RECORD

*Resource Name or # (Assigned by recorder) 2117 18th Street

Richmond Grove Neighborhood Historic Context Statement and Historic District Survey.

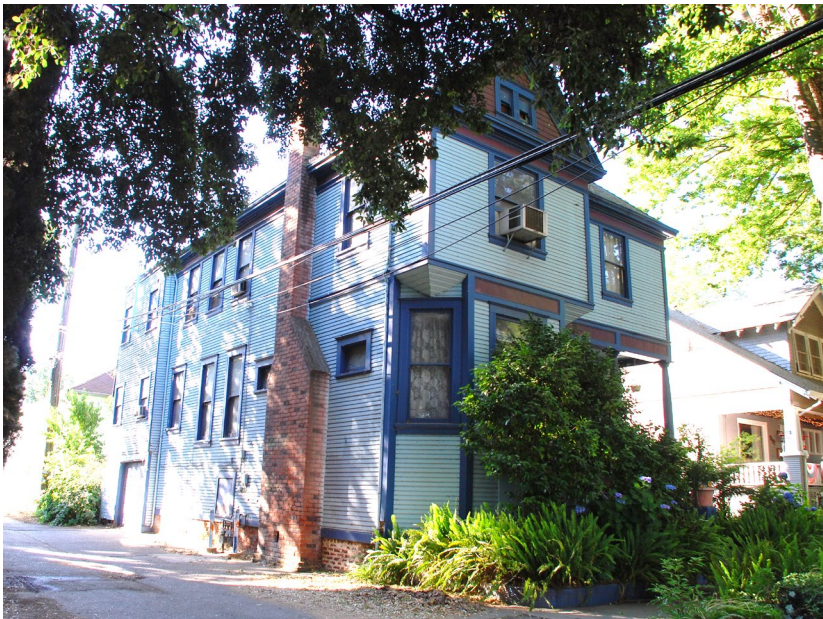
The 2.5-story Queen Anne Transitional house sits atop a raised basement and is rectangular in plan. It has a steeply-pitched gable-on-hip roof with medium eaves. Gable ends are clad in decorative fishscale shingles with decorative molding at the cornice and feature small double-hung wood-sash windows. The house is clad in narrow wood siding and has decorative friezes at the roofline and separating the first and second stories. There is a partial-width integral porch on the main (west) elevation with a balustrade made of turned wood posts and Tuscan columns with capitals and bases that rest on piers clad in the same siding as the house. The primary entrance is accessed via a wide set of wood steps and is fitted with a paneled wood door with a transom. Fenestration consists of double-hung wood sash windows with decorative casings. The main façade features a decorative cutaway window bay to the left of the entrance. A three-story rear addition has a flat roof and single-car garage on the ground floor, which is accessed via Uptown Alley.

P5b. Description of Photo: (View, date, accession #) Photograph 1: 1920 18th Street, north and west elevations, camera facing southeast, June 15 2021.

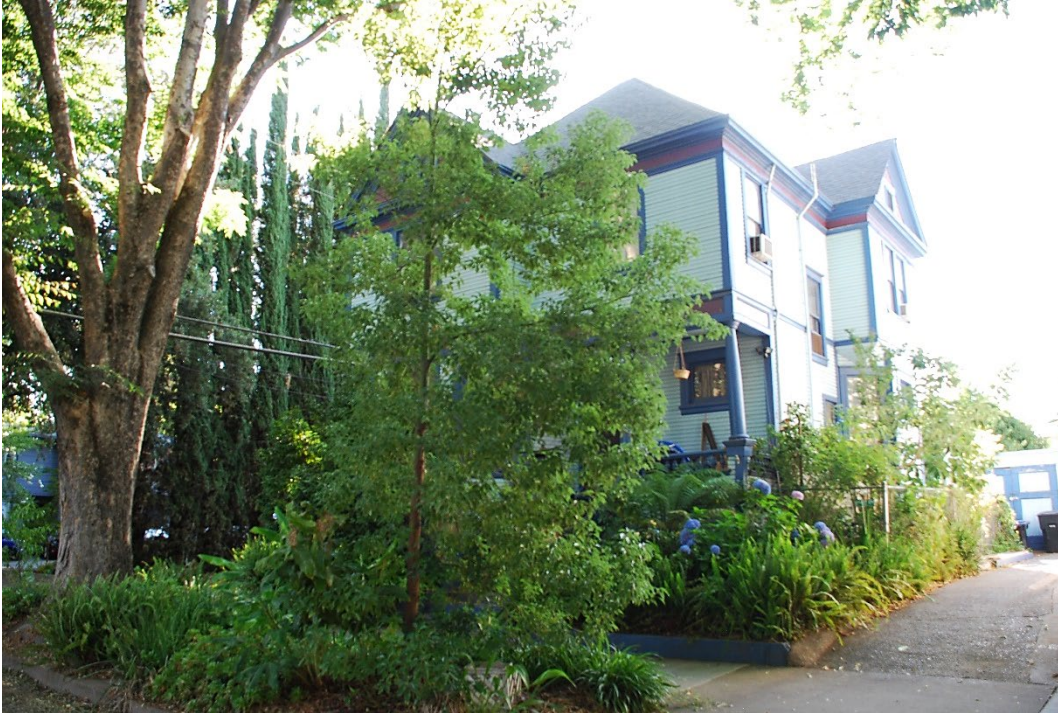
Photograph 2: 2117 18th Street, west and south elevations, camera facing northeast, June 15, 2021.
