State of California – The Resources Agency  
DEPARTMENT OF PARKS AND RECREATION  
PRIMARY RECORD

\*Resource Name or # (Assigned by recorder) 2209 14<sup>th</sup> Street

c. Address 2209 14<sup>th</sup> Street City Sacramento Zip 95818

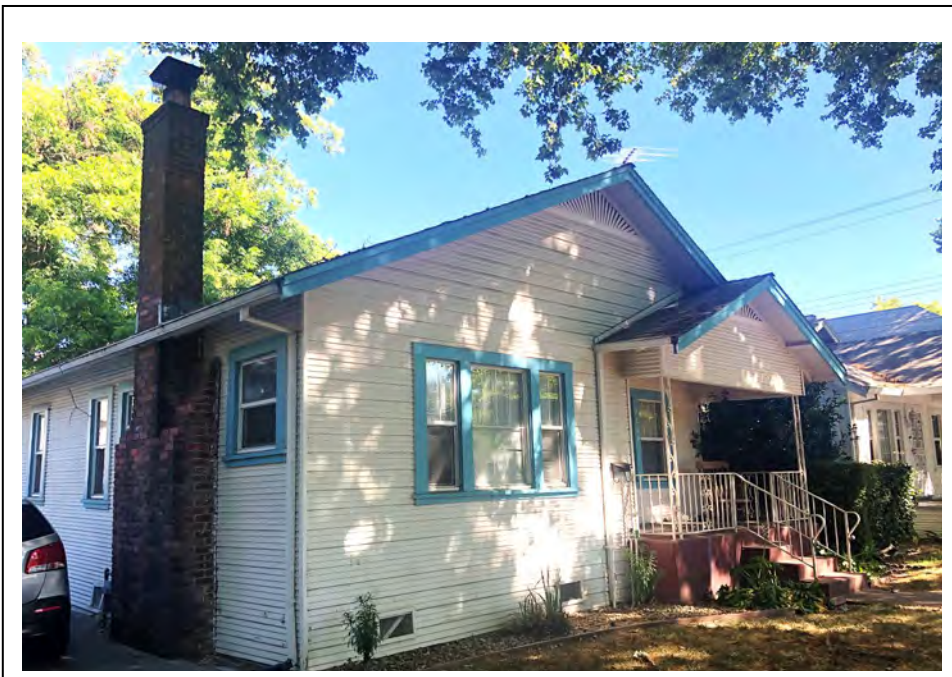
The Craftsman residence sits atop a raised basement and has a rectangular plan. Its medium-pitched front-gabled roof has a vent at the gable end and exposed purlins. There is a projecting partial-width porch on the main (west) façade with its own front-gabled roof. The main entrance, which does not face the street is fitted with a metal security screen door and is accessed via a set of concrete steps. Original porch supports have been replaced with wrought-iron supports and balustrade/railing. The house is clad in wood clapboard. Fenestration consists of vinyl replacement windows. The main façade features an assemblage of three cottage windows to the left of the entrance. There is a tall brick chimney on the north elevation. A narrow driveway to the north of the residence leads to a single-car garage at the rear of the parcel.

P5b. Description of Photo: (View, date, accession #) Photograph 1: North and west elevations, camera facing southeast, June 15, 2021.

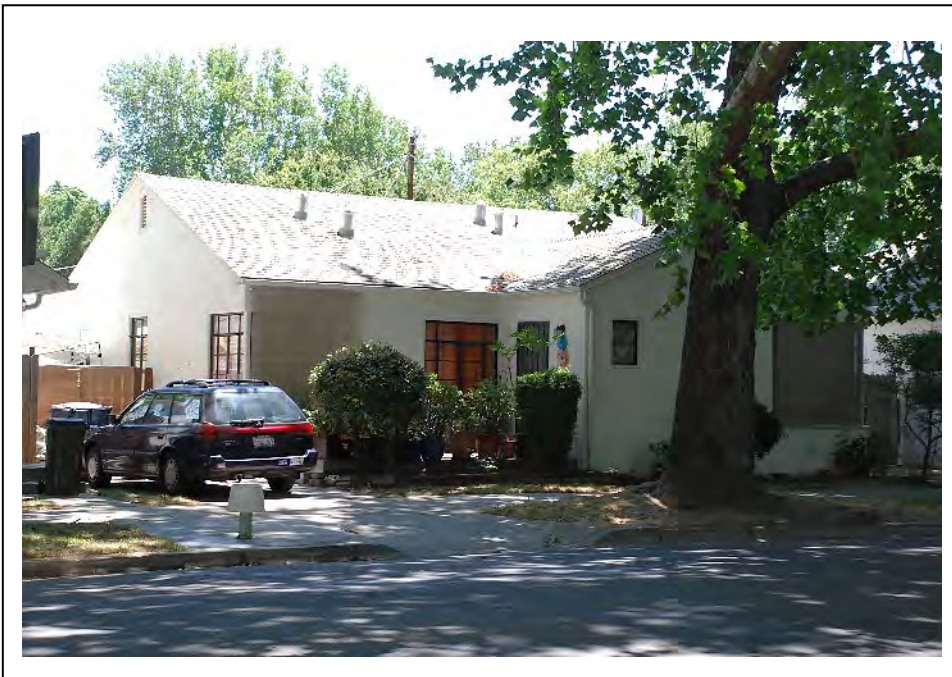
**\*P3a. Description:** (Describe resource and its major elements. Include design, materials, condition, alterations, size, setting, and boundaries)  
The one-story residence, which exhibits elements of Minimal-Traditional architecture, has an L-shaped plan and medium-pitched gabled roof with louvered vents on the gable ends and minimal eaves. It is clad in smooth stucco. The main entrance is on the north elevation on a projecting main (west) facade and fitted with a metal security screen. It is accessed via a low concrete deck and has no overhang or shelter. Fenestration consists of double-hung wood-sash windows and multiple-light steel casement windows. The house is adjacent to a similar house, a 10-unit courtyard apartment complex, and a duplex, all of which feature very similar architecture and plans; they appear to have been developed as a group in the early 1940s by local contractor Tony Brazil.

P5b. Description of Photo: (View, date, accession #) Photograph 1: North and west elevations, camera facing southeast, June 15, 2021.

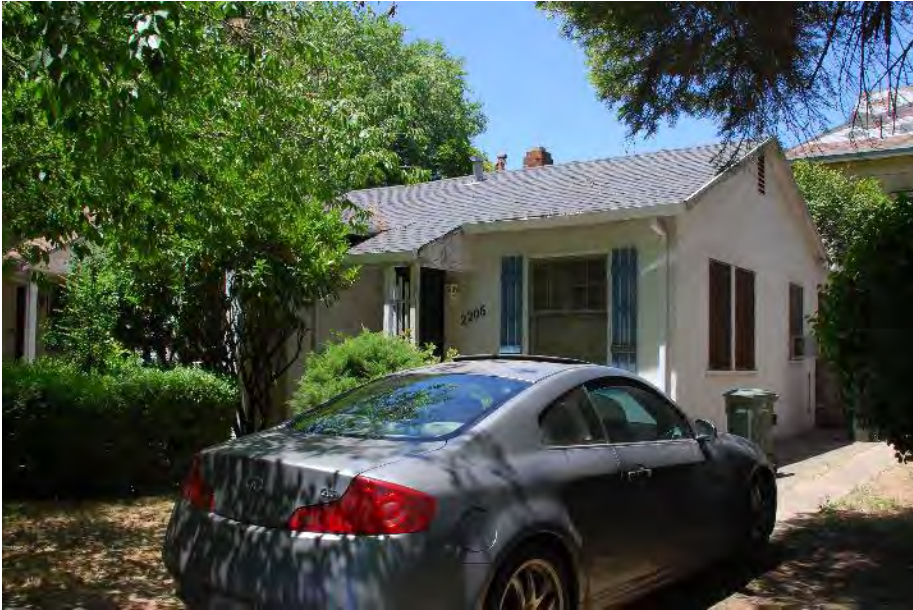
**\*P3a. Description:** (Describe resource and its major elements. Include design, materials, condition, alterations, size, setting, and boundaries)  
The one-story residence, which exhibits elements of Minimal-Traditional architecture, has a rectangular plan and medium-pitched side-gabled roof with louvered vents on the gable ends and minimal eaves. It is clad in textured stucco. The projecting entry porch on the main (east) façade shelters the centered main entrance, which is fitted with a metal security screen. Doubled square wood posts with vertical trim connecting them support the porch at the corner. Fenestration consists of double-hung wood-sash windows. The main façade features a double-hung eight-over-one wood-sash window to the right of the entrance, with decorative wood shutters. A narrow driveway north of the house leads to a small garage at the rear of the property.

P5b. Description of Photo: (View, date, accession #) Photograph 1: East and north elevations, camera facing southwest, June 15, 2021.

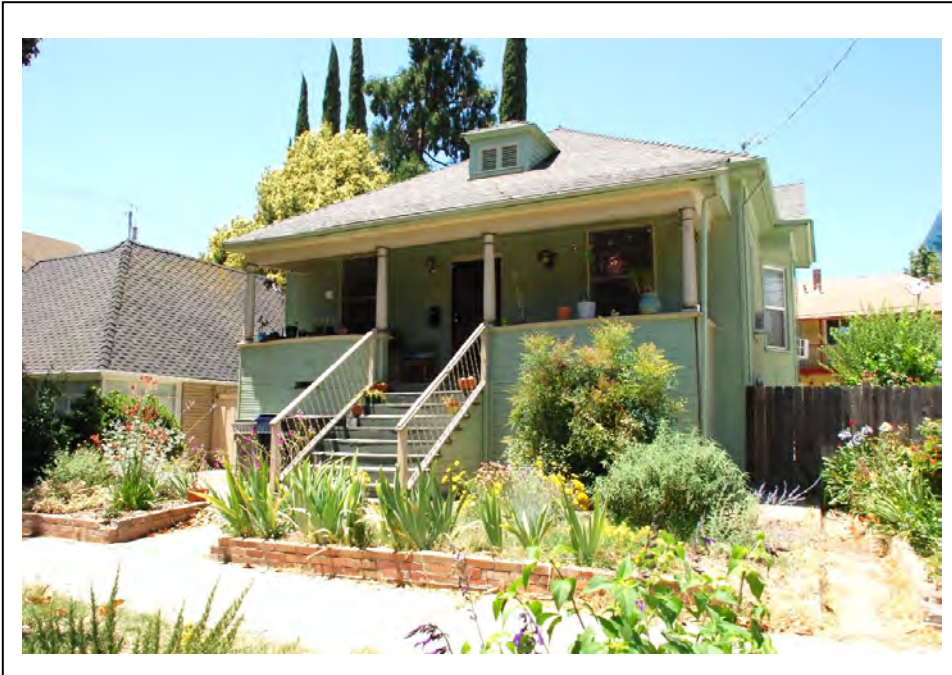
**\*P3a. Description:** (Describe resource and its major elements. Include design, materials, condition, alterations, size, setting, and boundaries)  
The 1.5-story American foursquare residence sits atop a raised basement and has a rectangular plan. It has a medium-pitched hipped roof with a hipped dormer and narrow boxed eaves. Its hipped dormer has two louvered vents. The house is clad in wood clapboard. The integral full-width porch on the main (east) façade shelters the centered main entrance, which is fitted with a metal security screen door and accessed via a wide set of wood steps. Tuscan columns support the porch at the corners and entrance; they rest on the solid clapboard balustrade. Fenestration consists of vinyl replacement windows in rectangular openings.

**P5b. Description of Photo:** (View, date, accession #) Photograph 1: East elevation, camera facing southwest, June 15, 2021.

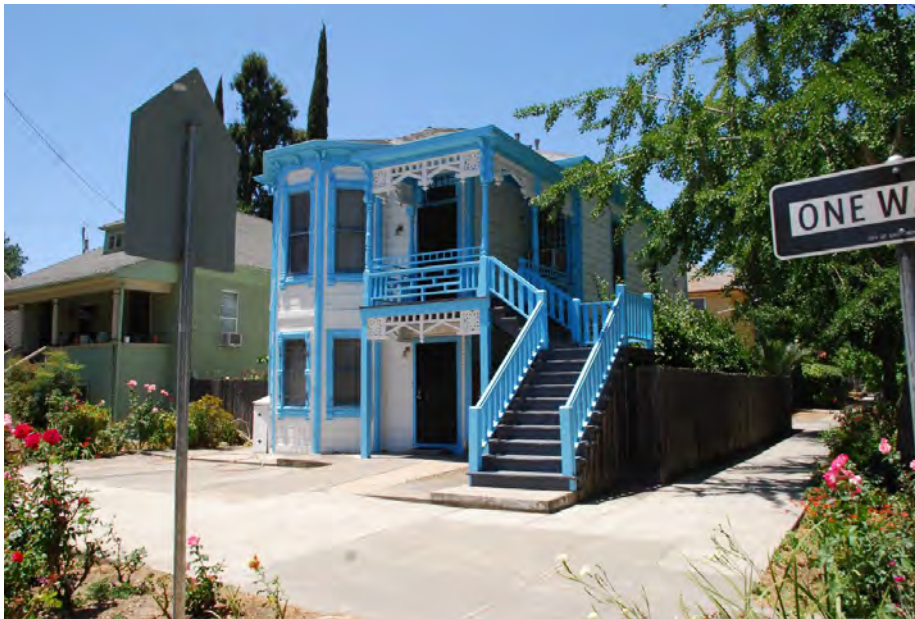
\*P3a. Description: (Describe resource and its major elements. Include design, materials, condition, alterations, size, setting, and boundaries)  
The two-story Italianate residence has a rectangular plan and hipped roof with a projecting volume at the south side of the main (east) façade. It appears to be an original race-basement house that was converted to a two story. The eaves are boxed and feature decorative corbels and frieze. It is clad in wood drop siding. A partial-width porch shelters entrances on the first and second floors; both are fitted with a metal security screen doors. The second floor porch accessed via a tall set of wood steps that turn at a landing. The porch has elaborate ornamental trim, turned wood posts, and balustrade with elaborate geometric pattern. Fenestration consists of double-hung wood sash windows in rectangular openings with elaborate decorative casings. The projecting south end of the main façade features cutaway bay windows.

P5b. Description of Photo: (View, date, accession #) Photograph 1: East and north elevations, camera facing southwest, June 15, 2021.

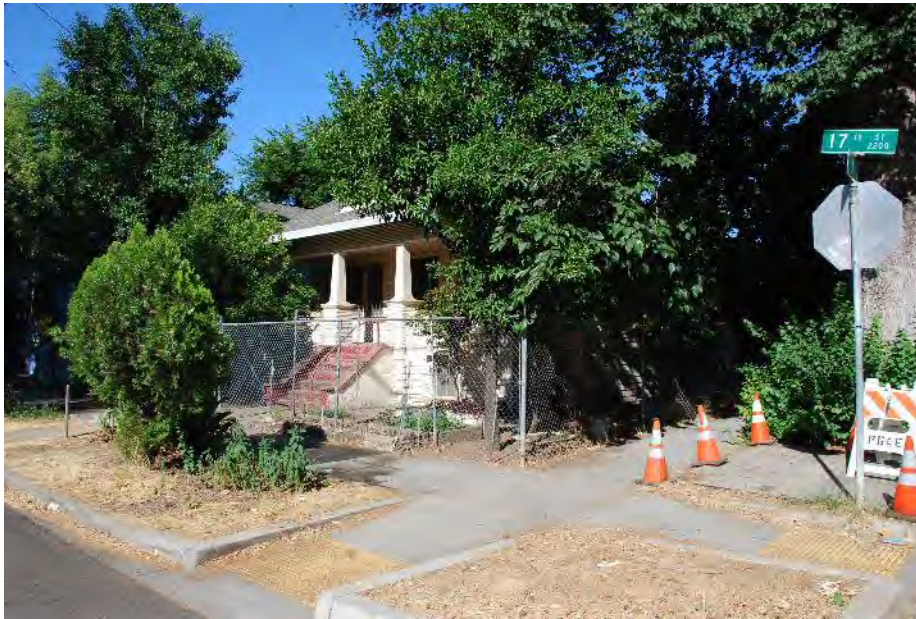
\*P3a. Description: (Describe resource and its major elements. Include design, materials, condition, alterations, size, setting, and boundaries)  
The one-story residence, which exhibits elements of Four-Square architecture, sits atop a raised basement and has a rectangular plan and medium-pitched hipped roof with exposed rafter tails. There is an eyebrow dormer with a louvered vent on the main (east) façade. The building is clad in horizontal wood clapboard, which is mostly narrow but wider at the basement level. The full-width porch on the main (east) façade shelters the centered main entrance, which has a metal security screen door and is accessed via a wide set of concrete steps with a metal handrail on the right. Battered wood columns with capitals and bases support the porch at the corners and entrance and rest on heavy piers, clad in the same clapboard as the house; the balustrade is solid. Fenestration consists of double-hung wood-sash windows. There is a small gabled garage behind the house to the west, accessed from V Street.

P5b. Description of Photo: (View, date, accession #) Photograph 1: East elevation, camera facing southwest, June 15, 2021.

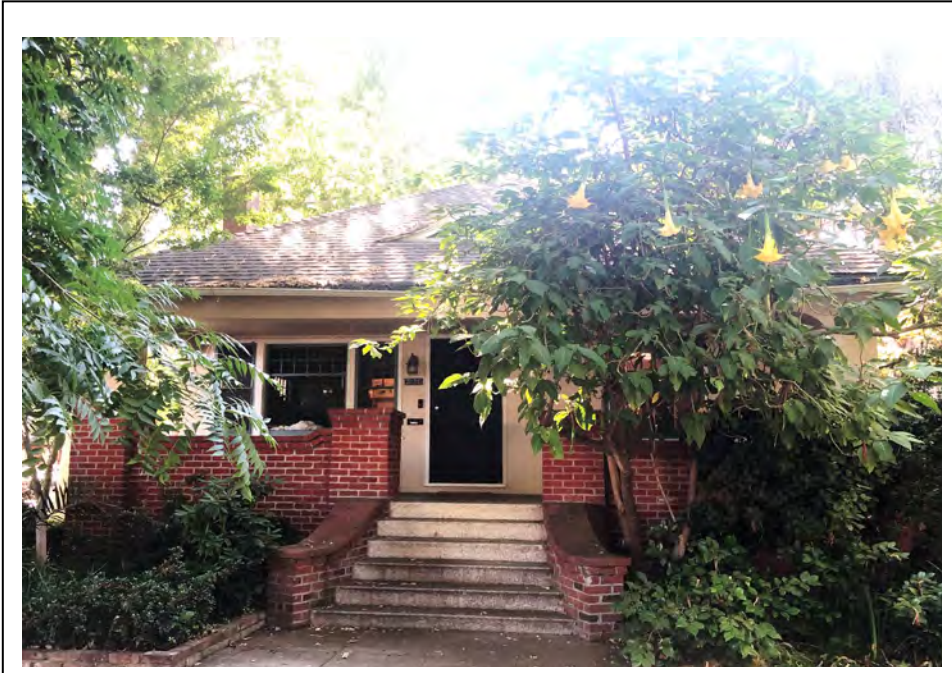
\*P3a. Description: (Describe resource and its major elements. Include design, materials, condition, alterations, size, setting, and boundaries)  
The one-story Craftsman residence sits atop a raised crawlspace and has a rectangular plan. It has a medium-pitched hipped roof with an eyebrow dormer fitted with a louvered vent and exposed rafter tails. It is clad in stucco. The full-width porch on the main (east) façade shelters the centered main entrance, which is fitted with a metal security-screen door. It features a brick balustrade with decorative crown and heavy piers at the corners and entrance. Its wide set of concrete steps flares outward at the bottom and is flanked by brick wing walls with decorative curved tops. Heavy square stucco columns rest on the two corner piers; porch openings are arched. A small area of brick wainscoting adjacent to the porch connects to a corbelled brick chimney on the south elevation. Fenestration consists of fixed and double-hung wood-sash windows in rectangular openings. The main façade features a decorative assemblage of three cottage windows. Side elevations also have some decorative multiple-light windows.

P5b. Description of Photo: (View, date, accession #) Photograph 1: East elevation, camera facing west, photograph taken June 15, 2021.

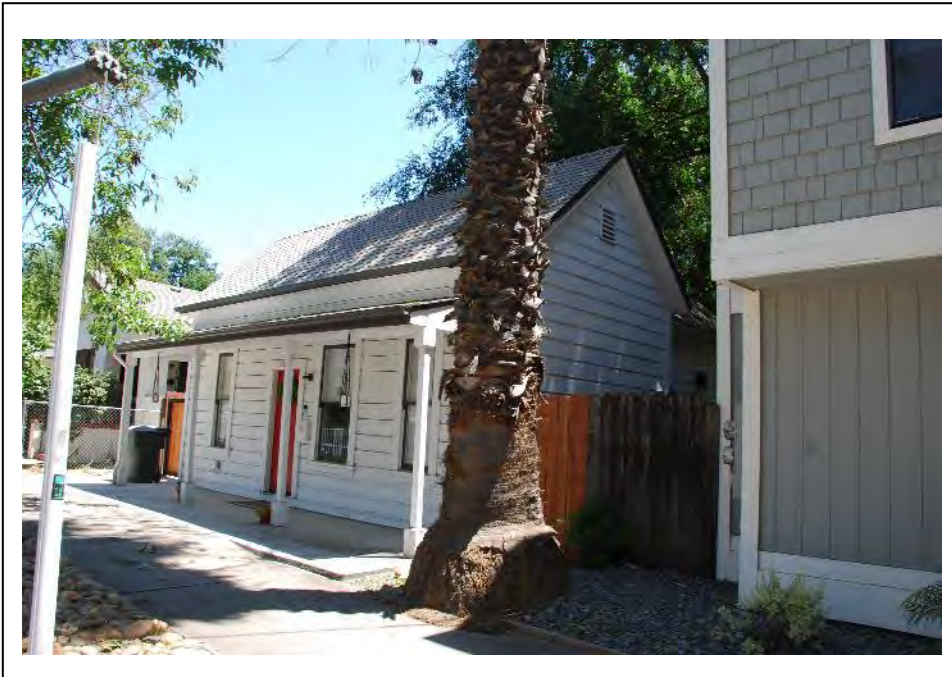
\*P3a. Description: (Describe resource and its major elements. Include design, materials, condition, alterations, size, setting, and boundaries)  
The small one-story Vernacular residence has a rectangular plan and steeply-pitched side-gabled roof with louvered vents on the gable ends and narrow boxed eaves. It is clad in wood drop siding. There is a projecting full-width porch on the main (west) elevation with a shed roof that shelters the main entrance, which is slightly left of center and fitted with a flat wood door. Fenestration consists of double-hung wood sash windows in tall rectangular openings. The concrete porch floor is at grade and the building apparently lacks a crawlspace or basement, extremely unusual for nineteenth century houses in Sacramento

P5b. Description of Photo: (View, date, accession #) Photograph 1: West and south elevations, camera facing northeast, June 15, 2021.

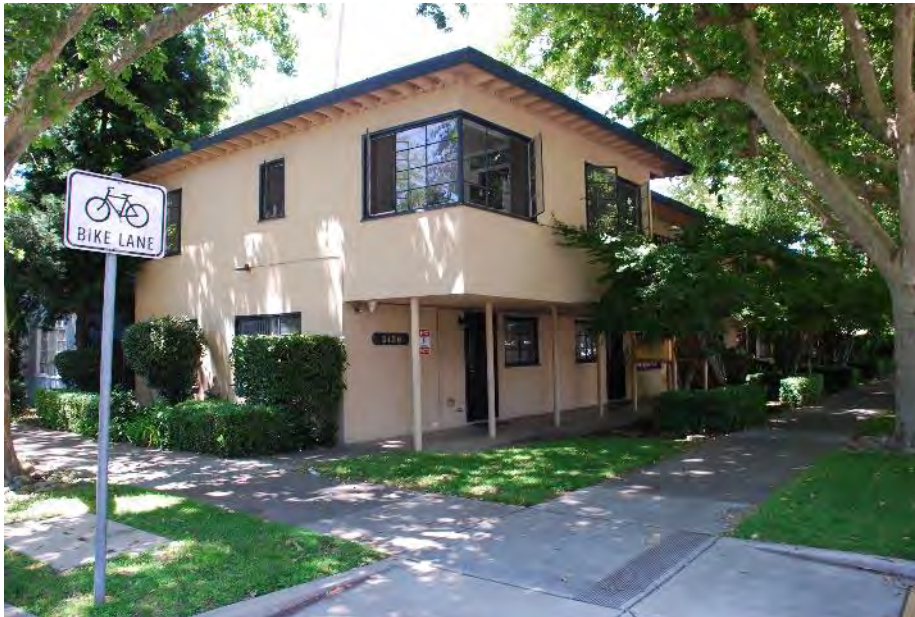
\*P3a. Description: (Describe resource and its major elements. Include design, materials, condition, alterations, size, setting, and boundaries)  
The two-story building, which exhibits elements of Mid-Century Modern architecture, has an L-shaped plan and flat roof with exposed rafter tails. It is identical to two neighboring apartment buildings, 1623 and 1625 V Street. It is clad in stucco. The second story projects on the south end of the east elevation and is supported by round metal columns, sheltering two of the first-floor entrances. A porch on the second story runs along the rest of the east elevation and shelters the first-floor apartment entrances; the balustrade is metal. Second-floor entrances are accessed by an exterior walkway with a metal balustrade. There are sets of concrete steps with metal balustrades leading to the walkway at the north end of the building and at the south, just north of the projecting volume. There is also a projecting second-floor deck with a metal balustrade on the north elevation, supported by round metal columns. The entrances to the apartments are fitted with wood paneled doors. Fenestration consists of multiple-light casement windows.

P5b. Description of Photo: (View, date, accession #) Photograph 1: East and north elevations, camera facing northwest, June 15, 2021.

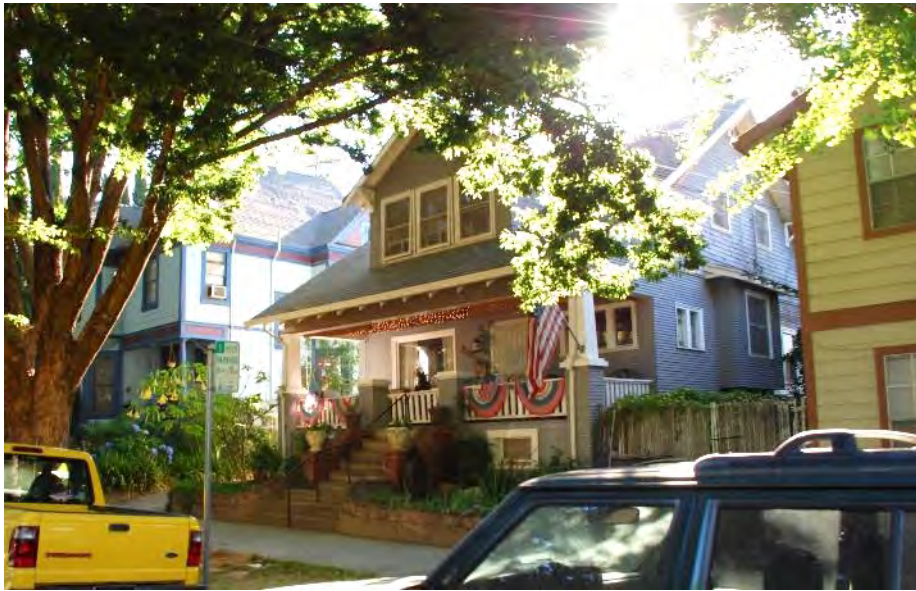
**\*P3a. Description:** (Describe resource and its major elements. Include design, materials, condition, alterations, size, setting, and boundaries)  
The 1.5-story Craftsman residence has a rectangular plan and sits atop a raised basement. The medium-pitched side-gabled roof has exposed rafter tails and triangular knee braces. Gable ends are clad in shingles; the rest of the house is clad in narrow horizontal wood clapboard. There is a large gable dormer on the main (west) façade with three windows. The full-width porch on the main façade shelters the centered main entrance, which has a metal security screen door and is accessed via a long set of concrete steps with brick wing walls and a central metal handrail. Battered wood columns support the porch at the corners and rest on heavy clapboard piers; the balustrade is wood. Fenestration consists of double-hung wood-sash windows with picture windows on the first floor of the main façade.

**P5b. Description of Photo:** (View, date, accession #) Photograph 1: West and south elevations, camera facing northeast, June 15, 2021.

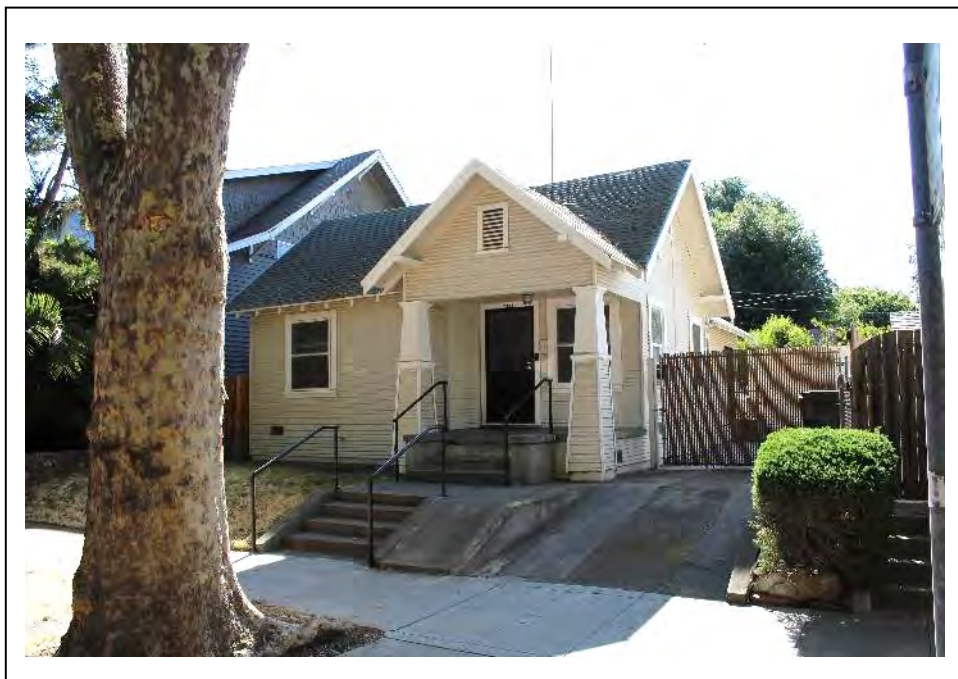
**P5b. Description of Photo:** (View, date, accession #) Photograph 1: West and south elevations, camera facing northeast, June 15, 2021.

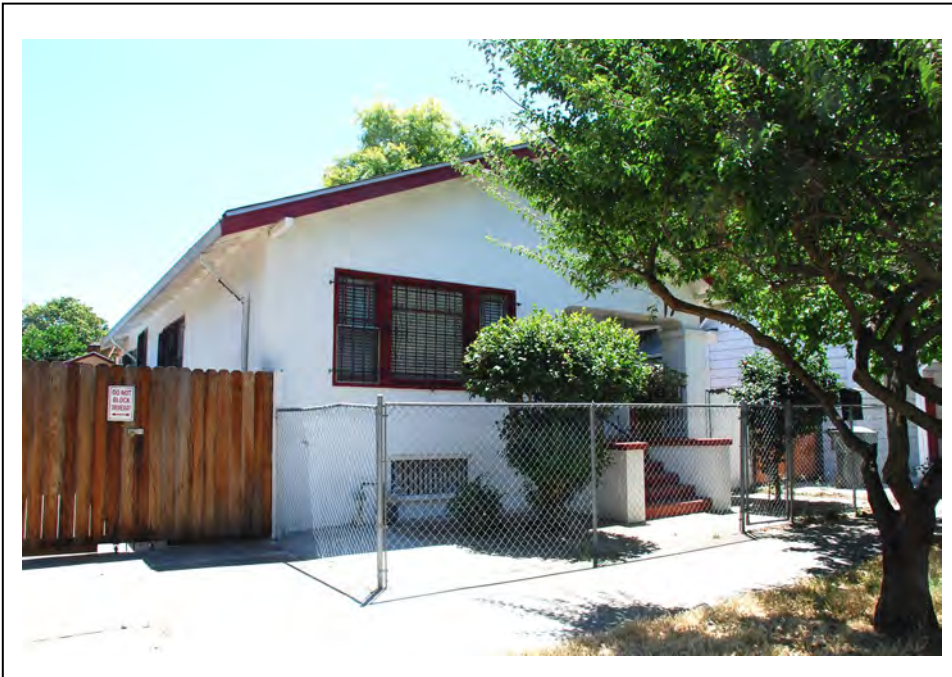
**\*P3a. Description:** (Describe resource and its major elements. Include design, materials, condition, alterations, size, setting, and boundaries)  
The one-story residence, which exhibits elements of Craftsman architecture, has a rectangular plan and gabled roof spray-on roof with vents on the gable ends and exposed rafter tails. It sits above a raised crawlspace and is clad in textured stucco. The integral partial-width porch on the main (west) elevation shelters the main entrance, which is accessed via a set of concrete steps. The entrance faces south rather than facing the street. A heavy stucco column imposed molding supports the porch at the corner; porch openings are rounded. Fenestration consists of a combination of picture and double-hung wood-sash windows. There is a nearly identical house next door at 2117 12th Street.

**P5b. Description of Photo:** (View, date, accession #) Photograph 1: North and west elevations, camera facing southeast, photograph taken June 15, 2021.

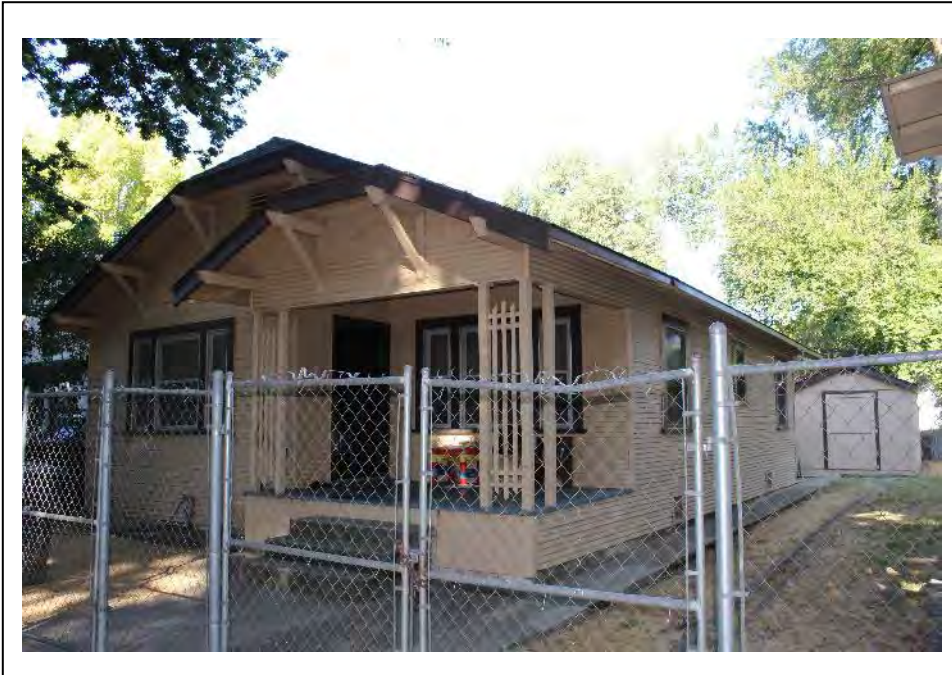
\*P3a. **Description:** (Describe resource and its major elements. Include design, materials, condition, alterations, size, setting, and boundaries)  
The one-story residence, which exhibits elements of Craftsman architecture, has a rectangular plan. The medium-pitched jerkinhead roof has a louvered vent on the gable end and triangular knee braces. Gable ends are clad in shingle; the rest of the house is clad in narrow horizontal wood clapboard. The projecting partial-width porch on the main (east) façade shelters the centered main entrance, which has a paneled wood door and faces north. It is accessed via a short set of concrete steps. Groups of three square wood columns support the porch at the corners. Fenestration consists of double-hung wood-sash windows.

P5b. Description of Photo: (View, date, accession #) Photograph 1: East and north elevations, camera facing northwest, June 15, 2021.

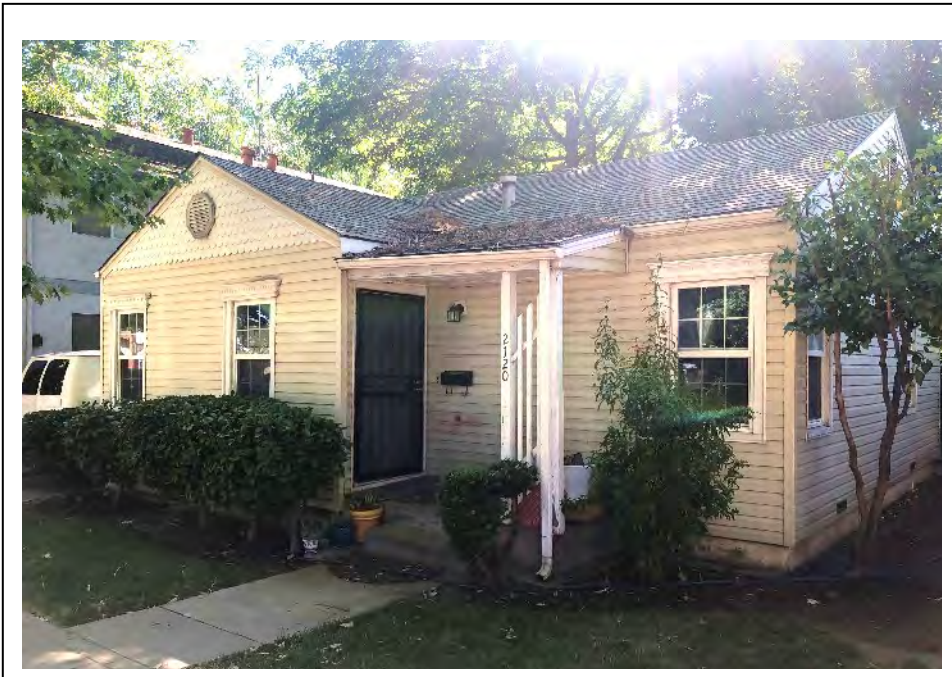
\*P3a. Description: (Describe resource and its major elements. Include design, materials, condition, alterations, size, setting, and boundaries)  
The Minimal Traditional residence one story with an L-shaped plan and medium-pitched cross-gable roof with a round vent on the gable end and minimal eaves. The gable end is clad in wood fishscale shingles; the rest of the house is clad in horizontal wood siding. The projecting partial-width porch on the main (east) façade has a shed roof and shelters the north-facing main entrance, which is accessed via a set of concrete steps and fitted with a security screen door. Fenestration consists of vinyl replacement windows with decorative crowns.

P5b. Description of Photo: (View, date, accession #) Photograph 1: East elevation, camera facing southwest, photograph taken June 15, 2021.

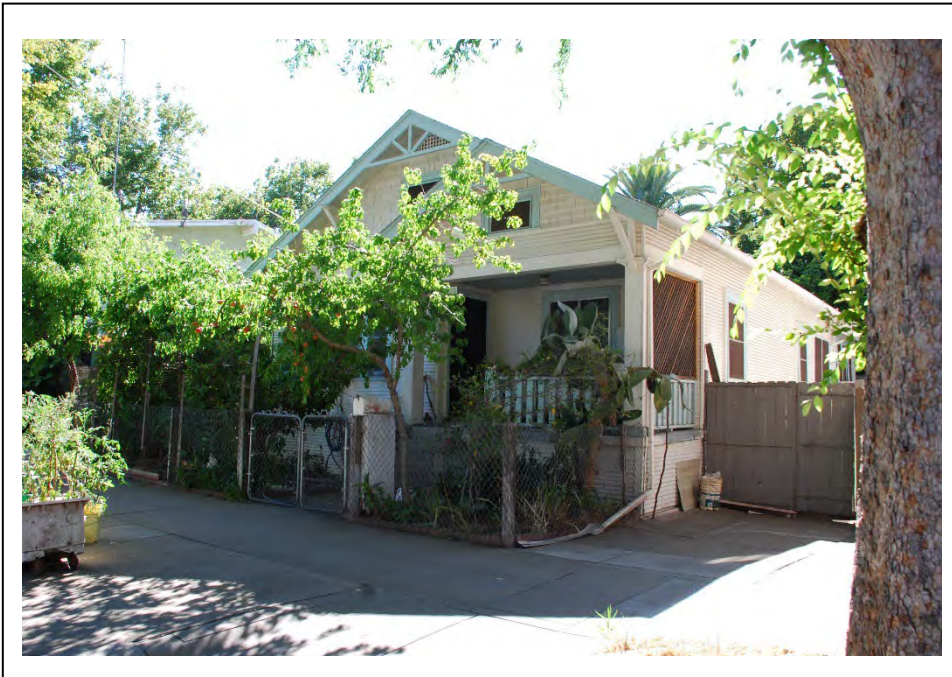
**\*P3a. Description:** (Describe resource and its major elements. Include design, materials, condition, alterations, size, setting, and boundaries)  
The 1.5-story residence, which exhibits elements of Craftsman architecture, sits atop a raised crawlspace and has a rectangular plan and medium-pitched gable roof. The eaves have knee braces and exposed rafter tails. There are decorative windows, trim, and latticed vents at the gable ends. Gable ends are clad in wood shingles; the balance of the house is clad in wood clapboard. The partial-width porch on the main (east) façade shelters the centered main entrance, which faces north and which is accessed via a set of concrete steps. Square columns with capitals and bases support the porch at the corners; the open balustrade is wood. Fenestration consists of double-hung wood-sash windows and some replacement sliding-sash windows.

P5b. Description of Photo: (View, date, accession #) Photograph 1: East and north elevations, camera facing southwest, June 15, 2021.

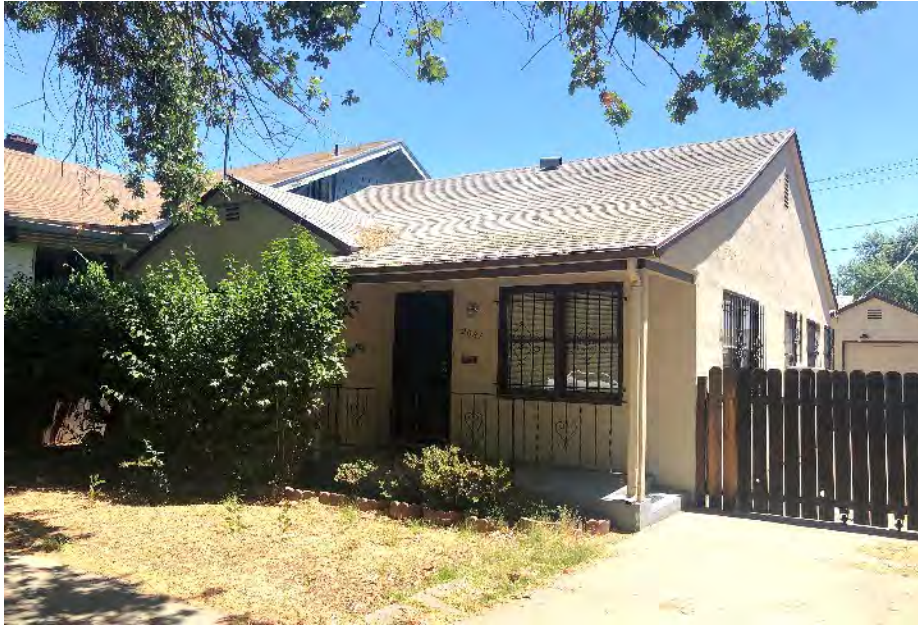
\*P3a. Description: (Describe resource and its major elements. Include design, materials, condition, alterations, size, setting, and boundaries)  
The one-story residence, which exhibits elements of Minimal Traditional architecture, has a rectangular plan and medium-pitched cross-gabled gable roof with vents on the gable ends and minimal eaves. It is clad in stucco. A partial-width integral porch on the main (west) façade shelters the main entrance, which has a metal security door and is accessed via a bowl concrete step. A metal pole supports the porch at the corner; the balustrade is decorative wrought-iron. Fenestration consists of double-hung wood-sash windows, which have wrought-iron security bars. A narrow driveway south of the house leads to a small garage with similar form and materials as the house and a hinged wood door in the vehicle opening.

P5b. Description of Photo: (View, date, accession #) Photograph 1: West and south elevations, camera facing northeast, June 15, 2021.

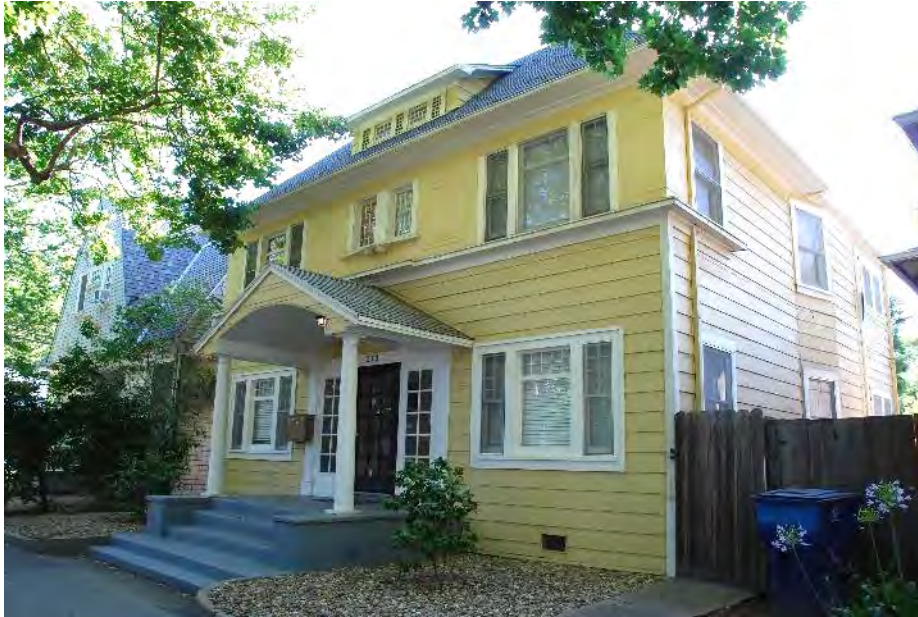
\*P3a. Description: (Describe resource and its major elements. Include design, materials, condition, alterations, size, setting, and boundaries)  
The two-story Colonial Revival residence has a rectangular plan and medium-pitched hipped roof. There is a low shed roof dormer on the main (west) façade that alternates vents with multiple-light fixed windows. The building is clad in horizontal wood drop siding with decorative square wood details on the second story of the main façade. The projecting partial-width porch on the main façade shelters the centered main entrance, which has a fully glazed paneled wood door with side lights and is accessed via a wide set of concrete steps. The porch has a gable roof and round wood columns with capitals and bases support the porch at the corners. Fenestration consists of double-hung wood-sash windows with multiple panes on the upper lights. The main façade features four decorative assemblages of three cottage windows on the main elevation.

P5b. Description of Photo: (View, date, accession #) Photograph 1: West and south elevations, camera facing northeast, June 15, 2021.

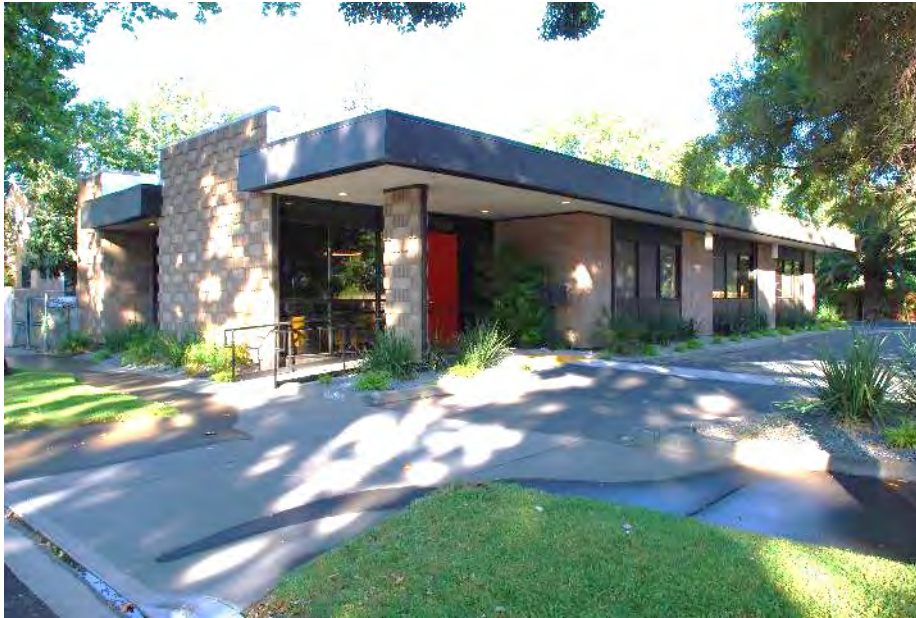
\*P3a. **Description:** (Describe resource and its major elements. Include design, materials, condition, alterations, size, setting, and boundaries)  
The one-story commercial building has a rectangular plan and flat roof with wide overhanging eaves. There is a parapet on the south elevation. On the east façade, projecting walls with decorative brick masonry that are taller than the roof alternate with glazed recessed volumes. The partial-width porch on the main (east) façade shelters the main entrance, which faces north and has a wood door and is accessed via a concrete ramp. A decorative brick masonry column supports the porch at the corner. The north elevation alternates commercial windows with stretches of wall clad in decorative brick masonry.

P5b. Description of Photo: (View, date, accession #) Photograph 1: East and north elevations, camera facing southwest, June 15, 2021.

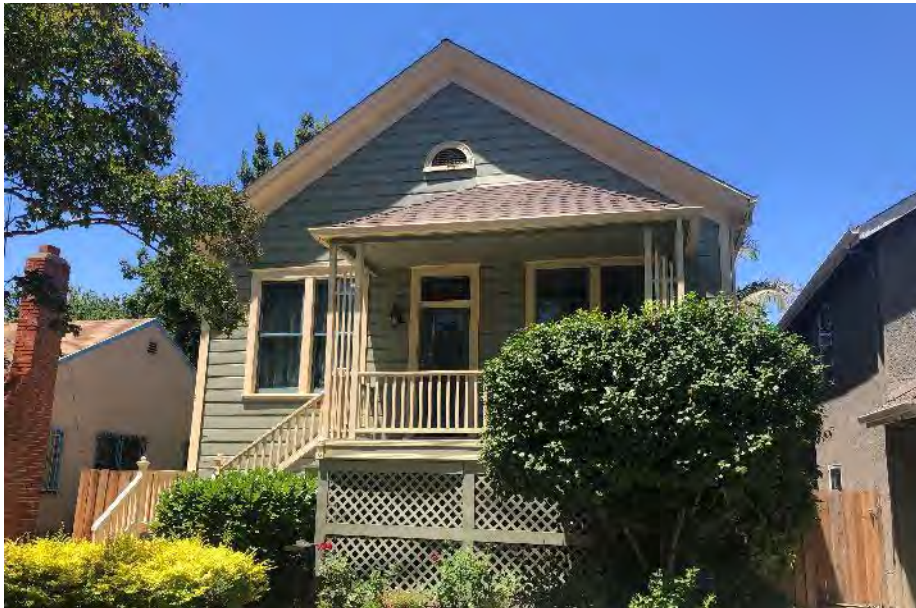
**\*P3a. Description:** (Describe resource and its major elements. Include design, materials, condition, alterations, size, setting, and boundaries)  
The folk Victorian residence sits atop a raised basement and has a rectangular plan. It features a steeply-pitched front-gabled roof with a louvered half round vent on the gable end and narrow eaves. It is clad in wood drop siding. The projecting partial-width porch on the north end of the main (east) façade has a flared hipped roof and shelters the centered main entrance. It is fitted with a multiple-light glazed wood door and transom, and is accessed from the south via a tall set of wooden steps with landing. Doubled wood posts connected by decorative trim support the porch at the corners; their style indicates that original porch supports were replaced after 1945. The simple open balustrade is wood. Fenestration consists of double-hung wood-sash windows in with decorative crowns. There is a narrow driveway south of the house.

**P5b. Description of Photo:** (View, date, accession #) Photograph 1: East elevation, camera facing west, June 15, 2021.

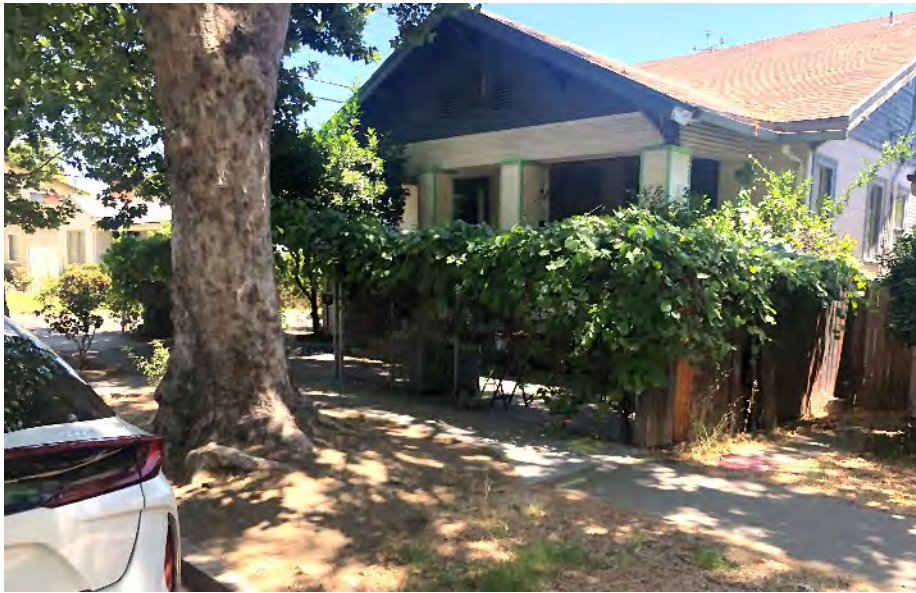
P5b. Description of Photo: (View, date, accession #) Photograph 1: West elevation, camera facing northeast, June 15, 2021.

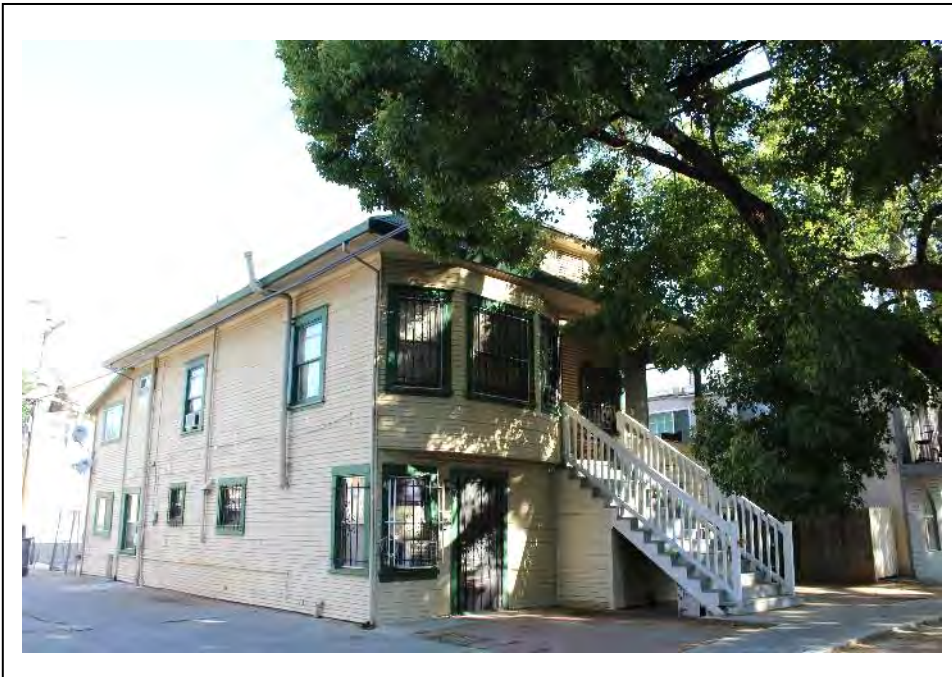
P5b. Description of Photo: (View, date, accession #) Photograph 1: West and south elevations, camera facing northwest, June 15, 2021.

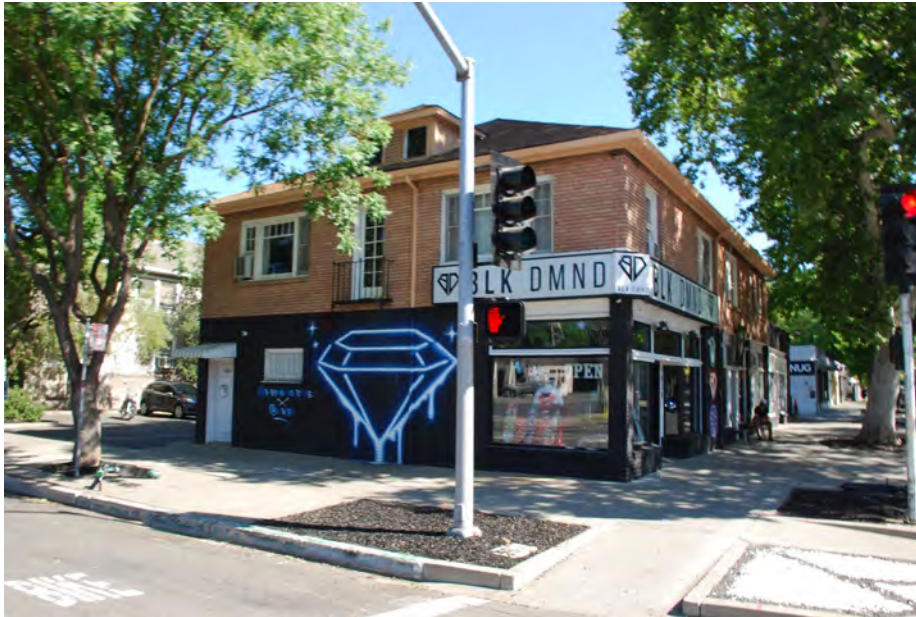
**P5b. Description of Photo:** (View, date, accession #) Photograph 1: South and east elevations, camera facing northwest, June 15, 2021.

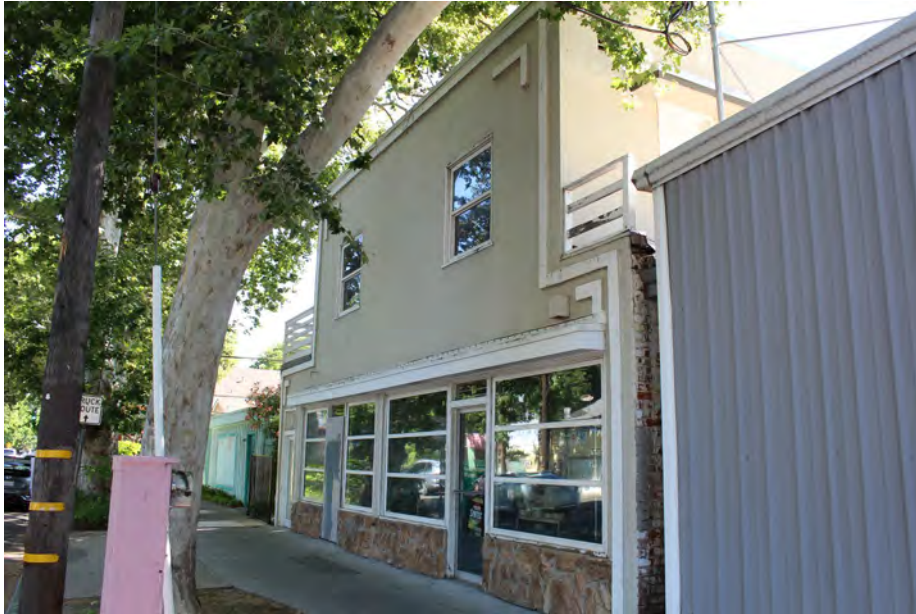
P5b. Description of Photo: (View, date, accession #) Photograph 1: West elevation, camera facing northeast, June 15, 2021.

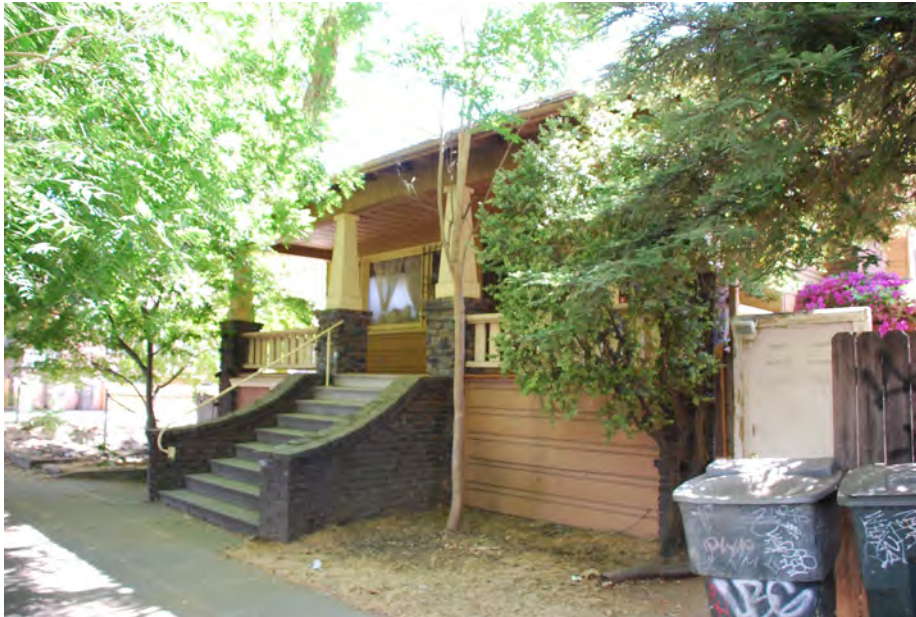
P5b. Description of Photo: (View, date, accession #) Photograph 1: West elevation, camera facing northeast, June 15, 2021.

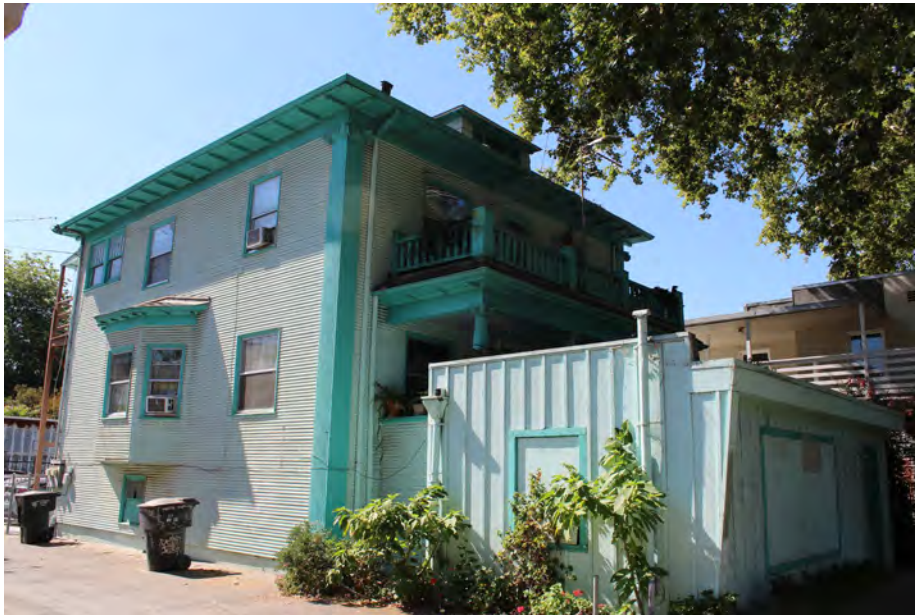
**P5b. Description of Photo:** (View, date, accession #) Photograph 1: North and west elevations, camera facing northeast, June 15, 2021.

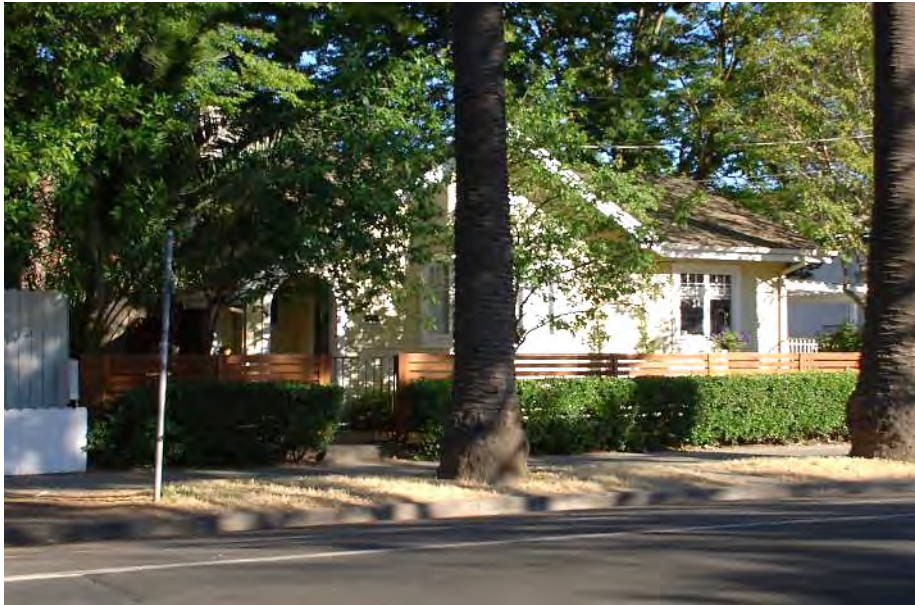
P5b. Description of Photo: (View, date, accession #) Photograph 1: East elevation, camera facing northwest, June 15, 2021.

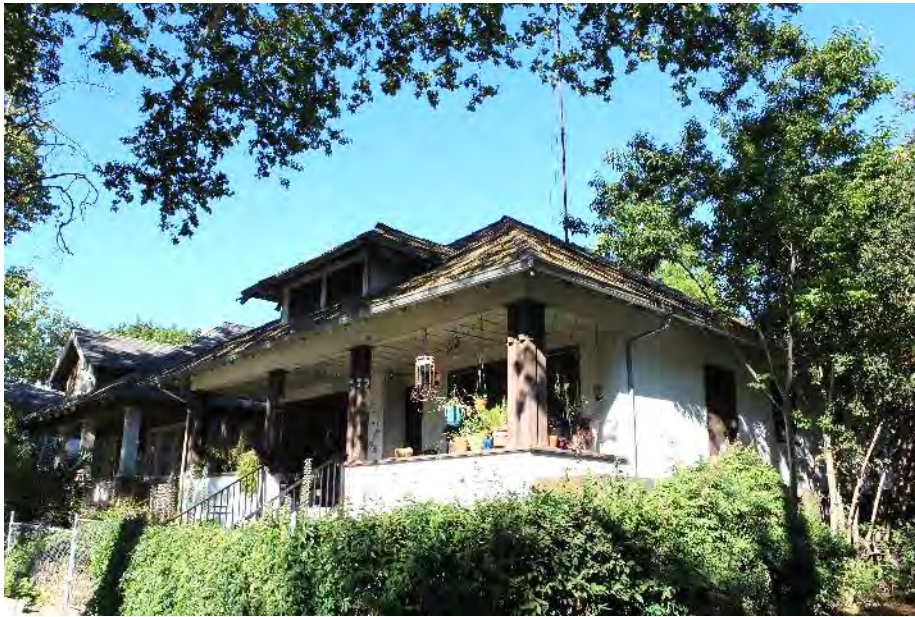
P5b. Description of Photo: (View, date, accession #) Photograph 1: East elevation, camera facing southwest, June 15, 2021.

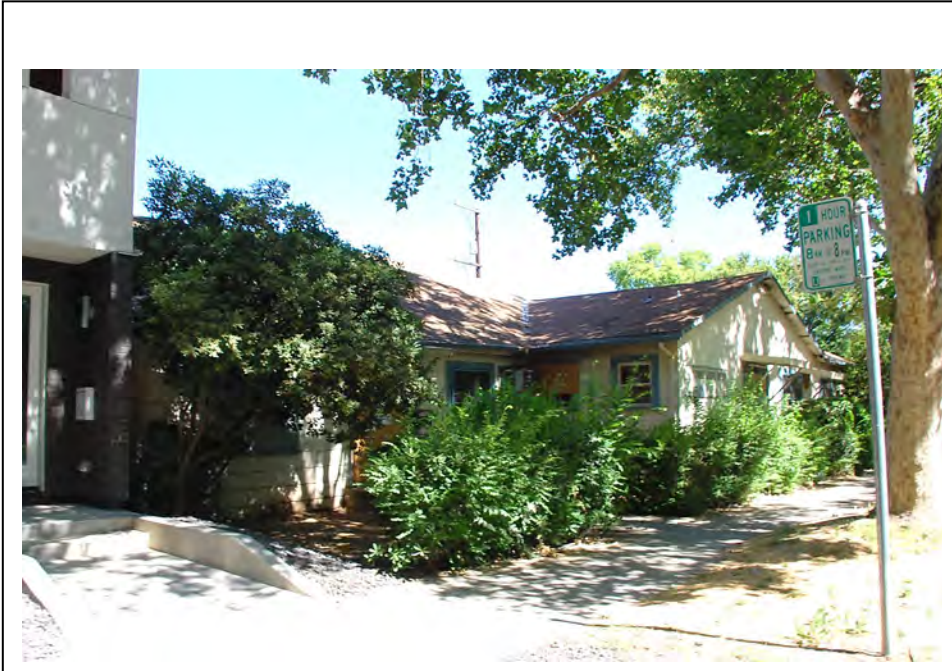
**P5b. Description of Photo:** (View, date, accession #) Photograph 1: East elevation, camera facing northwest, June 15, 2021.
