State of California – The Resources Agency  
DEPARTMENT OF PARKS AND RECREATION  
PRIMARY RECORD

\*Resource Name or # (Assigned by recorder) 2209 14<sup>th</sup> Street

c. Address 2209 14<sup>th</sup> Street City Sacramento Zip 95818

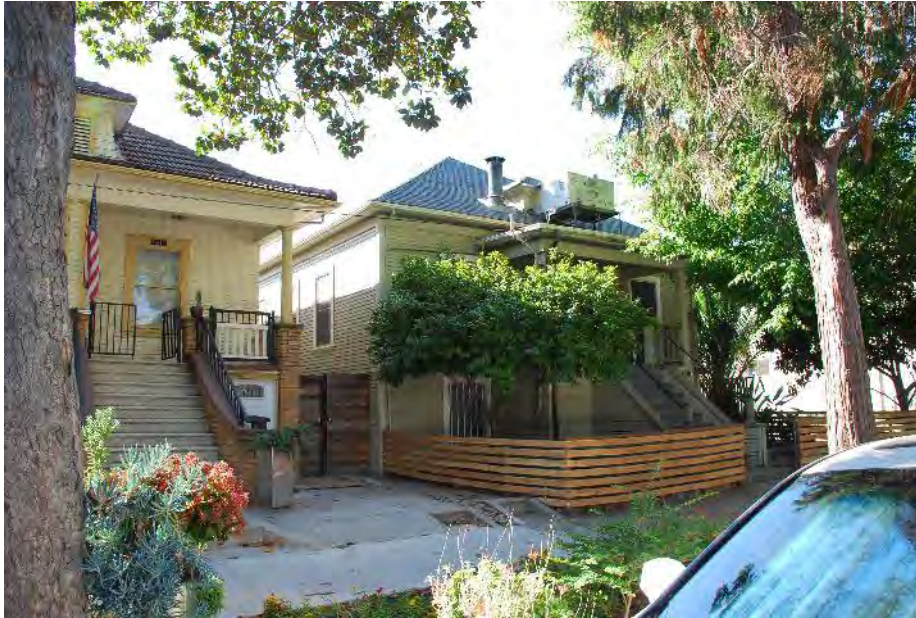
**P5b. Description of Photo:** (View, date, accession #) Photograph 1: West and south elevations, camera facing northeast, June 15, 2021.

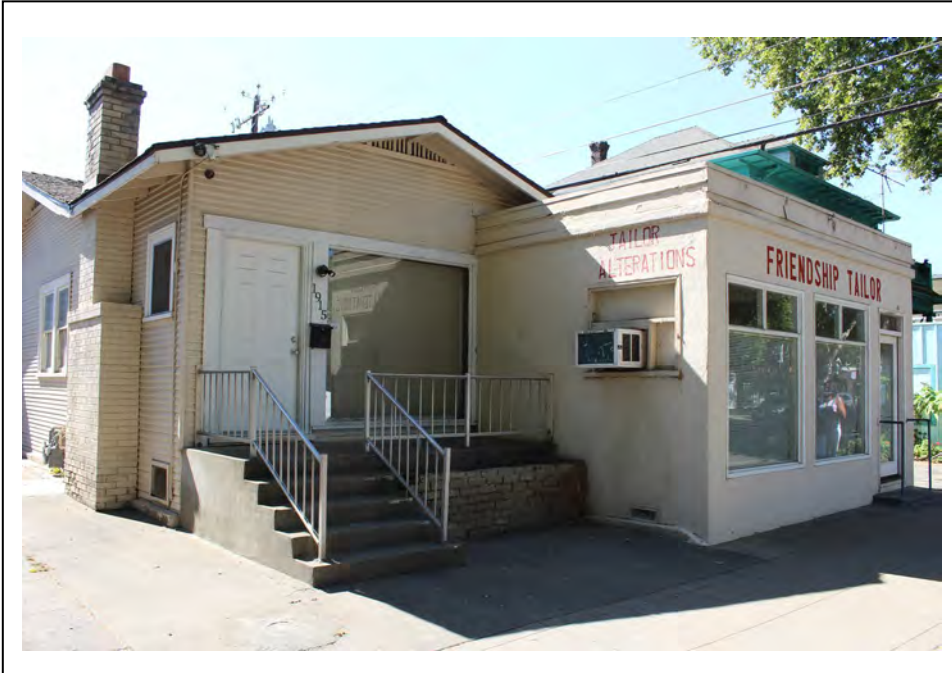
**P5b. Description of Photo:** (View, date, accession #) Photograph 1: North and west elevations, camera facing southeast, June 15, 2021.

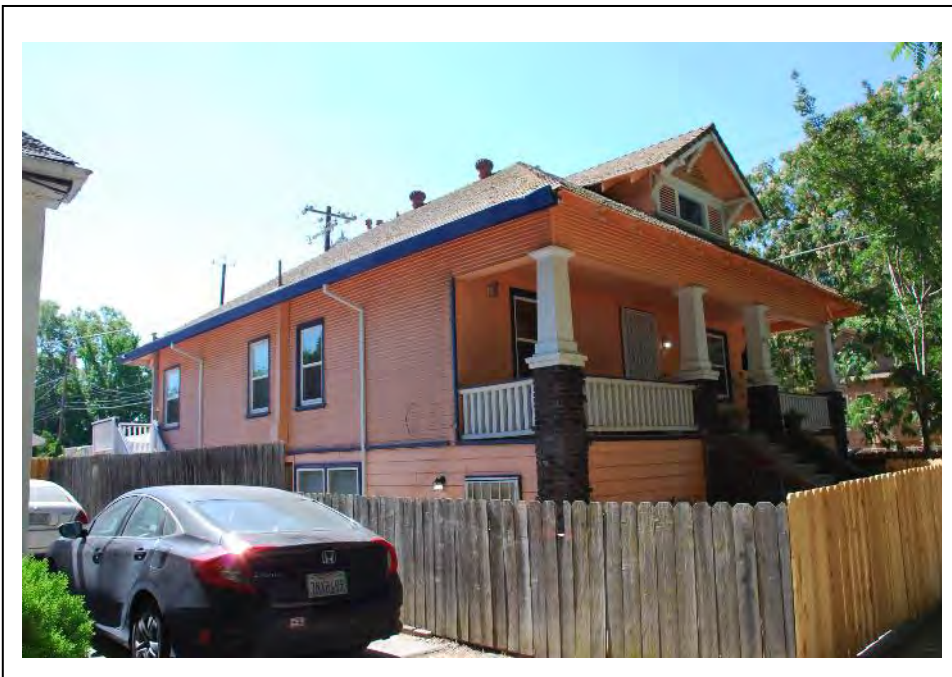
**P5b. Description of Photo:** (View, date, accession #) Photograph 1: North and west elevations, camera facing southeast, June 15, 2021.

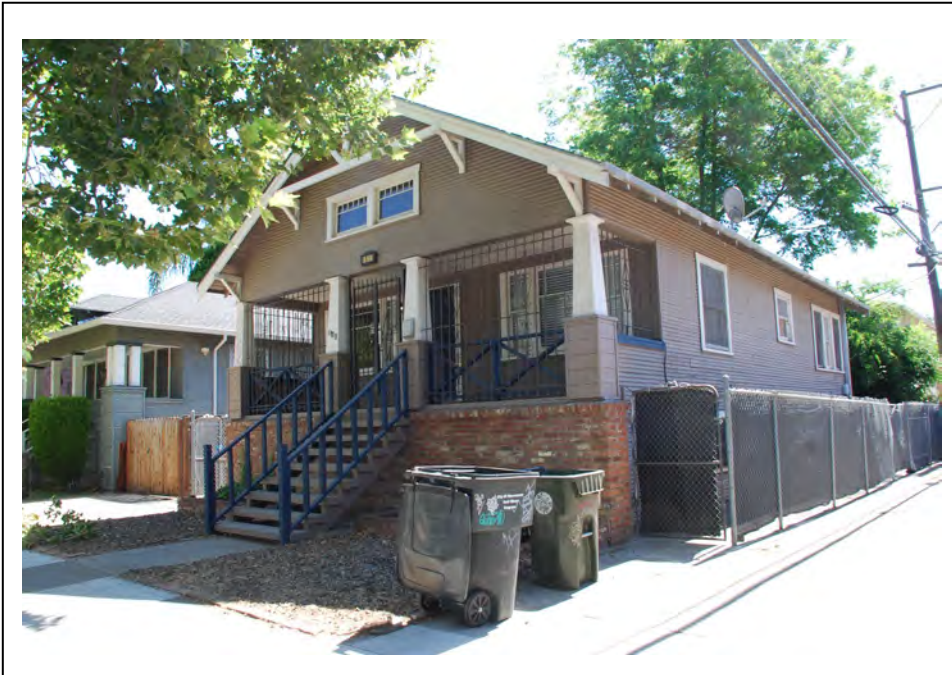
**P5b. Description of Photo:** (View, date, accession #) Photograph 1: West and south elevations, camera facing northeast, June 15, 2021.

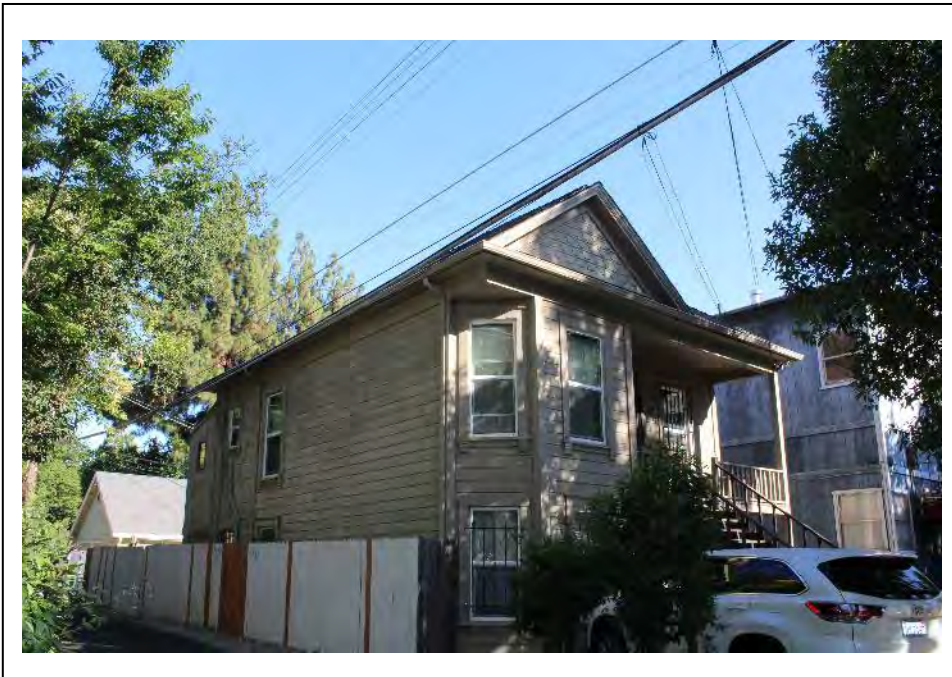
**P5b. Description of Photo:** (View, date, accession #) Photograph 1: South and east elevations, camera facing northwest, June 15, 2021.

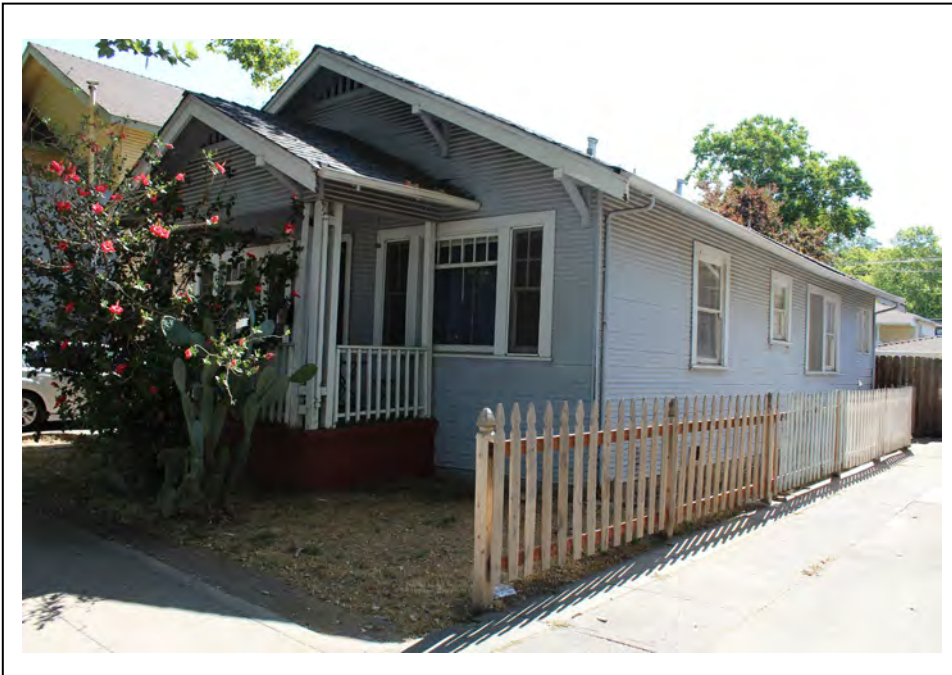
\*P3a. **Description:** (Describe resource and its major elements. Include design, materials, condition, alterations, size, setting, and boundaries)  
The one-story residence, which exhibits elements of Craftsman architecture, has a rectangular plan. The medium-pitched front-gabled roof has vents on the gable ends, exposed beams, and triangular knee braces. It is clad in horizontal wood clapboard. The projecting partial-width porch on the main (west) façade shelters the centered main entrance, which has a partially glazed paneled wood door and is accessed from the left via a wide set of concrete steps. Square wood columns support the porch at the corners; the balustrade is wood. Fenestration consists of double-hung wood-sash windows; those on the main façade have four upper lights. The main façade features two decorative assemblages of three cottage windows on either side of the entrance.

P5b. Description of Photo: (View, date, accession #) Photograph 1: West and south elevations, camera facing northeast, June 15, 2021.

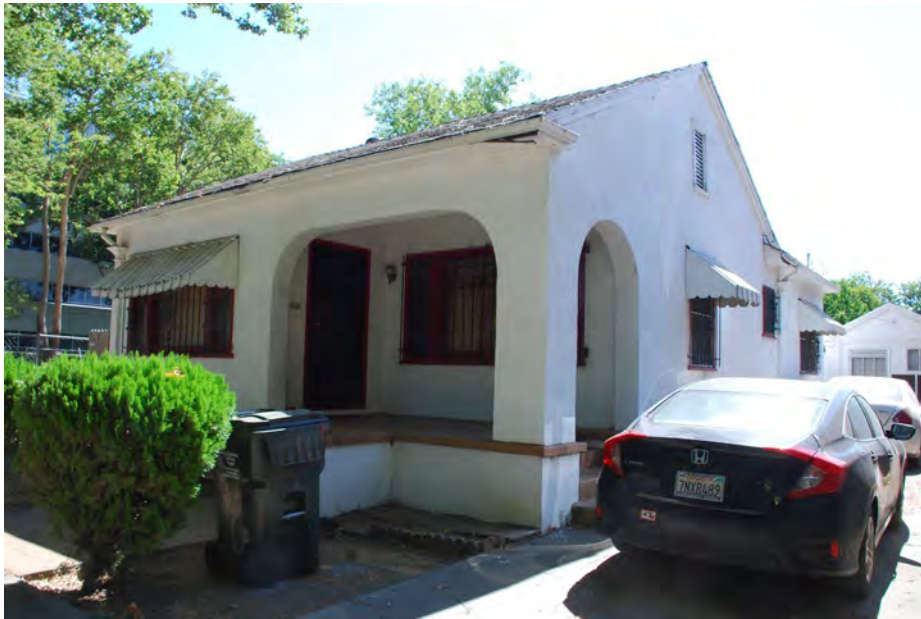
**\*P3a. Description:** (Describe resource and its major elements. Include design, materials, condition, alterations, size, setting, and boundaries)  
The one-story residence, which exhibits elements of Tudor architecture, sits atop a raised crawlspace and has a rectangular plan. Its medium-pitched side-gabled roof has returns and louvered vents on the gable ends; eaves are minimal. It is clad in stucco siding. There is a partial-width porch on the main (west) façade with arched openings at the west and south. That shelters the centered main entrance, which has a metal security-screen door and is accessed from the west and south via low sets of concrete steps. Fenestration consists of double-hung wood-sash windows with awnings. A long driveway to the south of the house leads to a small single-car garage at the rear of the property, which has been converted to an ancillary dwelling and has a window and human-scale door on its main façade rather than a vehicle door.

**P5b. Description of Photo:** (View, date, accession #) Photograph 1: West and south elevations, camera facing northeast, June 15, 2021.

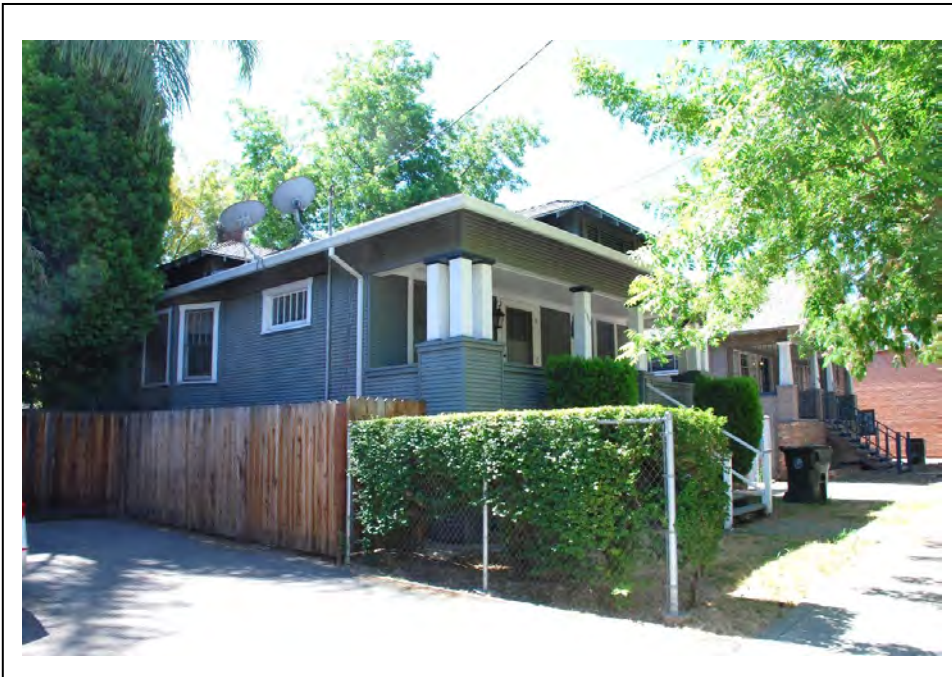
**\*P3a. Description:** (Describe resource and its major elements. Include design, materials, condition, alterations, size, setting, and boundaries)  
The residence, which exhibits elements of Craftsman architecture, is set back about 25 feet from 13<sup>th</sup> Street. The 1.5-story house sits atop a raised basement. The building has a rectangular plan and medium pitch hipped roof with hipped dormers fitted with louvered vents. Dormers and primary roof have exposed rafter tails. The house is clad in narrow wood clapboard. The full-width integral porch on the main (west) façade shelters the centered main entrance, which is fitted with a partially glazed paneled wood door and accessed via a wide set of wood steps. Square columns with capitals and bases support the porch and rest on heavy corner piers, which are clad in the same clapboard as the house; the balustrade is solid. Single columns flank the porch stairs, the corners of the porch feature three grouped columns. Fenestration consists of double-hung wood-sash windows.

**P5b. Description of Photo:** (View, date, accession #) Photograph 1: North and west elevations, camera facing southeast, June 15, 2021.

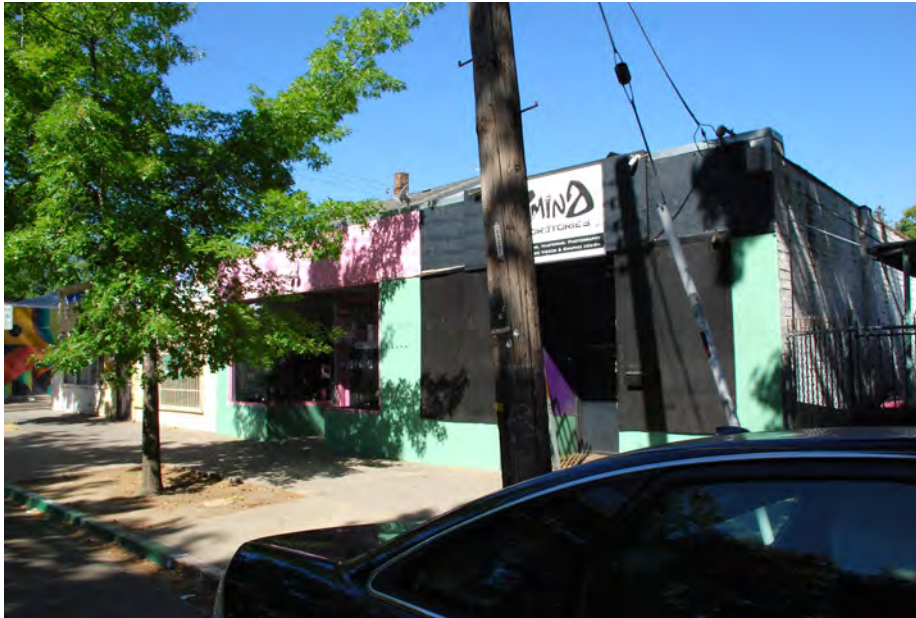
\*P3a. **Description:** (Describe resource and its major elements. Include design, materials, condition, alterations, size, setting, and boundaries)  
The one-story storefront commercial building has a rectangular plan and flat roof with a parapet on the main (east) facade. It is brick construction and its parapet is clad in stucco on east elevation. The main façade below the parapet is clad in ceramic tile. There are two recessed entrances flanked by large display windows on the main façade. The storefront to the left has fully glazed wood doors and wood-frame display windows. The entrance to the storefront to the right is obscured by a metal security door, and windows are covered. A box-type sign is affixed above the entrance to the right storefront. The north (side) elevation lacks fenestration.

P5b. Description of Photo: (View, date, accession #) Photograph 1: East and north elevations, camera facing southwest, June 15, 2021.

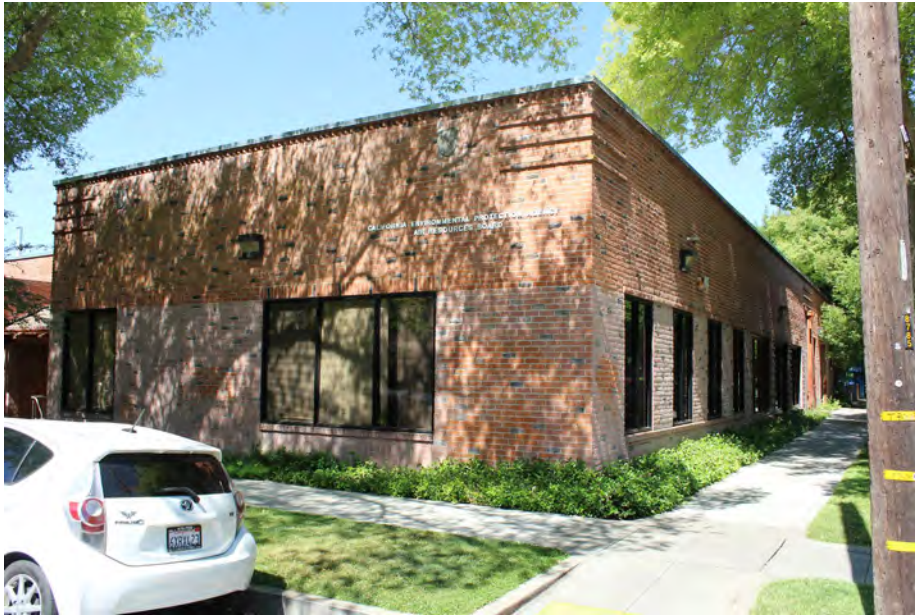
\*P3a. **Description:** (Describe resource and its major elements. Include design, materials, condition, alterations, size, setting, and boundaries)  
The one-story commercial building has an L-shaped plan and flat roof with minimal eaves. It is made of brick. The projecting partial-width porch on the main (east) façade has a steeply pitched clay tile shed roof. It shelters the main entrance, which is right of center and fitted with a paneled wood door and two commercial picture windows on either side. A projecting brick wall encloses the porch on its left side. Fenestration consists of commercial picture windows. A parking lot sits in front of the main façade to the left of the entry porch; there is a metal roll-up garage door.

P5b. Description of Photo: (View, date, accession #) Photograph 1: East and north elevations, camera facing southwest, June 15, 2021.

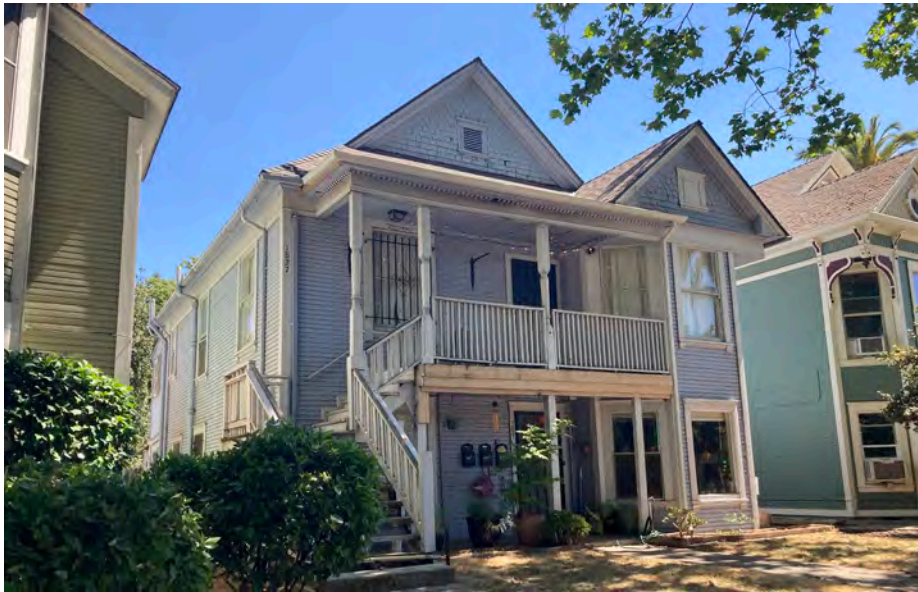
The two-story Queen Anne duplex has a rectangular plan and steeply-pitched gable-on-hip roof with louvered vents or decorative fixed windows on the gable ends and boxed eaves. Gable ends are clad in fishscale shingles; the balance of the house is clad in narrow wood siding. The partial-width porch on the main (south) façade shelters the centered upper and lower entrances, which have metal security screen doors. The second-story entrance is accessed from the west via a set of wood steps. Turned wood posts support the second floor porch at the corners; the tall replacement balustrade is wood. The porch is supported by plain square posts on the ground floor, which has been converted from an original basement to residential space. The cornice of the porch has dentil molding. Fenestration consists of double-hung wood-sash windows. The main façade features a two-story cutaway bay east of the entrance.

P5b. Description of Photo: (View, date, accession #) Photograph 1: West and south elevations, camera facing northeast, June 15, 2021.

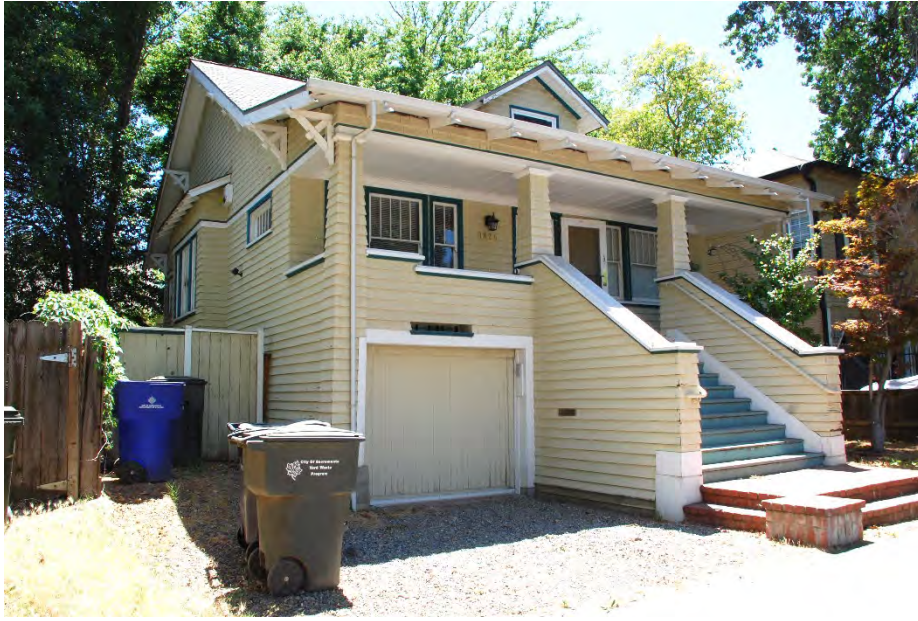
\*P3a. Description: (Describe resource and its major elements. Include design, materials, condition, alterations, size, setting, and boundaries)  
The 1.5-story Craftsman residence has a rectangular plan and medium-pitched gable roof with a gable dormer. It features decorative knee braces and shaped rafter tails. It is clad in wood lap siding with wood shingle at the dormer and gable ends. The projecting full-width porch on the main (north) façade shelters the centered main entrance, which has a fully-glazed wood door and is accessed via a wide set of wood steps. Square piers, clad in the same wood lap siding as the house, support the battered porch columns at the corners and entrance; the balustrade is solid. Fenestration consists of double-hung wood-sash windows. The main façade features two decorative assemblages of three cottage windows on either side of the entrance. A wood garage door is at the basement level east of the stairs. There is a square projecting window bay on the east elevation with its own shed roof.

P5b. Description of Photo: (View, date, accession #) Photograph 1: North and east elevations, camera facing southwest, June 15, 2021.

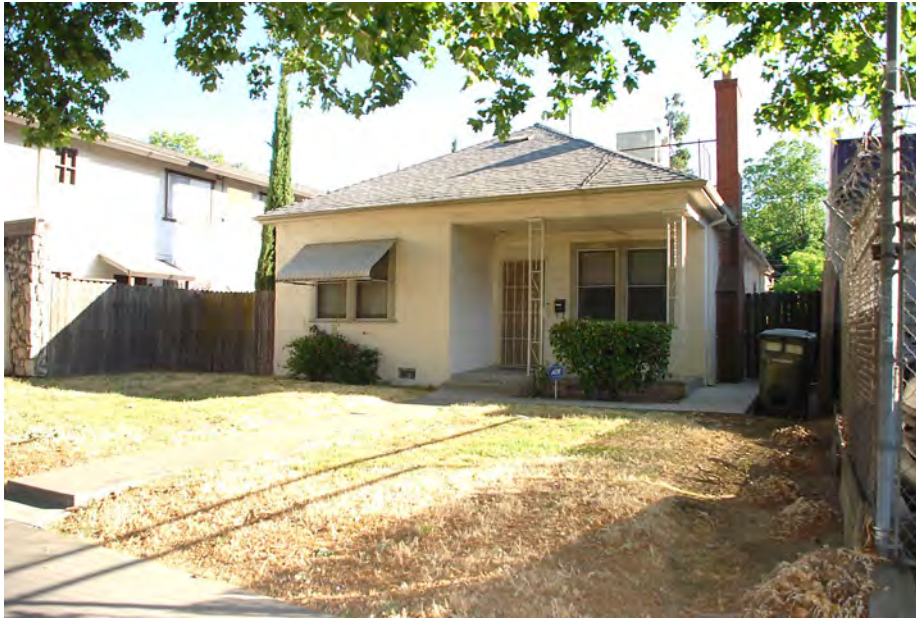
\*P3a. Description: (Describe resource and its major elements. Include design, materials, condition, alterations, size, setting, and boundaries)  
The one-story residence, which exhibits elements of Minimal-Traditional architecture, has a rectangular plan and medium-pitched hipped roof with minimal eaves. It is clad in stucco. The partial-width integral porch on the main (south) façade shelters the main entrance, which is right of center and is fitted with a metal security screen door. The porch is accessed via a low set of concrete steps. Decorative wrought-iron posts support the porch at the corners and entrance. Fenestration consists of double-hung wood-sash windows. The windows to the left of the entrance on the main façade are sheltered by an awning.

P5b. Description of Photo: (View, date, accession #) Photograph 1: South elevation, camera facing northwest, June 15, 2021.

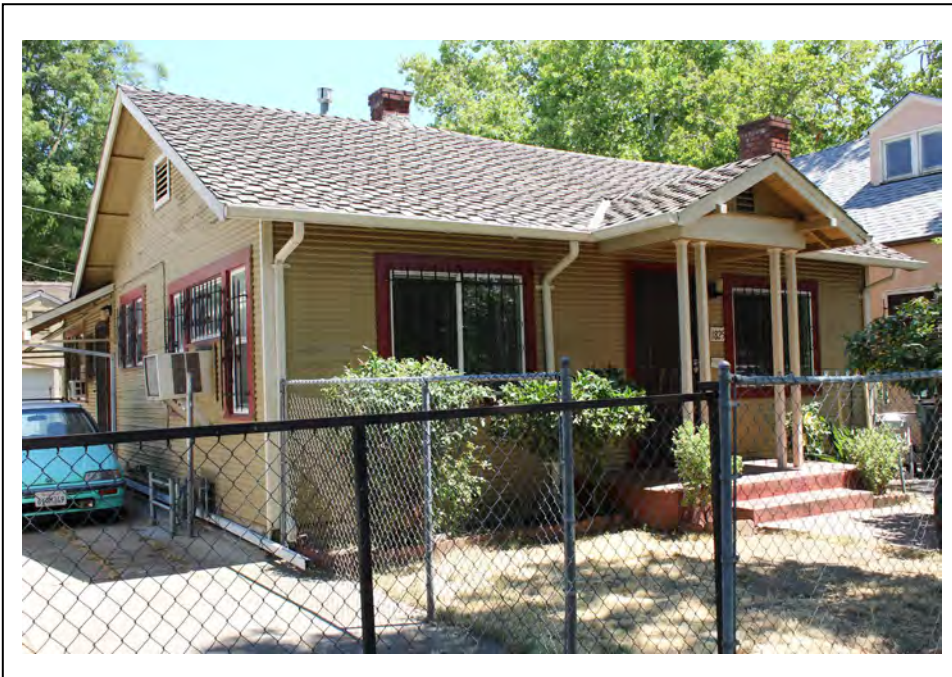
\*P3a. Description: (Describe resource and its major elements. Include design, materials, condition, alterations, size, setting, and boundaries)  
The one-story residence, which exhibits elements of Craftsman architecture, has a rectangular plan. The medium-pitched side-gabled roof has louvered vents on the gable ends and exposed roof beams. The building is clad in narrow horizontal wood clapboard. The projecting partial-width porch on the main (south) façade shelters the centered main entrance, which has a metal security screen door and is accessed via a low set of concrete steps. Pairs of square wood columns with capitals support the porch at the corners. Fenestration consists of replacement aluminum sliding windows.

P5b. Description of Photo: (View, date, accession #) Photograph 1: West and south elevations, camera facing northeast, June 15, 2021.

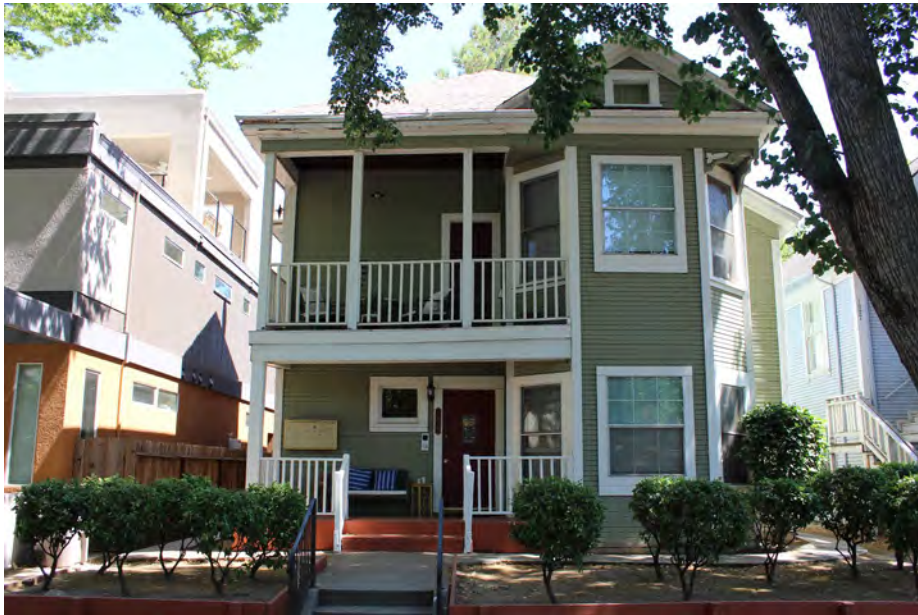
\*P3a. Description: (Describe resource and its major elements. Include design, materials, condition, alterations, size, setting, and boundaries)  
The 2.5 the-story residence, which exhibits elements of Queen Anne architecture, has a rectangular plan and medium-pitched gable-on-hip roof with boxed eaves. Gable end has a fixed decorative window and is clad in wood shingle; the balance of the house is clad in narrow drop siding. The two-story all partial-width porch on the main (south) façade shelters the centered entrances on both levels. The second-story entrance is fitted with a wood paneled door and is accessed only from the interior of the building. The first-story entrance is fitted with a partially glazed paneled wood door and is accessed via a wide set of concrete steps. Square wood posts support the porch at the corners; the tall replacement balustrade is wood. Fenestration consists of vinyl replacement windows with interior muntins. The main façade features cutaway bay windows to the right of the entrance with decorative brackets.

P5b. Description of Photo: (View, date, accession #) Photograph 1: South elevation, camera facing north, June 15, 2021.

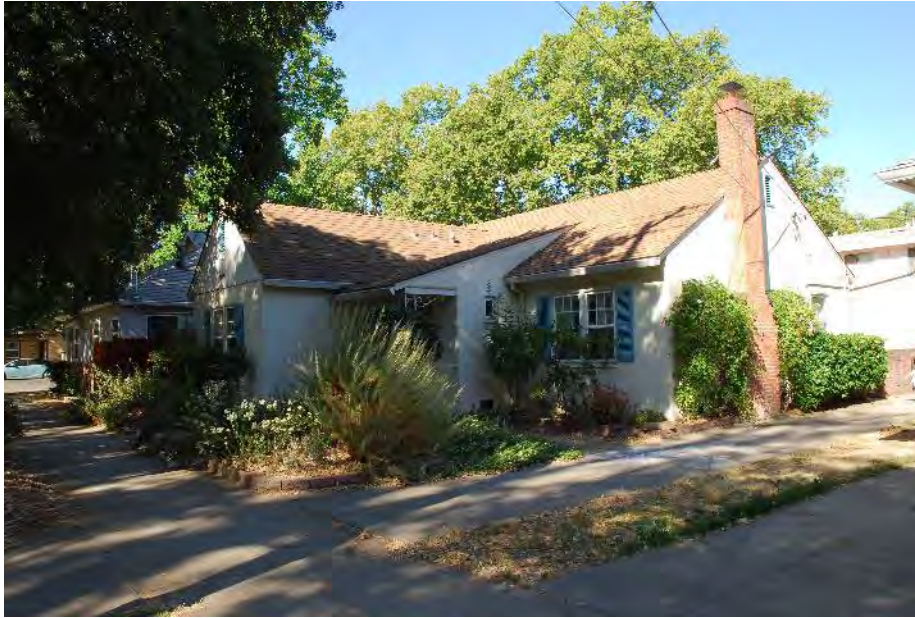
P5b. Description of Photo: (View, date, accession #) Photograph 1: East and north elevations, camera facing southwest, June 15, 2021.

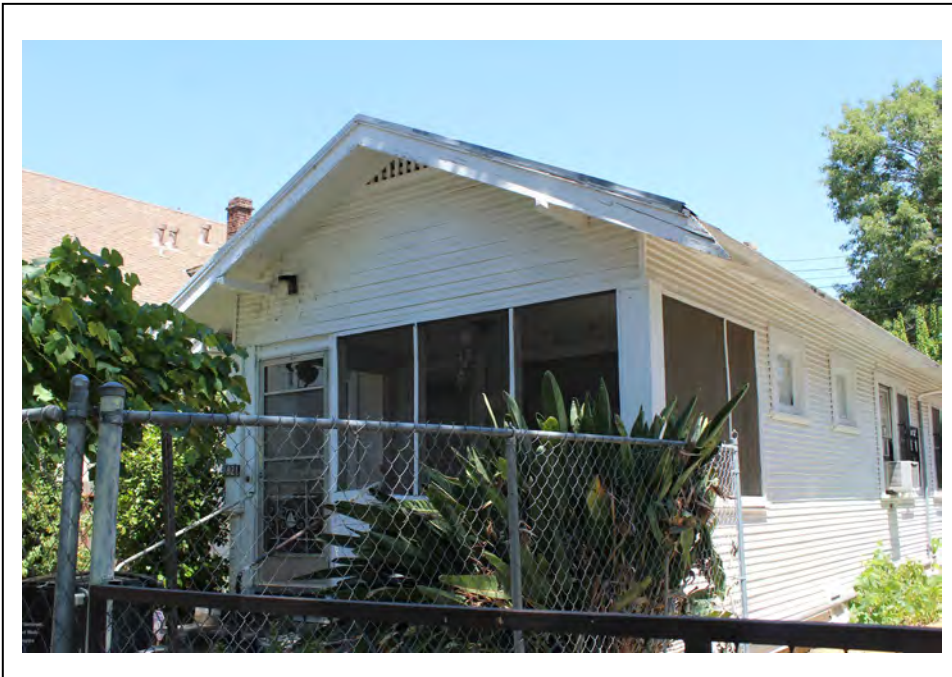
\*P3a. Description: (Describe resource and its major elements. Include design, materials, condition, alterations, size, setting, and boundaries)  
The one-story residence, which exhibits elements of Craftsman architecture, has a rectangular plan and medium-pitched front-gabled roof with vents on the gable ends and exposed roof beams. It is clad in narrow, horizontal wood clapboard. The partial-width screened porch on the main (south) façade shelters the centered main entrance. Entrance to the porch is via a metal screen door and a wide set of wood steps with a metal handrail. Fenestration consists of double-hung wood-sash windows.

P5b. Description of Photo: (View, date, accession #) Photograph 1: South and east elevations, camera facing northwest, June 15, 2021.

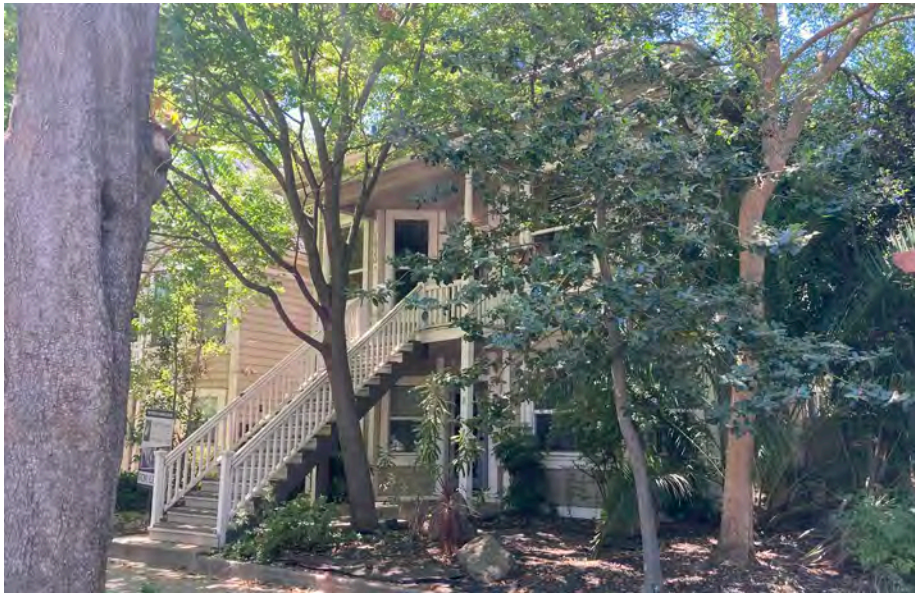
P5b. Description of Photo: (View, date, accession #) Photograph 1: North elevation, camera facing southeast, June 15, 2021.

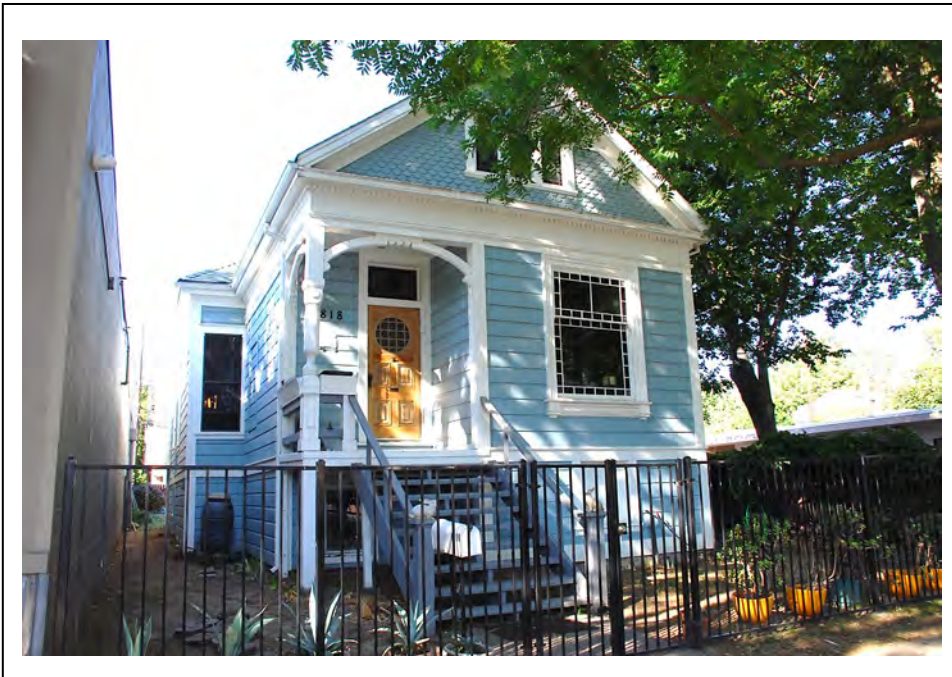
The 1.5-story Queen Anne residence sits atop a raised basement and has a rectangular plan and steeply-pitched combination gable and hip roof. Narrow boxed eaves are adorned with dentil molding. The gable end on the main (north) façade has three fixed windows topped by a horizontal cornice with dentil molding and is clad in fishscale shingles. The balance of the house is clad in wood drop siding. The partial-width integral porch on the main façade shelters the main entrance, which is left of center and has a partially glazed paneled wood replacement door. It is topped with a transom and is accessed via a wide set of wood steps. The porch features an elaborate turned wood post and ornamental trim with a plain open wood balustrade. Fenestration consists of double-hung wood-sash windows. The main façade features a decorative multiple-light window to the right of the entrance.

**P5b. Description of Photo:** (View, date, accession #) Photograph 1: East and north elevations, camera facing southwest, June 15, 2021.

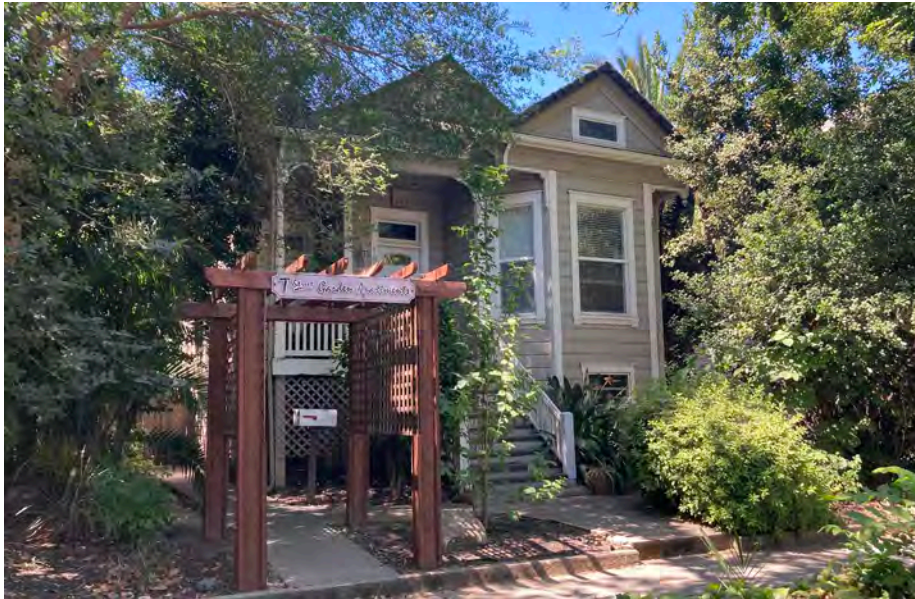
The 1.5-story Queen Anne residence sits atop a raised basement and has a rectangular plan. It features a medium-pitch gable-on-hip roof with a decorative fixed window and louvered vent on main façade gables. Gable ends are clad in fishscale shingles; the balance of the house is clad in wood drop siding. The partial-width porch on the main (north) façade shelters two entrances, which sit left of center and have partially glazed paneled replacement doors with transoms. They are accessed via a set of wood steps. A spindlework column supports the porch at the corner; the balustrade is wood. The main façade features a cutaway bay with decorative corner brackets. Fenestration consists of vinyl replacement windows in rectangular openings with decorative crowns and casings. There is a two-story apartment building behind the house. It has a very low-pitch roof with wide eaves, stucco cladding, and vinyl horizontal sliding-sash windows. It is accessed via Tomato Alley.

P5b. Description of Photo: (View, date, accession #) Photograph 1: North elevation, camera facing southwest, June 15, 2021.

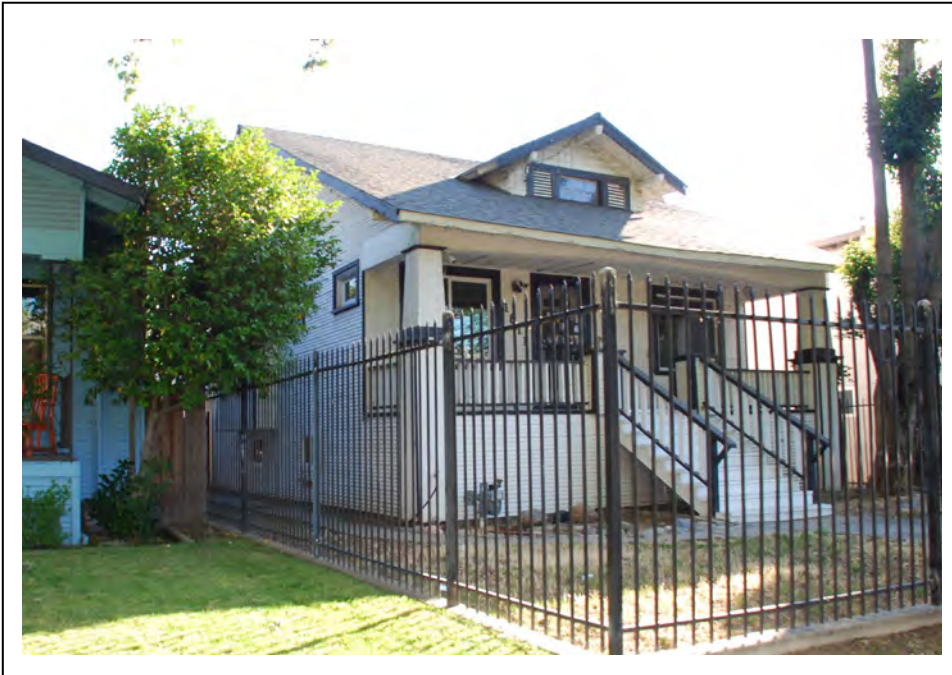
P5b. Description of Photo: (View, date, accession #) Photograph 1: West and south elevations, camera facing northeast, June 15, 2021.

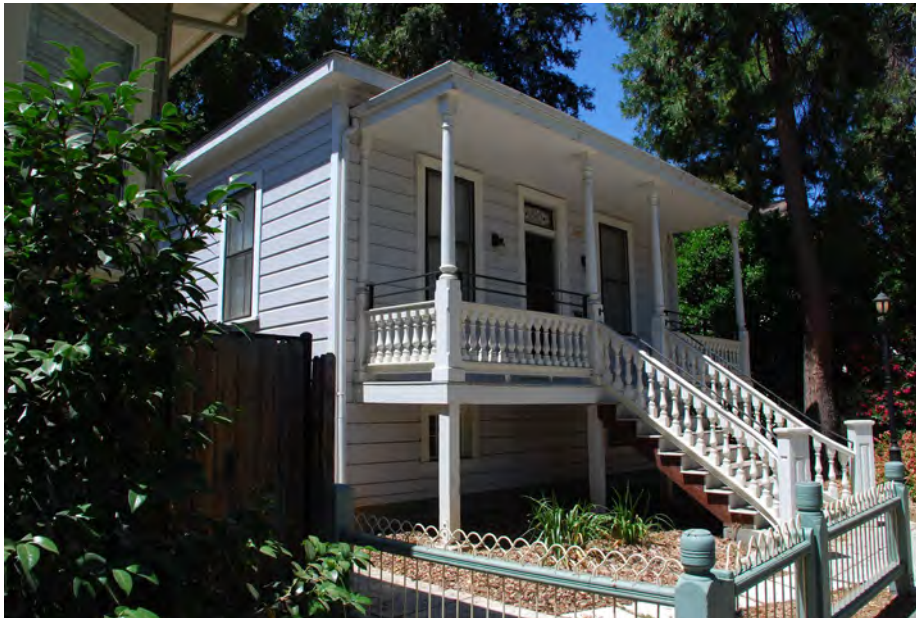
\*P3a. Description: (Describe resource and its major elements. Include design, materials, condition, alterations, size, setting, and boundaries)  
The one-story residence, which exhibits elements of Craftsman architecture, sits atop a raised basement and has a rectangular plan and low-pitched hipped roof. It is clad in horizontal wood drop siding. The full-width porch on the main (north) façade shelters the centered main entrance, which has a paneled wood door and stained-glass transom. It is accessed via a wide set of wood steps, which have a wood balustrade of turned posts that curves outward toward the bottom and is topped by a metal handrail. Turned wood columns support the porch at the corners and entrance; the wood balustrade is made up of turned posts and topped by a metal railing. Fenestration consists of large double-hung wood-sash windows in rectangular openings.

P5b. Description of Photo: (View, date, accession #) Photograph 1: East and north elevations, camera facing southwest, June 15, 2021.

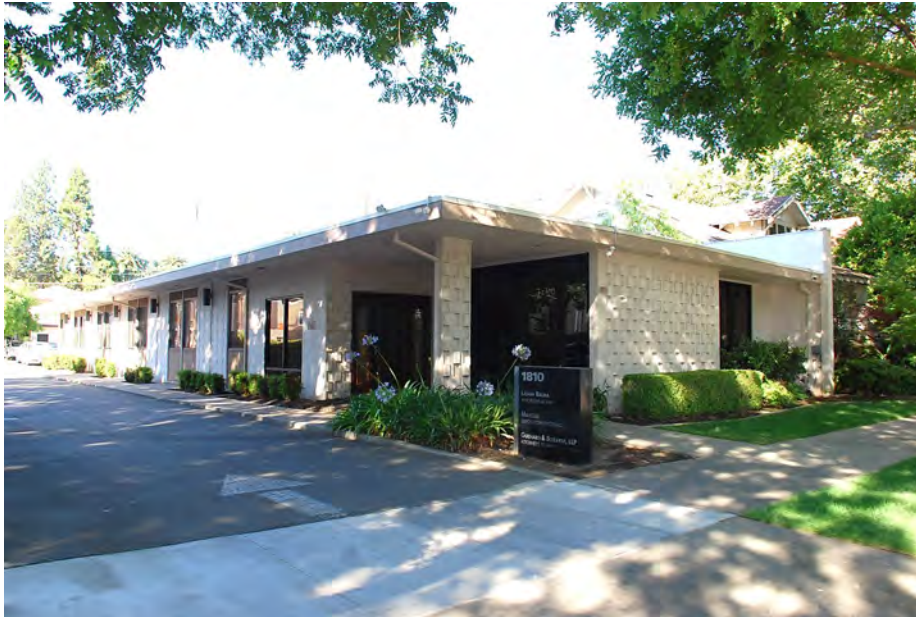
**\*P3a. Description:** (Describe resource and its major elements. Include design, materials, condition, alterations, size, setting, and boundaries)  
The one-story commercial building, which exhibits elements of Midcentury Modern architecture, has a rectangular plan and a heavy flat roof with wide projecting eaves. Decorative concrete masonry units are deployed on the main (north) façade to create a geometric pattern. The deeply recessed entrance at the northwest corner of the building is sheltered by the main roof, which is supported by a heavy square column featuring the same geometric pattern as the main façade. The minimalist yet handsome original design of the building has been somewhat compromised by installation of a paneled wood door flanked by side lights. Fenestration consists of large picture windows on the main façade and adjacent to the entrance that are divided into vertical sections, like the main entrance door, they appear to be replacements. Fixed windows on the east elevation, which face the parking lot, are paired in vertical openings. The areas of wall between the windows features a subtle diamond-shaped pattern and original cylindrical light fixtures.

P5b. Description of Photo: (View, date, accession #) Photograph 1: East and north elevations, camera facing northeast, June 15, 2021.

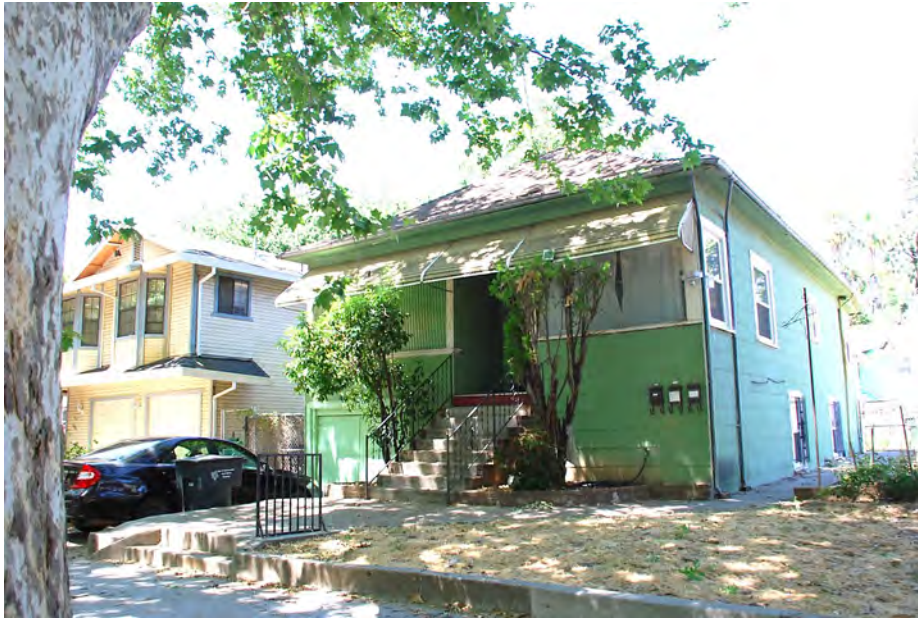
\*P3a. Description: (Describe resource and its major elements. Include design, materials, condition, alterations, size, setting, and boundaries)  
The one-story residence, which exhibits elements of Four-Square architecture, sits atop a raised basement and has a rectangular plan and medium-pitched hipped roof. It is clad in wide horizontal board siding. The main entrance on the south elevation is recessed and sheltered by a full-width awning. The entrance is fitted with a metal security screen door and accessed via a wide set of concrete steps with a metal balustrade. Fenestration consists of double-hung wood-sash windows. The main façade features two full-width picture windows on either side of the entrance. There is a wooden garage door to the left of the staircase at the basement level.

P5b. Description of Photo: (View, date, accession #) Photograph 1: South and east elevations, camera facing northwest, June 15, 2021.

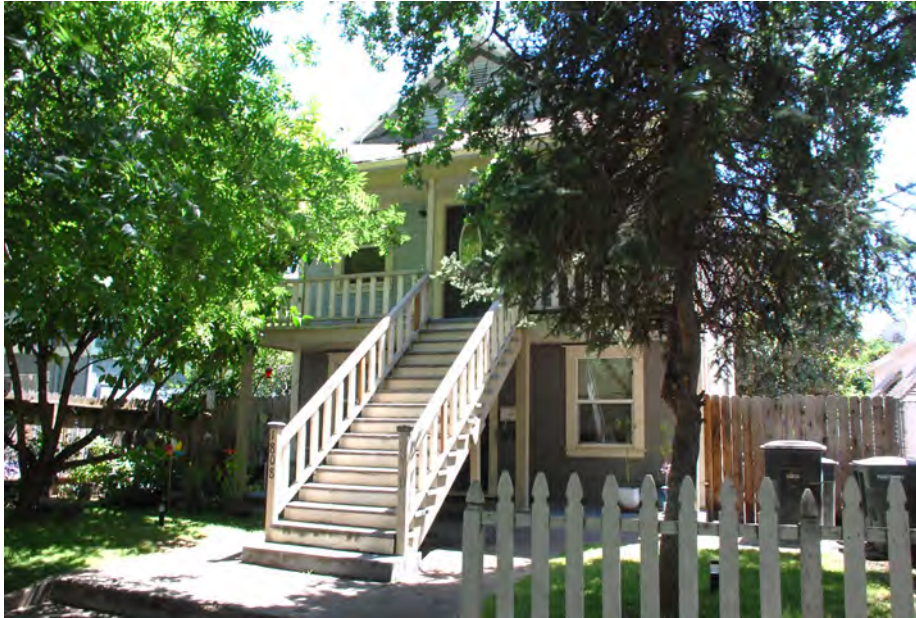
**P5b. Description of Photo:** (View, date, accession #) Photograph 1: North elevation, camera facing south, June 15, 2021.

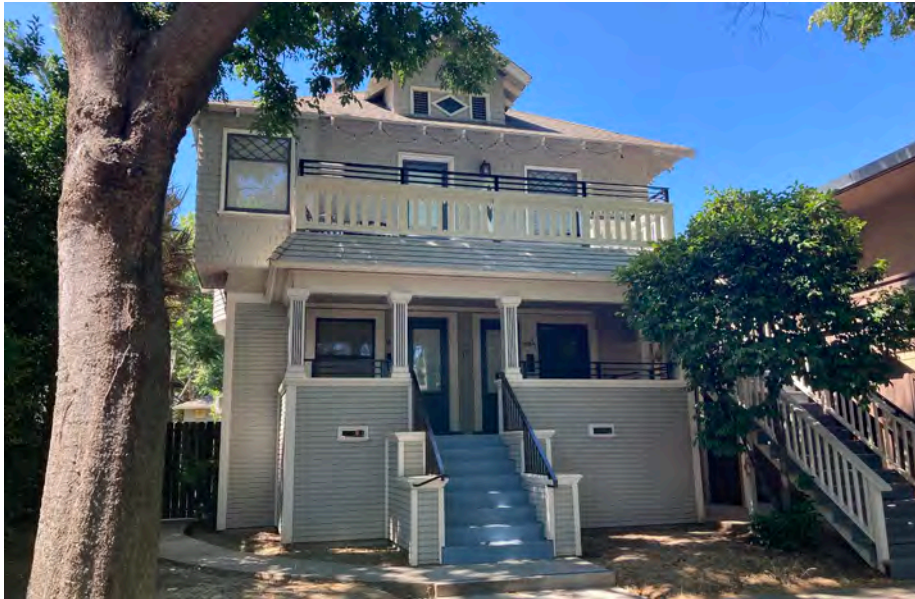
P5b. Description of Photo: (View, date, accession #) Photograph 1: North elevation, camera facing south, June 15, 2021.

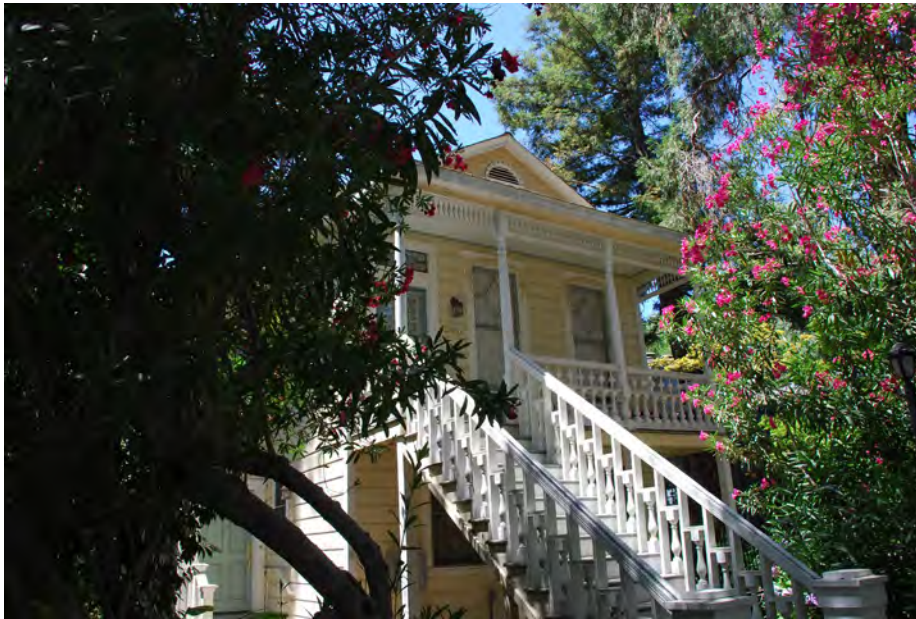
P5b. Description of Photo: (View, date, accession #) Photograph 1: East and north elevations, camera facing southwest, June 15, 2021.

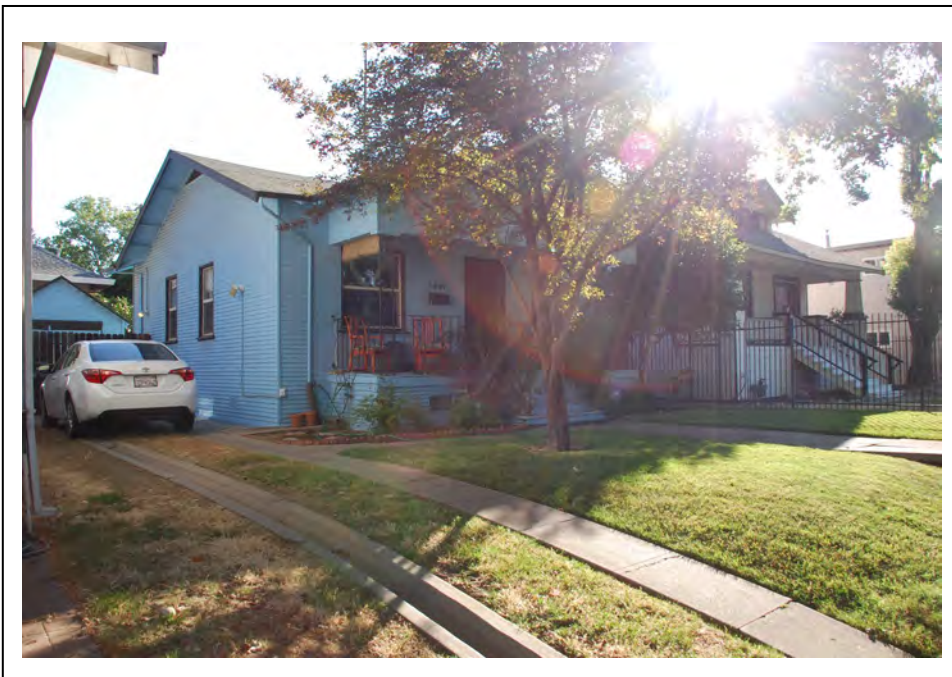
P5b. Description of Photo: (View, date, accession #) Photograph 1: West and south elevations, camera facing northeast, June 15, 2021.

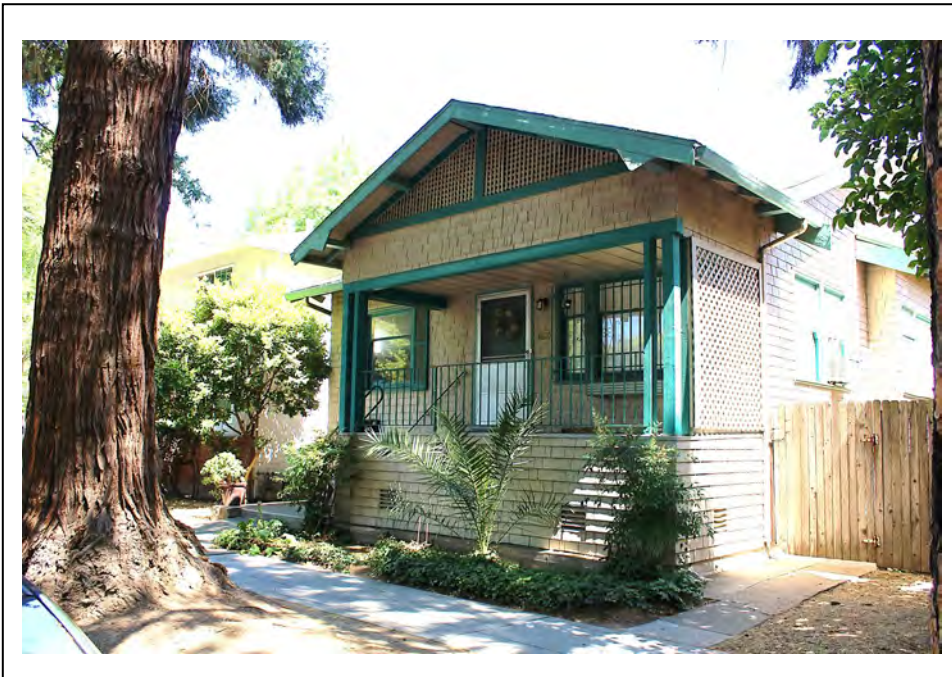
P5b. Description of Photo: (View, date, accession #) Photograph 1: South elevation, camera facing northwest, June 15, 2021.
