State of California – The Resources Agency  
DEPARTMENT OF PARKS AND RECREATION  
PRIMARY RECORD

\*Resource Name or # (Assigned by recorder) 2209 14<sup>th</sup> Street

c. Address 2209 14<sup>th</sup> Street City Sacramento Zip 95818

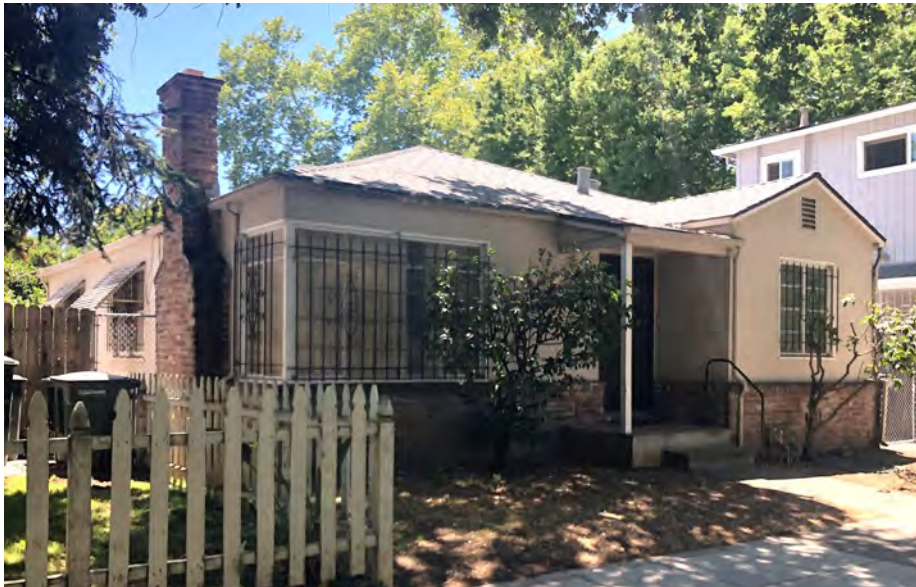
P5b. Description of Photo: (View, date, accession #) Photograph 1: East and north elevations, camera facing southwest, June 15, 2021.

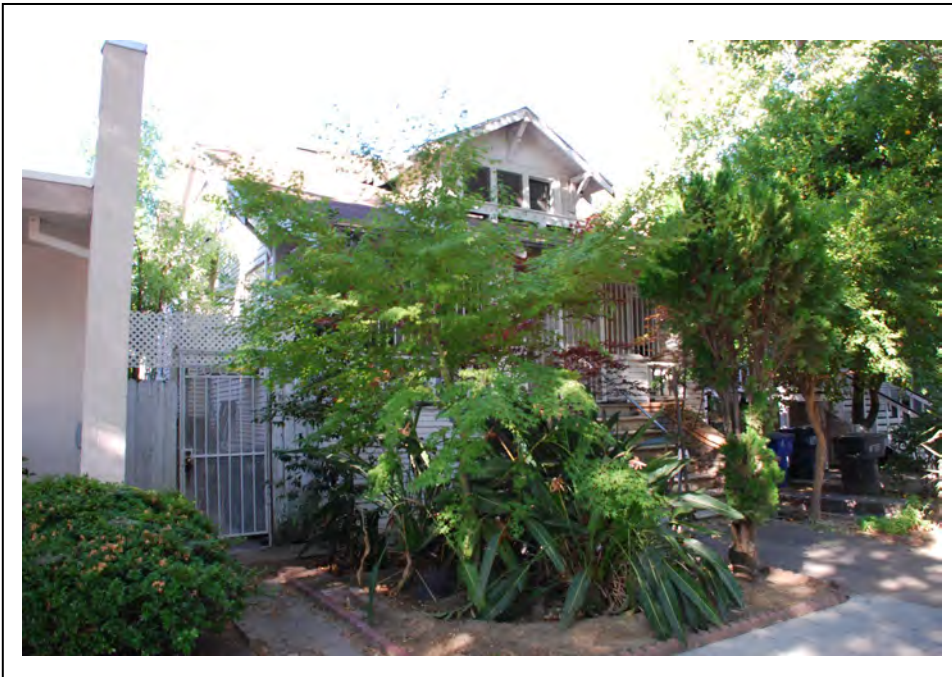
P5b. Description of Photo: (View, date, accession #) Photograph 1: North elevation, camera facing southwest, June 15, 2021.

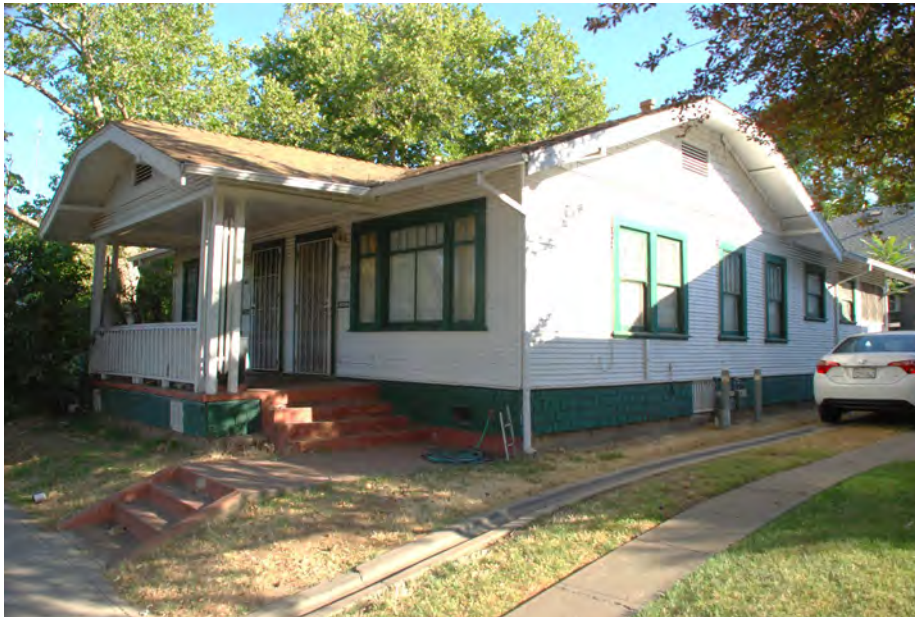
**P5b. Description of Photo:** (View, date, accession #) Photograph 1: South and east elevations, camera facing northeast, June 15, 2021.

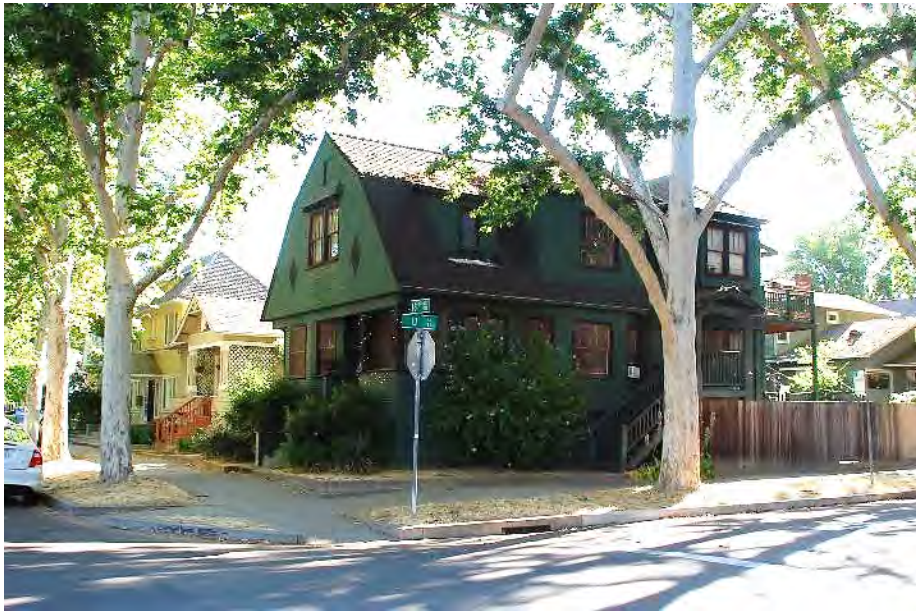
\*P3a. **Description:** (Describe resource and its major elements. Include design, materials, condition, alterations, size, setting, and boundaries)  
The 1.5-story duplex, which exhibits elements of Transitional architecture, has a rectangular plan and a medium-pitched gambrel roof. The gable end is clad in wood shingle, and there are several large dormers on each side with shed or hipped roofs that are also clad in wood shingle; the rest of the building is clad in narrow horizontal clapboard. The partial-width porch on the main (west) façade shelters the main entrance, which is right of center and has a partially glazed paneled wood door. It is accessed via a wide set of wood steps with low clapboard wing walls. Square wood columns with capitals and bases support the porch at the corner and entrance; they rest on the solid balustrade, clad in the same clapboard as the house. A second entrance on the south façade is sheltered by a projecting partial-width porch with a gable roof supported by wood columns. It is accessed from the left via a set of wood steps; the porch and steps have a wood balustrade. Additional stairs and entrances project off the east façade. Fenestration consists of double-hung wood-sash windows with multi-light upper panes; there are wide, shallow cutaway bay windows on the north, west, and south elevations.

P5b. Description of Photo: (View, date, accession #) Photograph 1: West and south elevations, camera facing northeast, June 15, 2021.

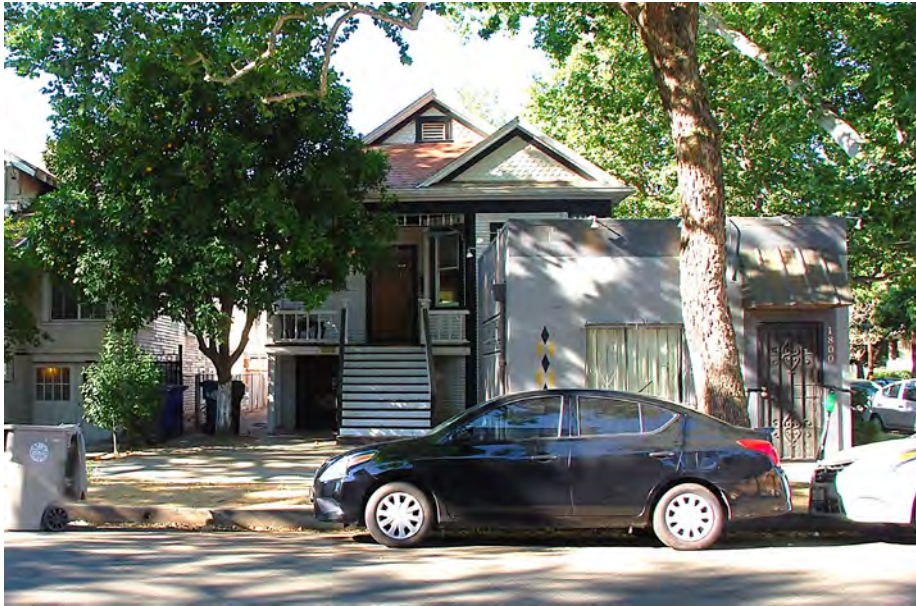
\*P3a. Description: (Describe resource and its major elements. Include design, materials, condition, alterations, size, setting, and boundaries)  
The building consists of a two-story folk Victorian with a one-story Utilitarian commercial addition in front. The house has a rectangular plan and medium-pitched gable-on-hip roof with a louvered vent on the gable end. Gable ends are clad in fishscale shingles with dentil molding at the cornice; the balance of the house is clad in wood clapboard. Ornamental features include elaborate brackets over the cutaway bay windows and spindle work details on the second-story partial-width porch. The main (north) façade entrance has a Craftsman-style partially glazed paneled wood door and is accessed via a wide set of wood steps. The porch has a plain open wood balustrade, and also shelters a first-floor entrance to the left of the steps. Fenestration consists of double-hung wood-sash windows. The commercial building projects in front of the west third of the north façade of the residence. It has a rectangular plan, flat roof, and is constructed of concrete masonry units. A projecting awning shelters the main entrance, which is right of center and fitted with metal security screen door. Fenestration consists of sliding aluminum-sash windows and a fixed window to the left of the entrance. Murals on the east and west elevations of the building advertise a tattoo business.

P5b. Description of Photo: (View, date, accession #) Photograph 1: North elevations, camera facing south, June 15, 2021.

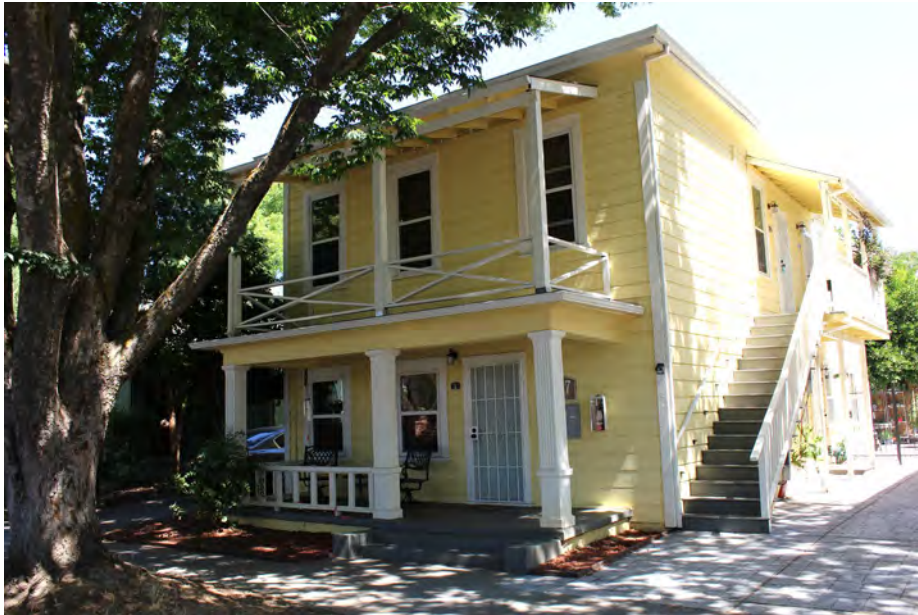
\*P3a. Description: (Describe resource and its major elements. Include design, materials, condition, alterations, size, setting, and boundaries)  
The two-story residence has a rectangular plan and low-pitched hipped roof with boxed eaves. It is clad in wood drop siding. The projecting partial-width two-story porch on the main (south) façade shelters the main entrance, which is right of center and fitted with a security screen door. It is accessed via a low set of concrete steps. Square wood columns with capitals and bases support the porch at the corners; the open balustrade is wood. The second floor porch features a shed roof, square wood columns and wood balustrade with a simple X. Fenestration consists of vinyl replacement windows in rectangular openings. There are additional entrances on the east (side) façade. The second-story entrances are sheltered by a shed-roof porch with square wood columns and a wood balustrade. They are fitted with metal security screen doors and are accessed via a set of wood steps. The second floor balcony entrance shelters an entrance on the first floor of the east façade, fitted with a metal security screen door.

P5b. Description of Photo: (View, date, accession #) Photograph 1: South and east elevations, camera facing northwest, June 15, 2021.

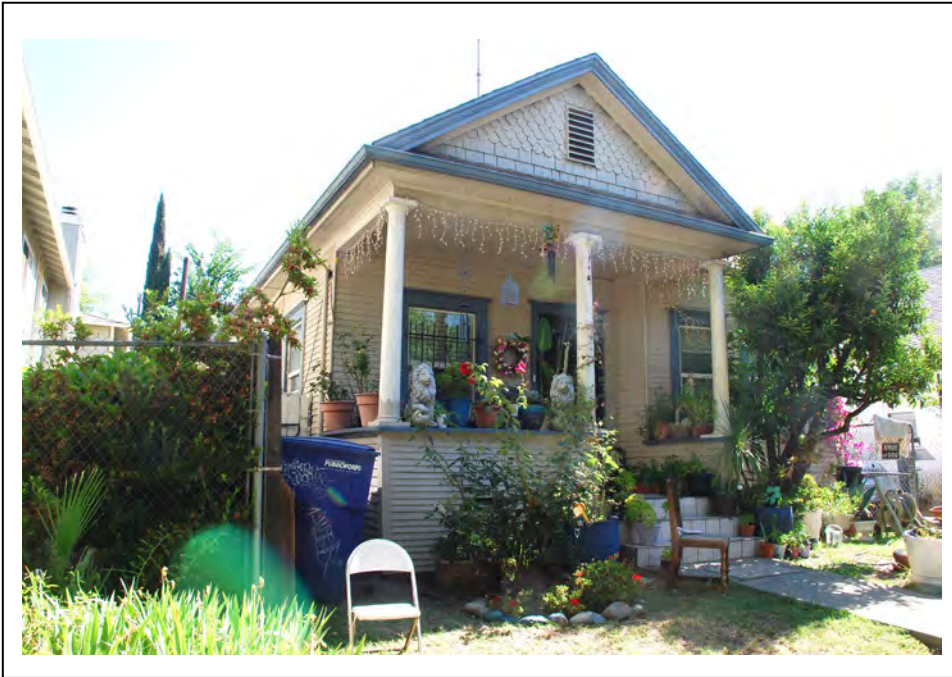
P5b. Description of Photo: (View, date, accession #) Photograph 1: West and south elevations, camera facing northeast, June 15, 2021.

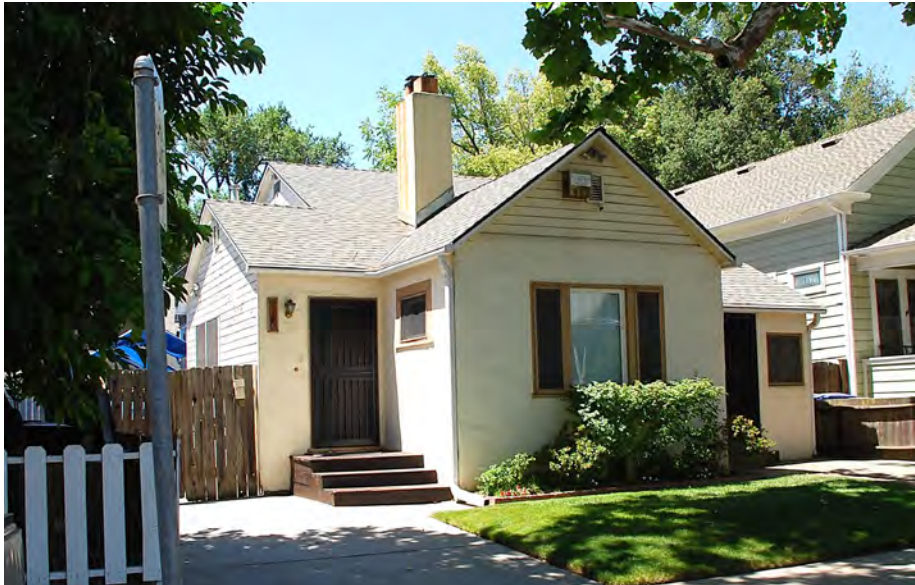
The one-story residence, which exhibits elements of Minimal Traditional architecture, has a T-shaped plan and medium-pitched cross-gabled roof with louvered vents on the gable ends. Most of the main (north) façade is clad in stucco, but the front gable end as well as the rest of the building is clad in wood lap siding. The two main entrances, which are located on each side of the projecting front volume, are fitted with metal security screen doors and accessed via low sets of concrete steps. Fenestration consists of replacement sliding windows, with a decorative assemblage of three cottage windows at the center of the main façade.

**P5b. Description of Photo:** (View, date, accession #) Photograph 1: East and north elevations, camera facing southwest, June 15, 2021.

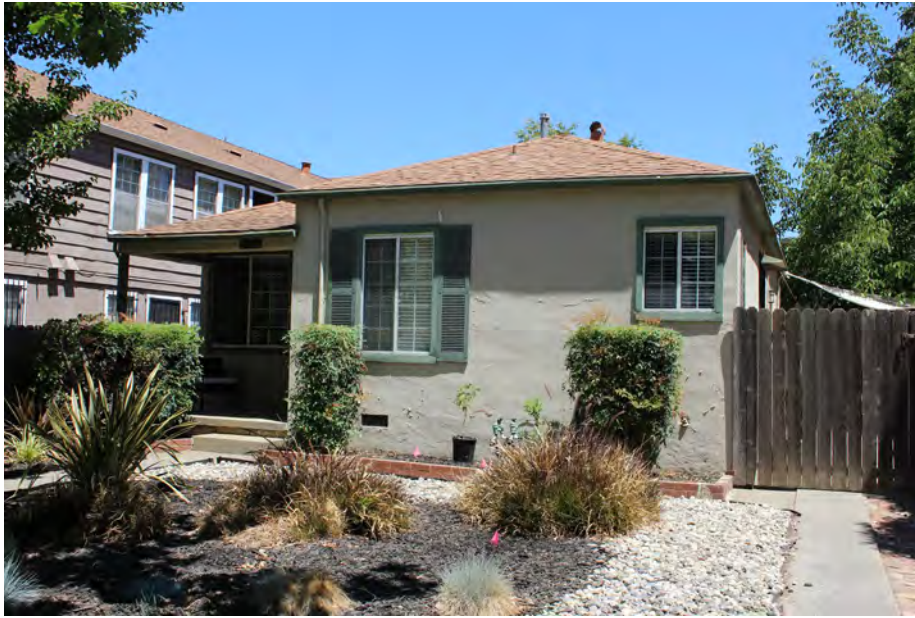
\*P3a. Description: (Describe resource and its major elements. Include design, materials, condition, alterations, size, setting, and boundaries)  
The one-story residence, which exhibits elements of Minimal Traditional architecture, has a rectangular plan and medium-pitched hipped roof. It is clad in stucco. The partial-width porch on the main (south) façade shelters the main entrance, which is left of center and is accessed via low concrete steps. A square wood column supports the porch at the corner. A second entrance on the east façade is sheltered by an awning and fitted with a metal security screen door. Fenestration consists of replacement sliding multiple-light windows; a central window on the main façade has wood shutters.

P5b. Description of Photo: (View, date, accession #) Photograph 1: South elevation, camera facing northwest, June 15, 2021.

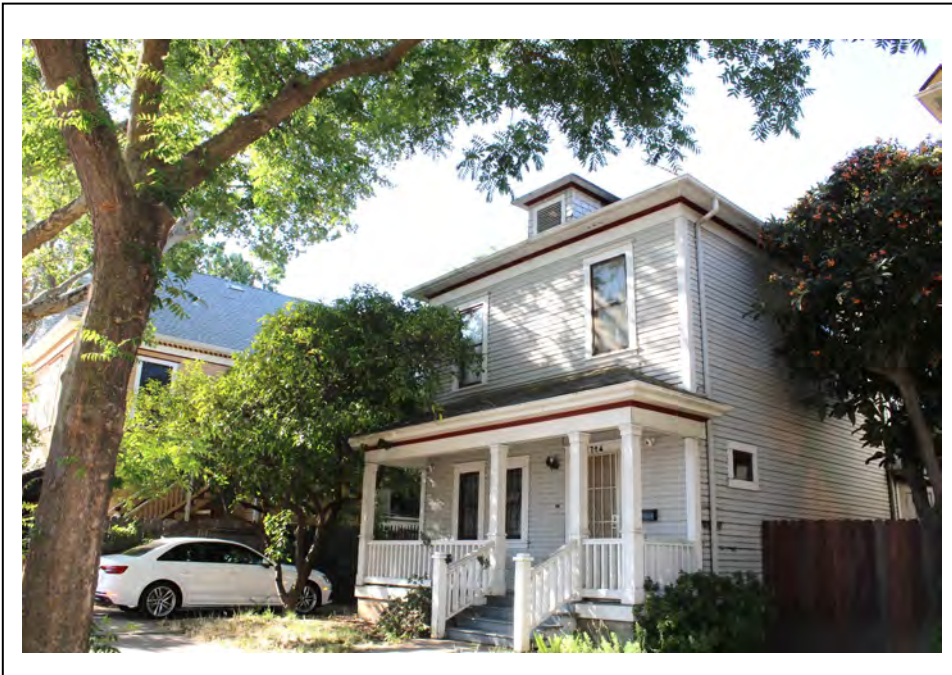
**\*P3a. Description:** (Describe resource and its major elements. Include design, materials, condition, alterations, size, setting, and boundaries)  
The two-story American Foursquare residence has a rectangular plan and medium-pitched hipped roof and a hipped dormer with a louvered vent; eaves are boxed. The dormer is clad in wood shingles; the balance of the house is clad in narrow horizontal wood siding. The projecting full-width porch on the main (north) façade has a hipped roof and shelters the main entrance, which is right of center, has a metal security door, and is accessed via a set of wood steps. Square wood columns with capitals and bases support the porch at the corners and entrance; the simple open balustrade is wood. Fenestration consists of double-hung wood-sash windows in rectangular openings.

**P5b. Description of Photo:** (View, date, accession #) Photograph 1: North and west elevations, camera facing southeast, June 15, 2021.

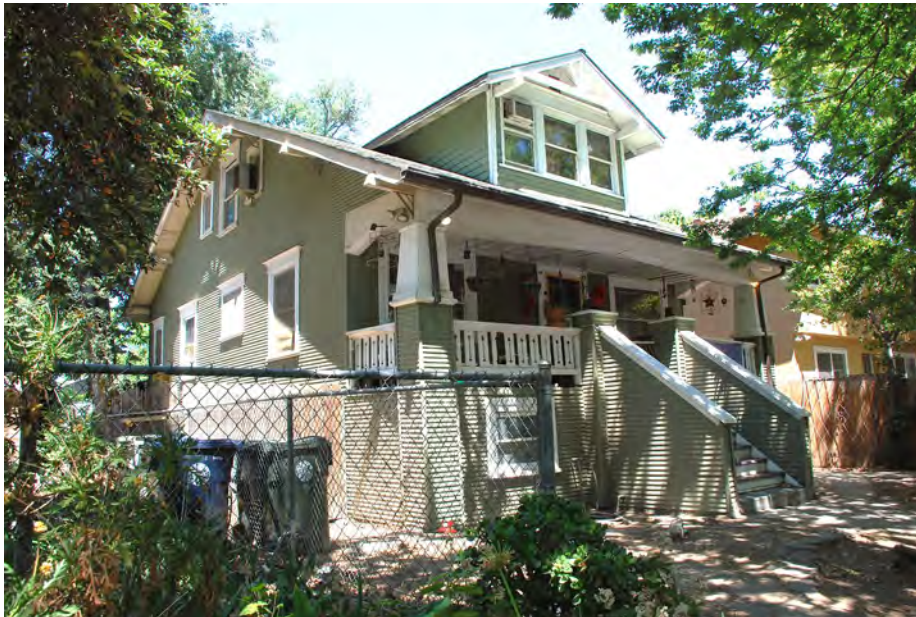
P5b. Description of Photo: (View, date, accession #) Photograph 1: West and south elevations, camera facing northeast, June 15, 2021.

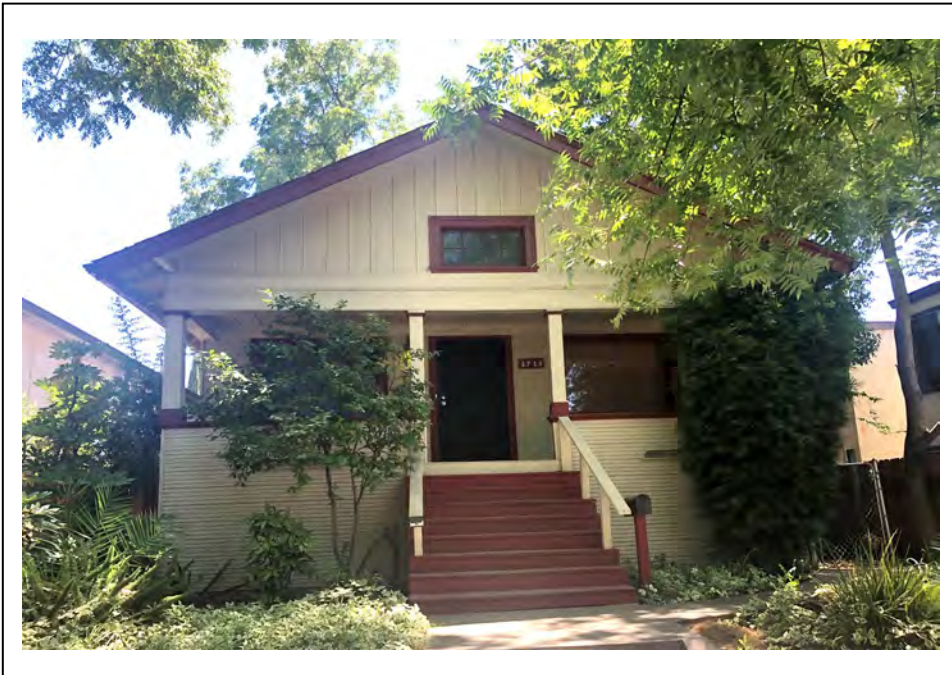
P5b. Description of Photo: (View, date, accession #) Photograph 1: North elevation, camera facing south, June 15, 2021.

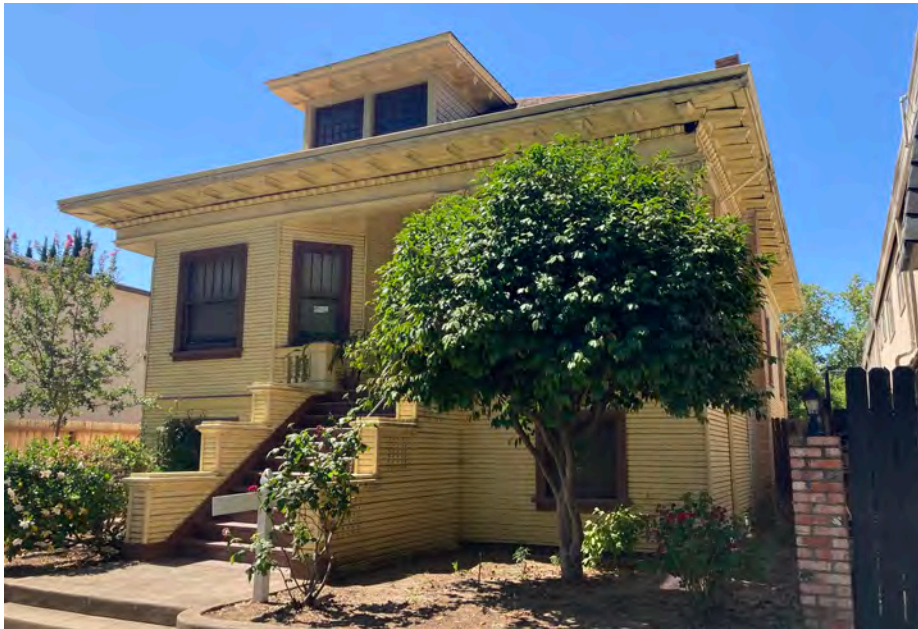
\*P3a. Description: (Describe resource and its major elements. Include design, materials, condition, alterations, size, setting, and boundaries)  
The one-story Four-Square residence sits atop a raised basement and has a rectangular plan and medium-pitched hipped roof with exposed rafter tails and a decorative cornice. There are hipped dormers on the main (north) and east elevations; they each have two fixed windows with multiple lights. The house is clad in narrow horizontal wood siding. The partial-width porch on the main (north) façade shelters the centered main entrance, which has a glazed paneled wood door. It is accessed via a wide set of wood steps with wood wing walls and a metal handrail on one side. Square wood columns with ionic capitals and bases support the porch at the corner and entrance; the balustrade is turned wood posts. Fenestration consists of double-hung wood-sash windows with multiple-light upper panes. The main façade features a cutaway bay window to the left of the entrance.

P5b. Description of Photo: (View, date, accession #) Photograph 1: North elevation, camera facing southeast, June 15, 2021.

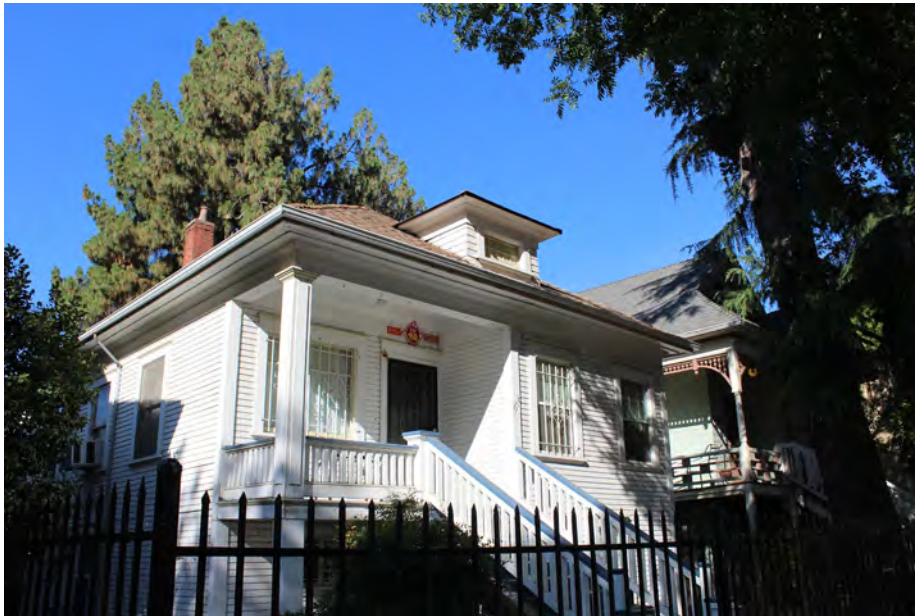
**\*P3a. Description:** (Describe resource and its major elements. Include design, materials, condition, alterations, size, setting, and boundaries)  
The one-story residence, which exhibits elements of Four-Square architecture, sits atop a raised basement and has a rectangular plan. It has a medium-pitched hipped roof and a hipped dormer with decorative fixed multi-white window. The building is clad in wood clapboard. The partial-width porch on the main (north) façade shelters the main entrance, which is left of center and has a partially glazed paneled wood door. It is accessed via a tall set of wood steps. Square wood columns with capitals support the porch at the corner; the open balustrade is wood. Fenestration consists of a combination of replacement and wood-sash windows. The main façade features a decorative picture window to the left of the entrance.

**P5b. Description of Photo:** (View, date, accession #) Photograph 1: East and north elevations, camera facing southwest, June 15, 2021.

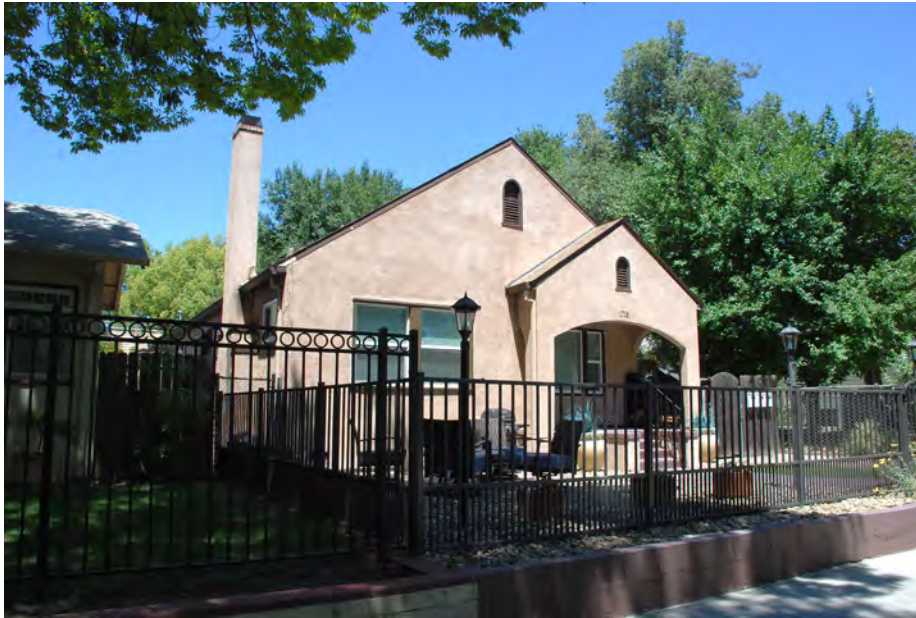
\*P3a. Description: (Describe resource and its major elements. Include design, materials, condition, alterations, size, setting, and boundaries)  
The one-story residence has a rectangular plan and medium-pitched front-gabled roof. The louvered vents on the gable ends have rounded tops. The building is clad in stucco. The projecting partial-width porch on the main (south) façade has an arched opening and shelters the centered main entrance, which is fitted with a metal security screen door. The concrete steps have low, flat concrete wing walls and a metal balustrade on one side. Fenestration consists of replacement vinyl slider windows. There is a chimney on the west elevation.

P5b. Description of Photo: (View, date, accession #) Photograph 1: South elevation, camera facing northwest, June 15, 2021.

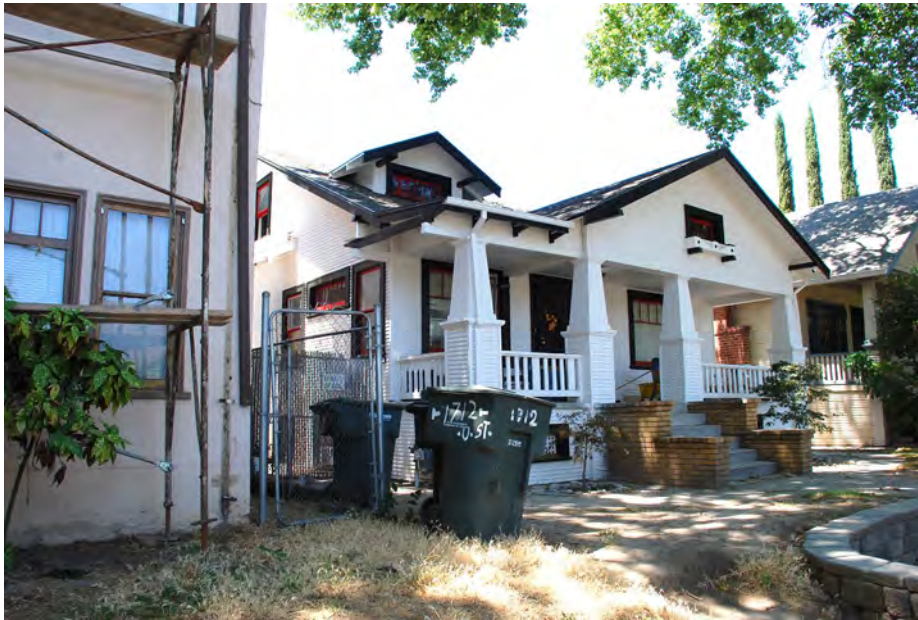
P5b. Description of Photo: (View, date, accession #) Photograph 1: East and north elevations, camera facing southwest, June 15, 2021.

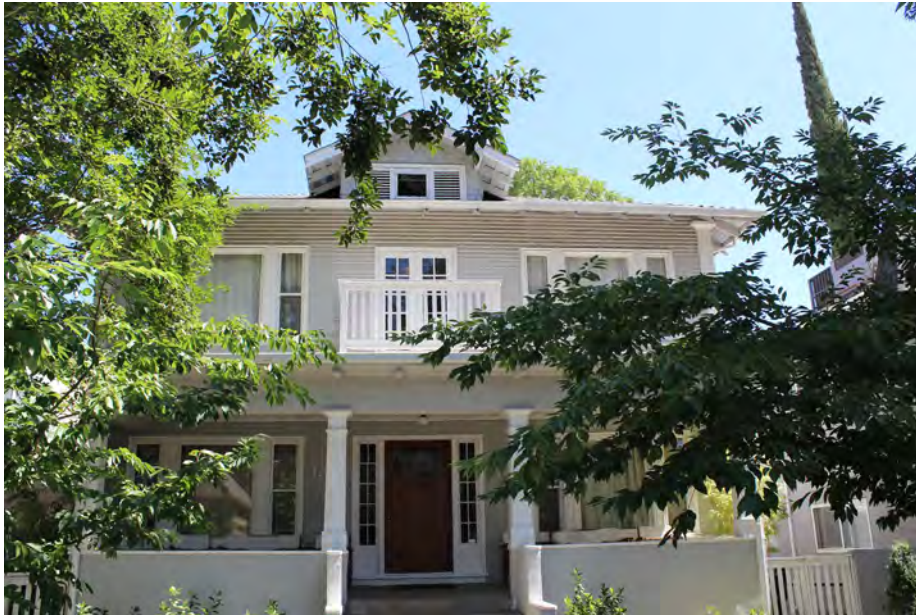
**\*P3a. Description:** (Describe resource and its major elements. Include design, materials, condition, alterations, size, setting, and boundaries)  
The two-story Four-Square residence has a rectangular plan and medium-pitched hipped roof with exposed rafter tails. The gabled dormer on the main (south) façade is clad in wood shingle and has a fixed window with louvered vents on either side. The house is otherwise clad in narrow horizontal wood siding. The projecting full-width porch on the main façade has a flat roof and shelters the centered main entrance, which has a partially glazed paneled wood door with sidelights. It is accessed via a wide set of concrete steps with concrete wing walls. Square wood columns with capitals and bases support the porch at the corners and entrance; they rest on a solid stucco balustrade. Fenestration consists of double-hung wood-sash windows. The main façade features four decorative assemblages of three windows, two on either side of the entrance and two on the second story. A balcony with multiple-light glazed French doors are centered on the second floor.

**P5b. Description of Photo:** (View, date, accession #) Photograph 1: South elevation, camera facing north, June 15, 2021.

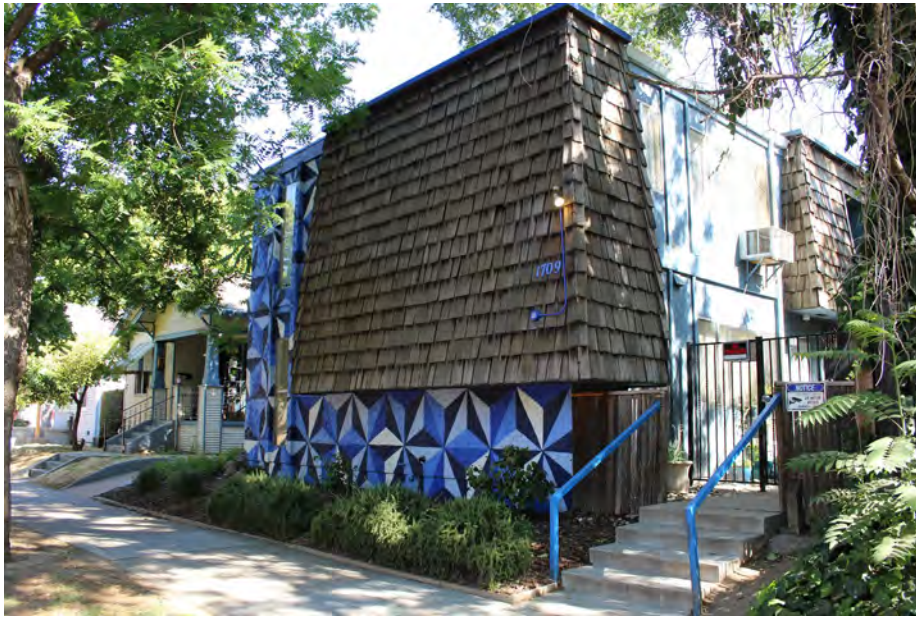
\*P3a. Description: (Describe resource and its major elements. Include design, materials, condition, alterations, size, setting, and boundaries)  
The two-story apartment building is a good example of Modern mansard architecture. It has a rectangular plan and flat roof and is clad in textured stucco. Entrances are on the east (side) façade, and are fitted with wood doors and accessed via sets of concrete steps. Fenestration consists of sliding aluminum-sash windows and fixed windows. The wood shake faux mansard is the primary decorative feature in an otherwise utilitarian building consisting of a simple rectangular box. The main façade mansard is exaggerated in proportion, beginning halfway up the ground floor and rising to the top of the building; it covers most of the main façade. Decorative mansards on the side elevation are somewhat smaller, beginning at the division between the floors, and are pierced by window openings. The stucco area of the main (south) façade features a geometric mural.

P5b. Description of Photo: (View, date, accession #) Photograph 1: South and east elevations, camera facing northwest, June 15, 2021.

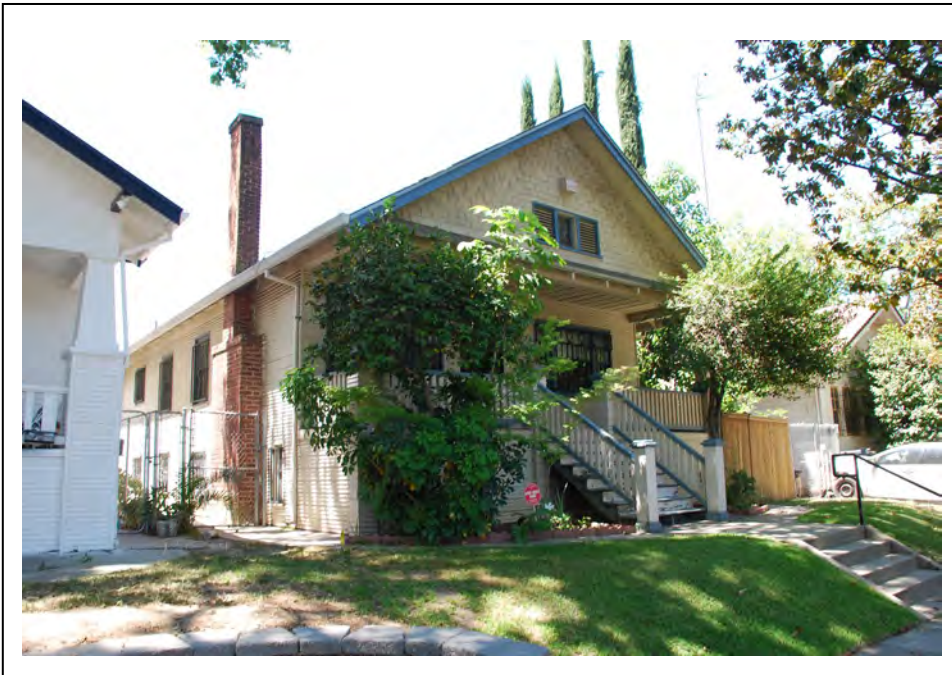
**\*P3a. Description:** (Describe resource and its major elements. Include design, materials, condition, alterations, size, setting, and boundaries)  
The one-story Minimal Traditional residence sits atop a raised basement and has a rectangular plan. The medium-pitched front-gabled roof with has a small window flanked by louvered vents on the gable end. The gable end is clad in wood shingles; the rest of the house is clad in horizontal narrow wood clapboard. The full-width porch on the main (north) façade shelters the centered main entrance, which has a metal security screen door and is accessed via a set of wood steps. Battered wood columns with capitals and bases support the porch at the corners and rest on heavy clapboard piers; the balustrade is wood. Fenestration consists of double-hung wood-sash windows. The main façade features two decorative assemblages of three cottage windows on either side of the entrance. There is a brick chimney on the east elevation.

P5b. Description of Photo: (View, date, accession #) Photograph 1: East and north elevations, camera facing southwest, June 15, 2021.

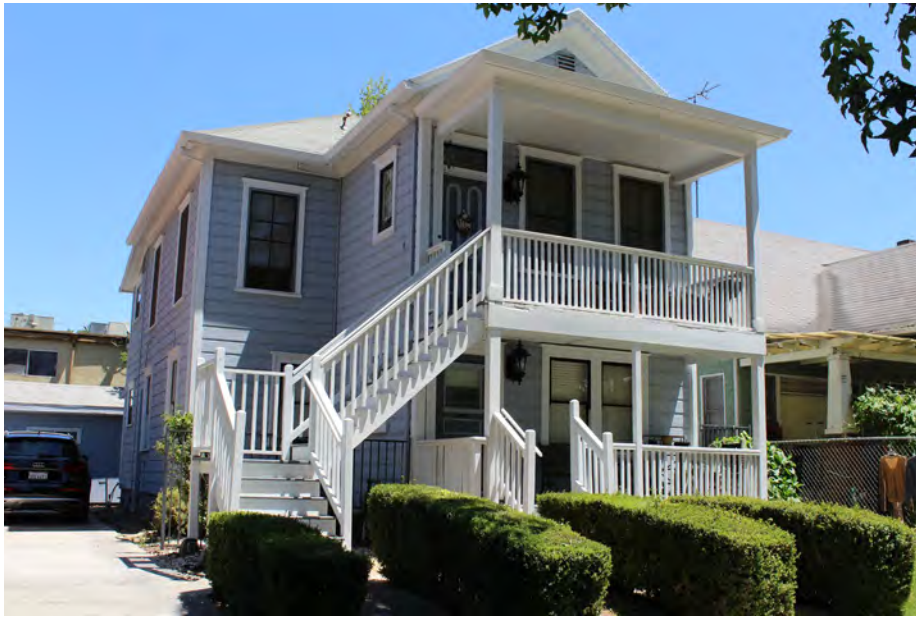
**\*P3a. Description:** (Describe resource and its major elements. Include design, materials, condition, alterations, size, setting, and boundaries)  
The two-story residence, which exhibits elements of Transitional architecture, has a roughly L-shaped plan. The roof is hipped on the main volume, while the projecting front volume has a gabled roof with a louvered vent on the gable end. It is clad in horizontal wood drop siding. The projecting partial-width porch on the main (south) façade shelters the second-story entrance, which is left of center and directly above the first-story entrance. The second-story entrance is fitted with a wood paneled door and transom and accessed by a long set of wood stairs. The first-story entrance is fitted with a partially glazed paneled wood door and is accessed via a set of wood steps. Square wood columns support the porch at the corners; the balustrade is wood. Fenestration consists of double-hung wood-sash windows, many with multiple lights.

P5b. Description of Photo: (View, date, accession #) Photograph 1: West and south elevations, camera facing northeast, June 15, 2021.

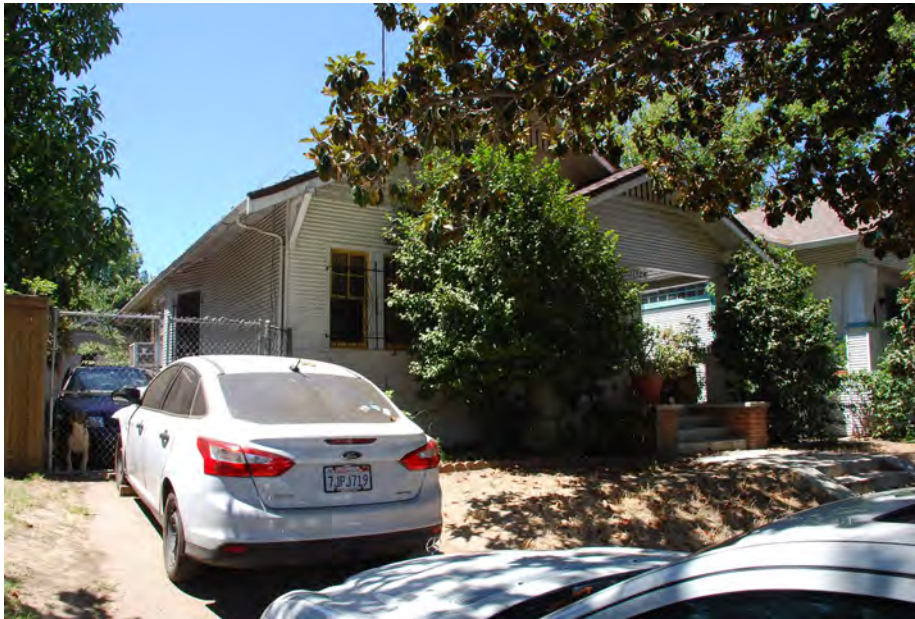
\*P3a. Description: (Describe resource and its major elements. Include design, materials, condition, alterations, size, setting, and boundaries)  
The one-story residence, which exhibits elements of Craftsman architecture, sits atop a raised basement and has a rectangular plan. The medium-pitched cross-gabled roof has vertical wooden vents on the gable ends and triangular knee braces. Gable ends are clad in wood shingles; the rest of the house is clad in narrow horizontal wood clapboard. The projecting partial-width porch on the main (north) façade shelters the centered main entrance, which faces to the side and is fitted with a metal security screen door. The porch is accessed via a wide set of concrete steps with low brick wing walls. Battered wood columns with capitals and bases support the porch at the corners and rest on heavy clapboard piers. Fenestration consists of double-hung wood-sash windows with multiple lights in the upper panes. The main façade features two decorative assemblages of three cottage windows on either side of the entrance.

P5b. Description of Photo: (View, date, accession #) Photograph 1: East and north elevations, camera facing southwest, June 15, 2021.

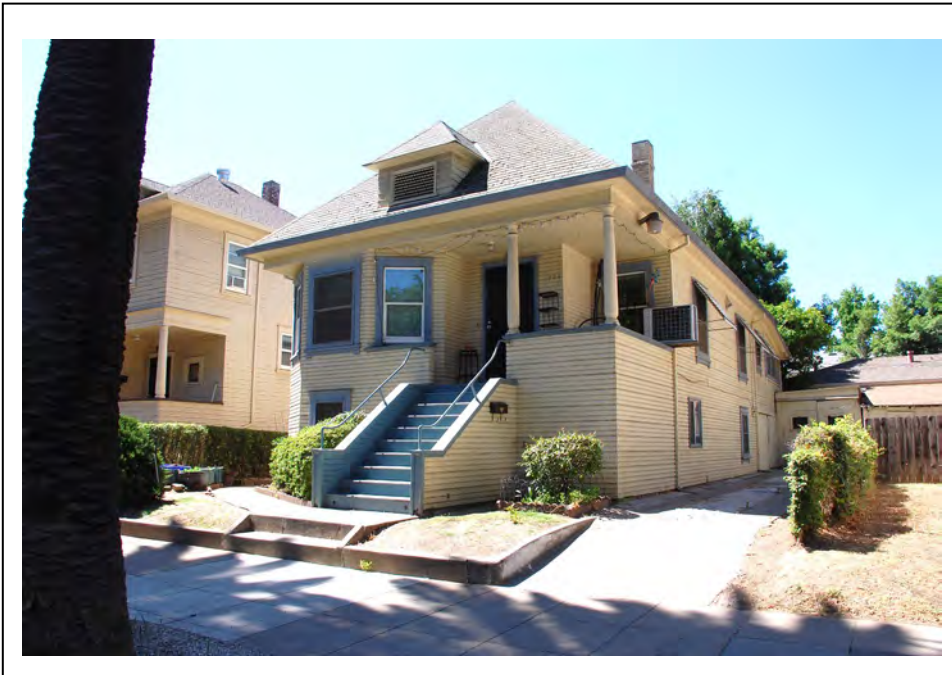
\*P3a. Description: (Describe resource and its major elements. Include design, materials, condition, alterations, size, setting, and boundaries)  
The one-story Four-Square residence sits atop a raised basement and has a rectangular plan and medium-pitched hipped roof. It is clad in wood clapboard. The partial-width wraparound porch on the main (north) façade shelters the main entrance, which is right of center and has a metal security screen door. It is accessed via a wide set of wood steps with wood wing walls and metal hand railings. Round wood columns with capitals and bases support the porch at the corner and entrance; they rest on the solid clapboard balustrade. There is a hipped dormer with a wide louvered vent on the main façade. Fenestration consists of double-hung wood-sash windows. The main façade features a cutaway bay window to the left of the porch.

P5b. Description of Photo: (View, date, accession #) Photograph 1: North and west elevations, camera facing southeast, June 15, 2021.

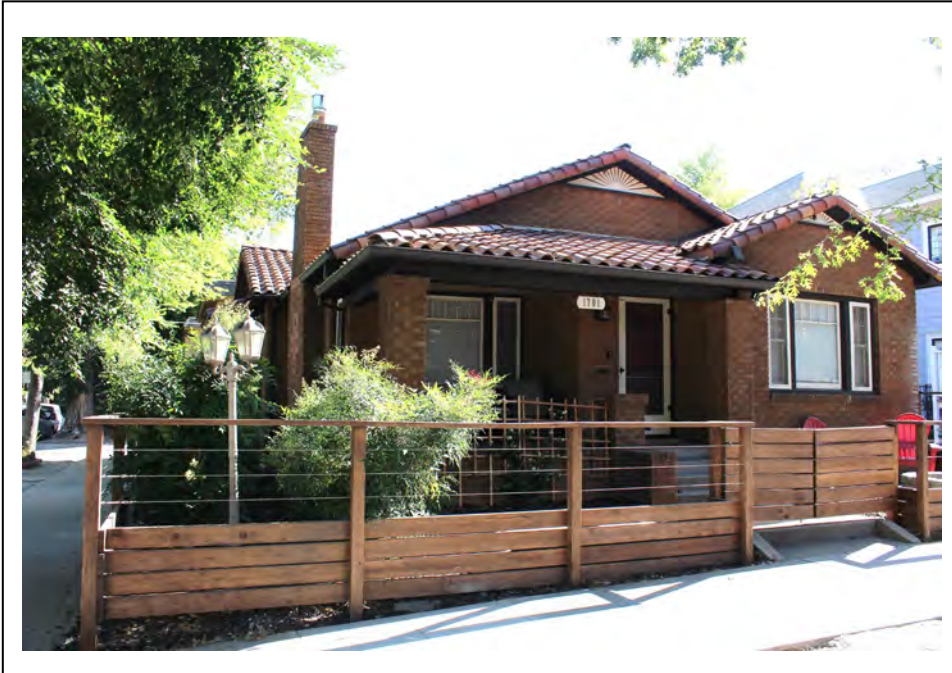
\*P3a. Description: (Describe resource and its major elements. Include design, materials, condition, alterations, size, setting, and boundaries)  
The one-story residence, which exhibits elements of Craftsman architecture, has a roughly rectangular plan. The medium-pitched cross-gabled roof has decorative vents on the gable ends and is made of clay tile. The building is made of brick. The projecting partial-width porch on the main (south) façade has a hipped roof and shelters the centered main entrance, which is fitted with a metal screen door and is accessed via a wide set of concrete steps with brick wing walls. Square brick columns support the porch at the corners. A second entrance on the west façade is sheltered by a shed roof and is fitted with a partially glazed paneled wood door with side lights. It is accessed via a wide set of concrete steps with a wooden balustrade. Fenestration consists of double-hung wood-sash windows with multiple lights on the upper panes. The main façade features two decorative assemblages of three cottage windows on either side of the entrance. There is a brick chimney with slanted sides and decorative circles of brick on the west façade.

P5b. Description of Photo: (View, date, accession #) Photograph 1: West and south elevations, camera facing northeast, June 15, 2021.

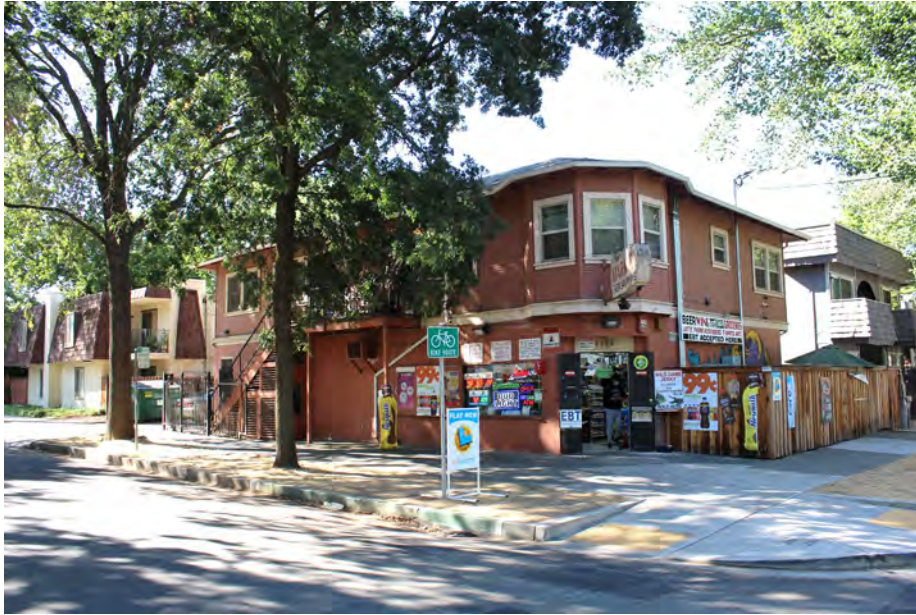
P5b. Description of Photo: (View, date, accession #) Photograph 1: North and west elevations, camera facing southeast, June 15, 2021.

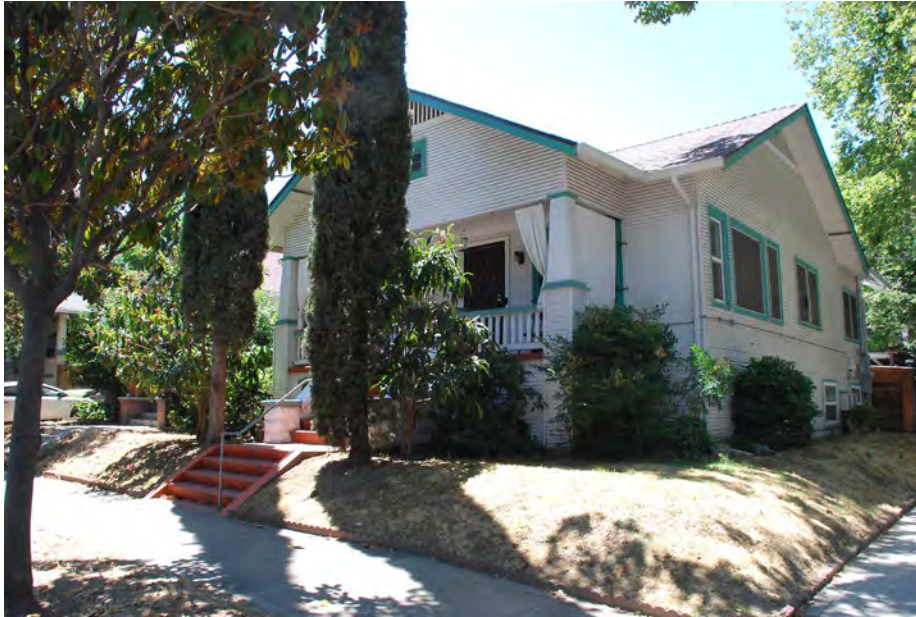
P5b. Description of Photo: (View, date, accession #) Photograph 1: North and west elevations, camera facing southeast, June 15, 2021.

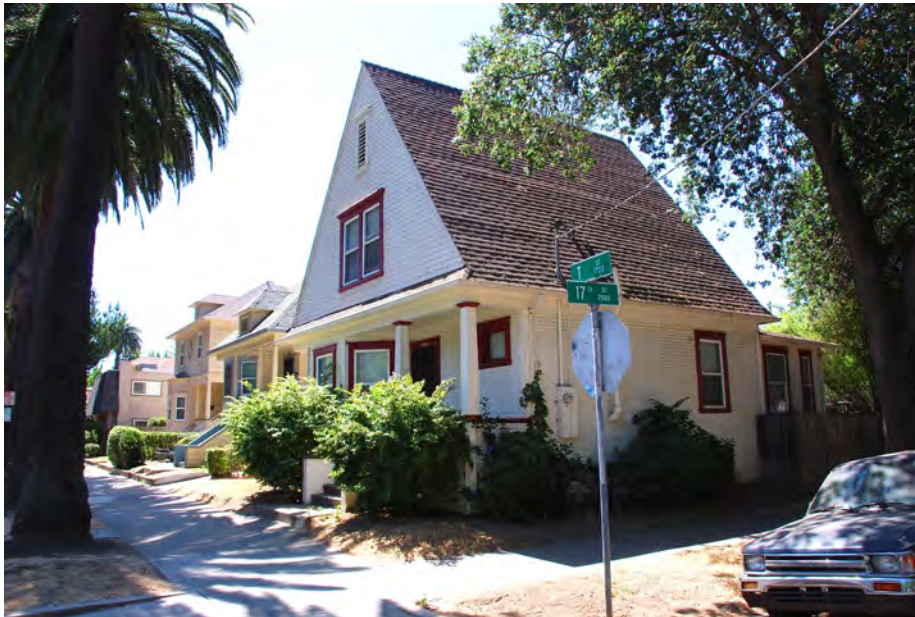
P5b. Description of Photo: (View, date, accession #) Photograph 1: North and west elevations, camera facing southeast, June 15, 2021.

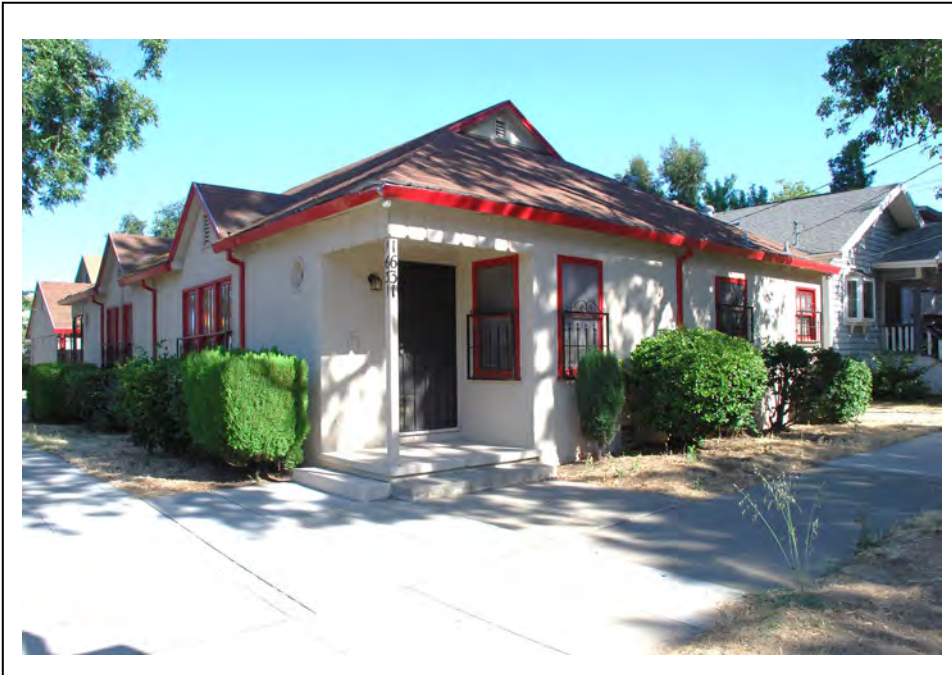
**P5b. Description of Photo:** (View, date, accession #) Photograph 1: West and south elevations, camera facing northwest, June 15, 2021.

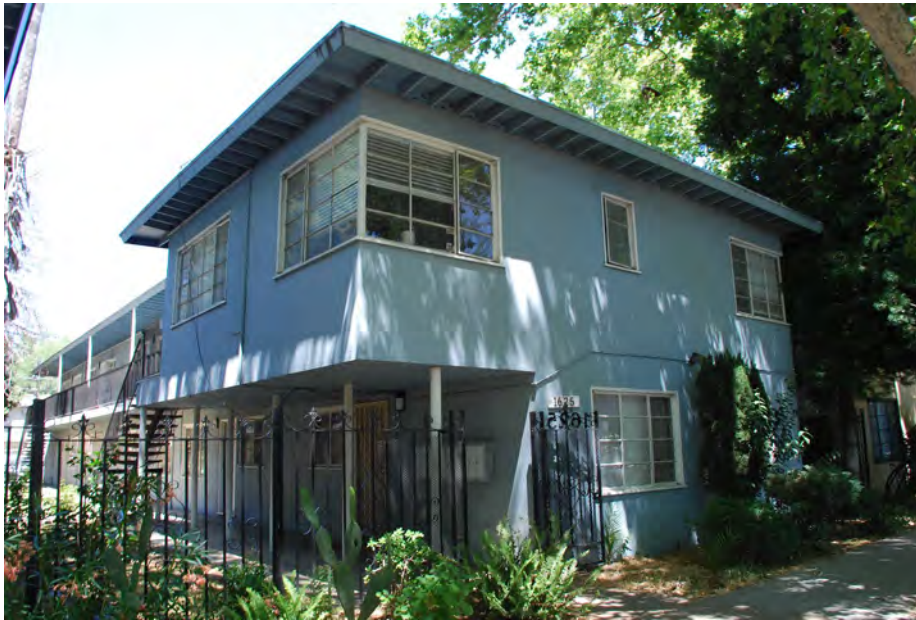
P5b. Description of Photo: (View, date, accession #) Photograph 1: West and south elevations, camera facing northeast, June 15, 2021.

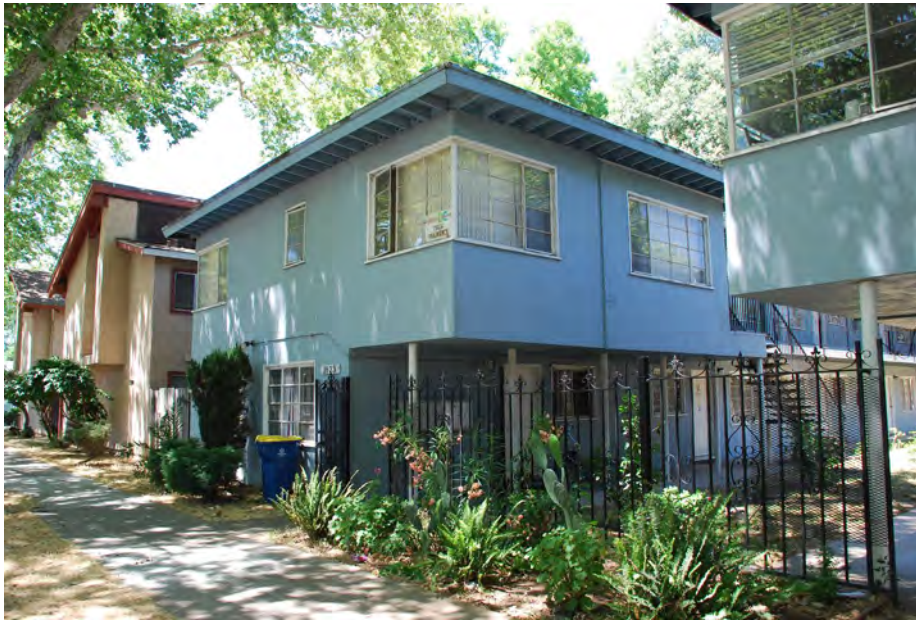
P5b. Description of Photo: (View, date, accession #) Photograph 1: South and east elevations, camera facing northwest, June 15, 2021.
