State of California – The Resources Agency  
DEPARTMENT OF PARKS AND RECREATION  
PRIMARY RECORD

\*Resource Name or # (Assigned by recorder) 2209 14<sup>th</sup> Street

c. Address 2209 14<sup>th</sup> Street City Sacramento Zip 95818

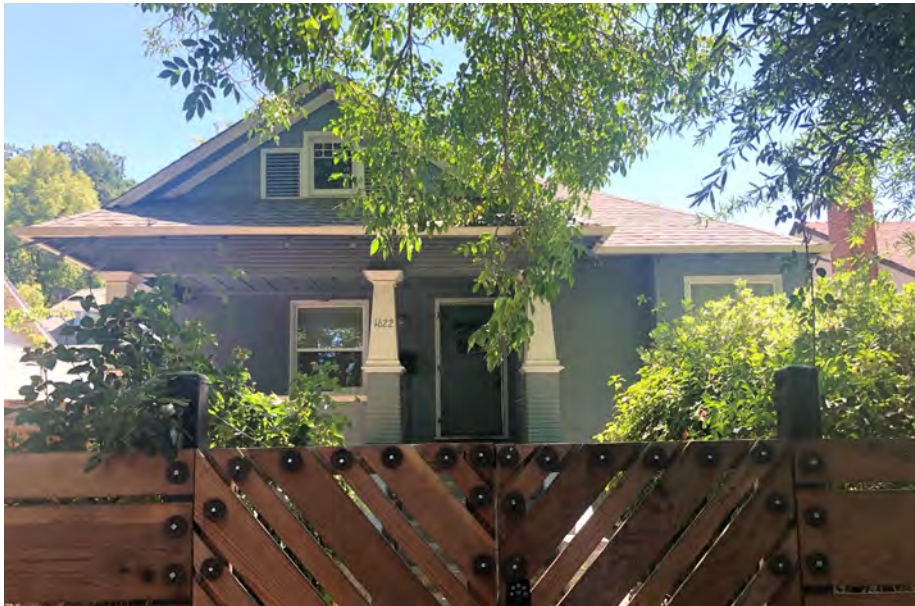
P5b. Description of Photo: (View, date, accession #) Photograph 1: North elevation, camera facing south, June 15, 2021.

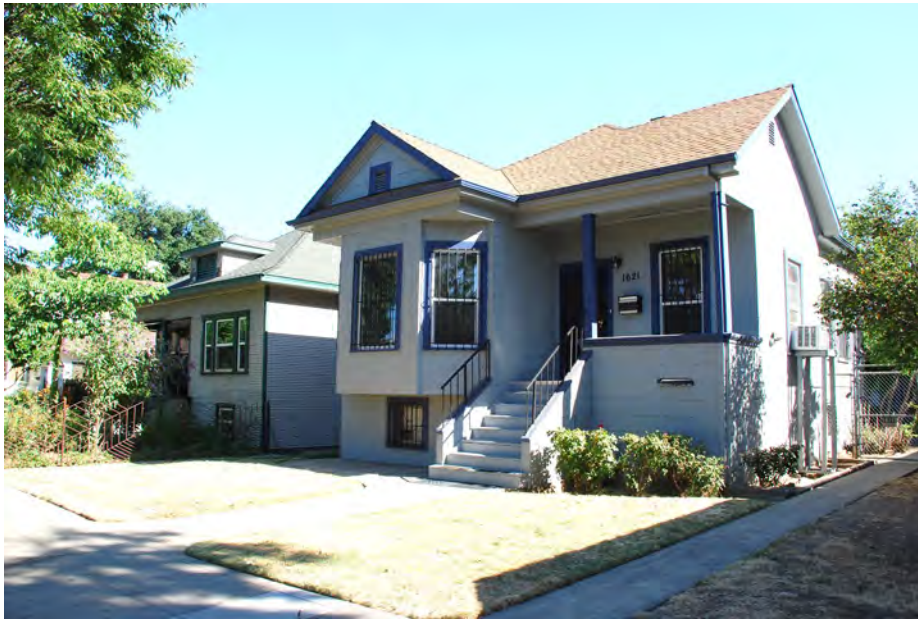
P5b. Description of Photo: (View, date, accession #) Photograph 1: South and east elevations, camera facing northwest, June 15, 2021.

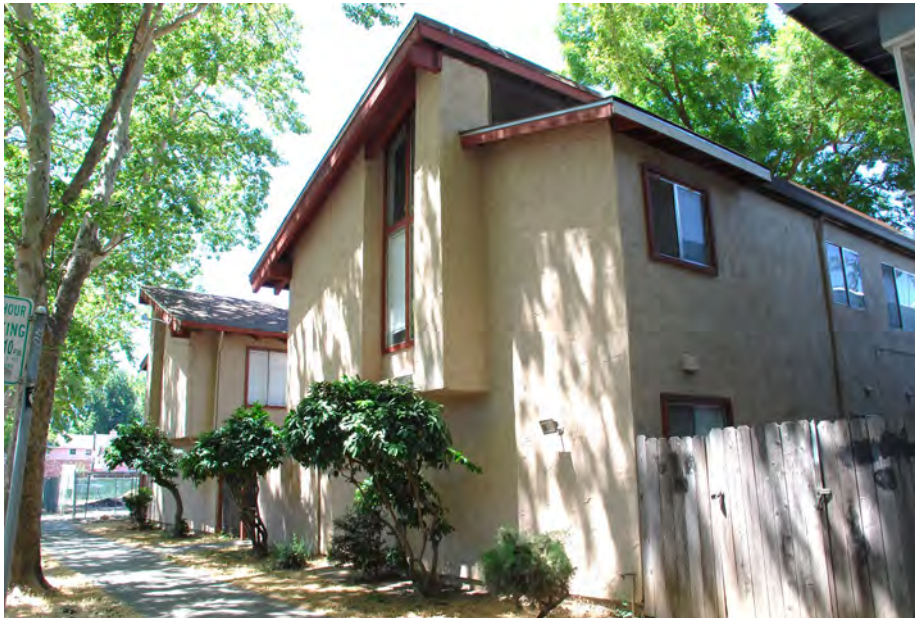
P5b. Description of Photo: (View, date, accession #) Photograph 1: South and east elevations, camera facing northwest, June 15, 2021.

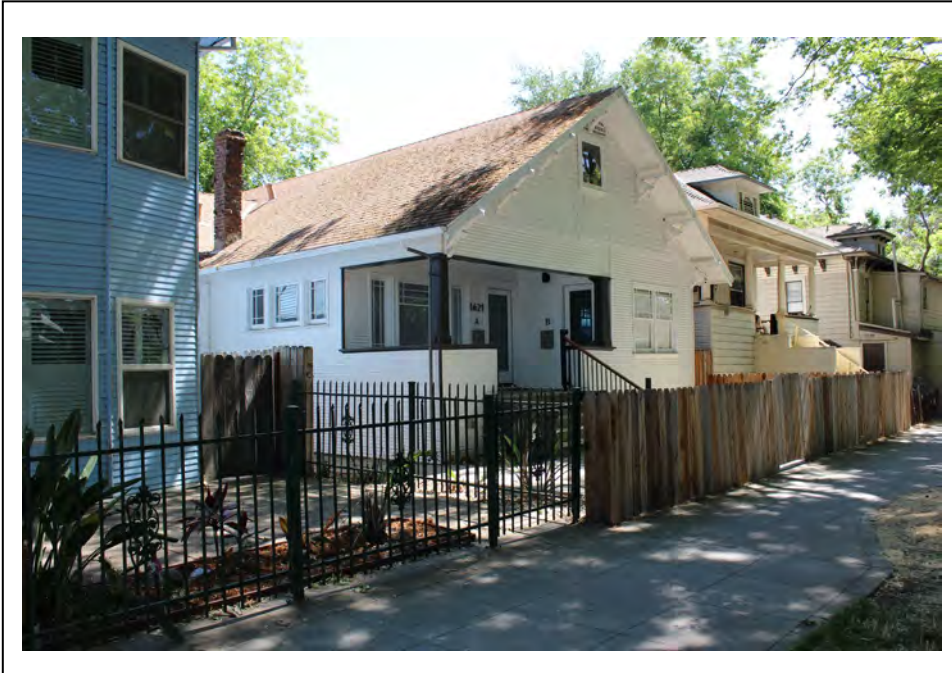
**P5b. Description of Photo:** (View, date, accession #) Photograph 1: West and south elevations, camera facing northeast, June 15, 2021.

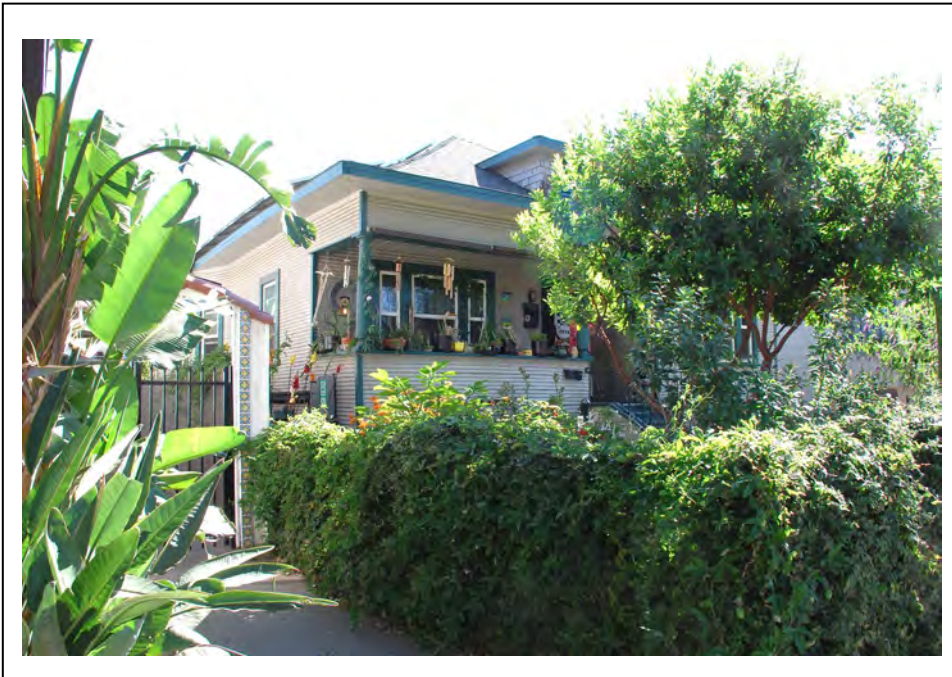
**\*P3a. Description:** (Describe resource and its major elements. Include design, materials, condition, alterations, size, setting, and boundaries)  
The one-story American Four-Square residence sits atop a raised basement and has a rectangular plan and medium-pitch hipped roof. It has medium eaves and a hipped dormer with two louvered vents. The dormer is clad in wood shingles; the rest of the house is clad in narrow wood clapboard. The partial-width integral porch on the main (south) façade shelters the centered main entrance, which is fitted with a metal security door and is accessed via a wide set of wood steps. Tuscan columns support the porch at the corners and rest on the solid balustrade. Fenestration consists of vinyl replacement windows. The main façade features two assemblages of three windows each. A double garage at the rear of the property has a flat roof and metal roll-up door. It is accessed via Victorian Alley.

**P5b. Description of Photo:** (View, date, accession #) Photograph 1: West and south elevations, camera facing northeast, June 15, 2021.

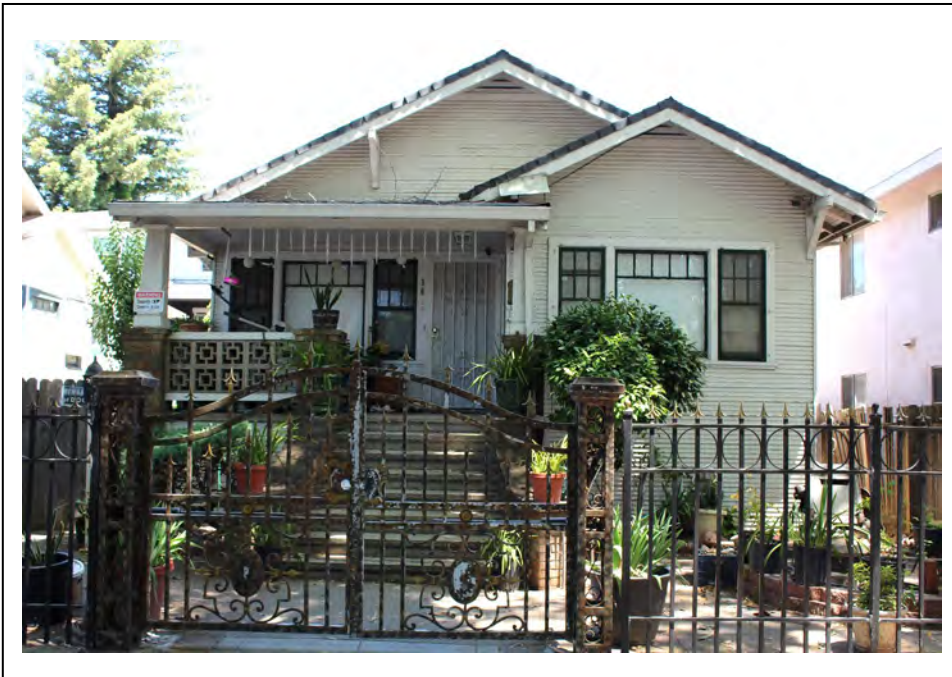
**\*P3a. Description:** (Describe resource and its major elements. Include design, materials, condition, alterations, size, setting, and boundaries)  
The one-story Craftsman residence sits atop a raised basement and has a roughly rectangular plan. The medium-pitched front-gabled roof has triangular knee braces. The building is clad in narrow horizontal wood clapboard. The projecting partial-width porch on the main (south) façade has a shed roof and shelters the centered main entrance, which is fitted with a metal security screen door and is accessed via a wide set of concrete steps with brick wing walls. Battered wood columns with capitals and bases support the porch at the corners and rest on heavy brick piers; the balustrade is wood and cinderblock, with blocks with decorative cutouts repeating in a pattern. Fenestration consists of double-hung wood-sash windows. The main façade features two decorative assemblages of three cottage windows on either side of the entrance.

**P5b. Description of Photo:** (View, date, accession #) Photograph 1: South elevation, camera facing north, June 15, 2021.

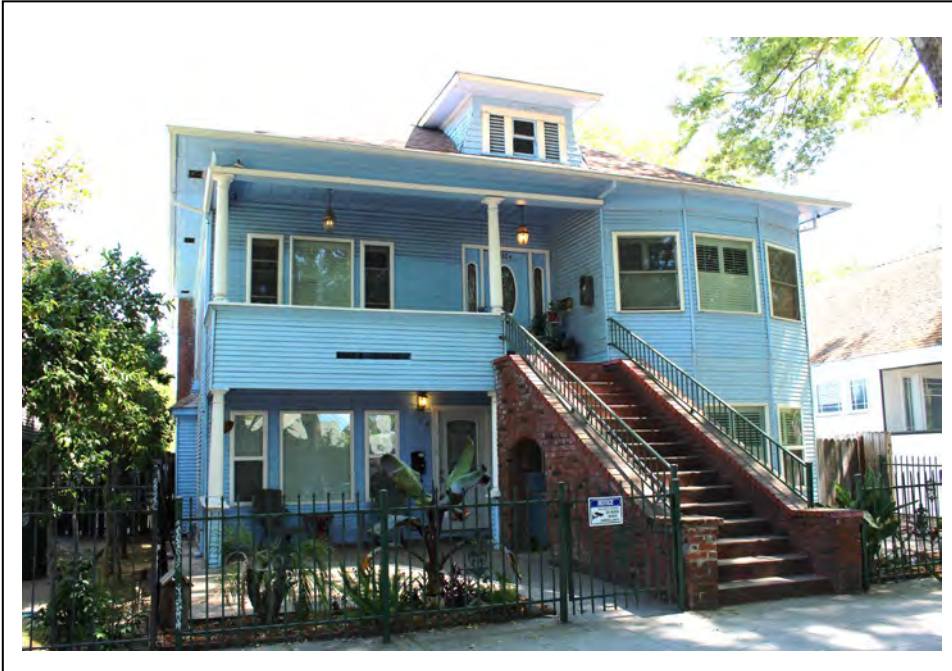
**\*P3a. Description:** (Describe resource and its major elements. Include design, materials, condition, alterations, size, setting, and boundaries)  
The two-story Four-Square residence has a rectangular plan and medium-pitched hipped roof with a hipped dormer. The dormer has a double-hung wood-sash window with two louvered vents on either side. The dormer is clad in wood shingle; the rest of the house is clad in horizontal wood clapboard. The partial-width porch on the main (south) façade shelters the centered main entrance, which is on the second floor and has a partially glazed paneled wood door with side lights on either side. It is accessed via a wide set of concrete steps with brick wing walls and metal hand rails. There is a passageway with arched openings in the wing walls under the stairs. Round wood columns with capitals and bases support the porch at the corners and rest on the solid clapboard balustrade. The porch also shelters the first-story entrance, which is fitted with a partially glazed paneled wood door. Fenestration consists of aluminum slider windows. The main façade features a wide, shallow cutaway bay window on the right side of the main façade.

**P5b. Description of Photo:** (View, date, accession #) Photograph 1: South elevation, camera facing northeast, June 15, 2021.

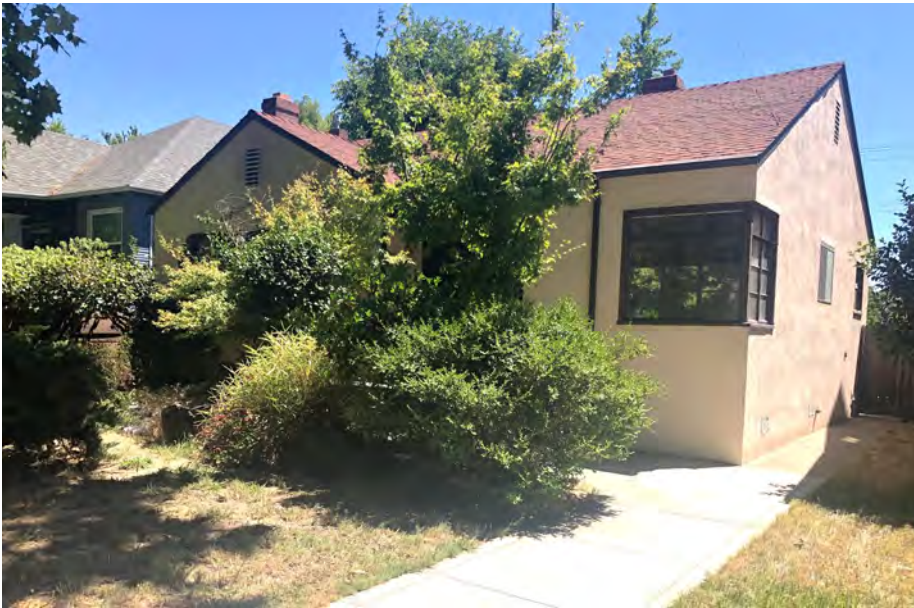
\*P3a. Description: (Describe resource and its major elements. Include design, materials, condition, alterations, size, setting, and boundaries)  
The one-story residence, which exhibits elements of Minimal Traditional architecture, has a roughly rectangular plan and medium-pitched cross-gabled roof with louvered vents on the gable ends. It is clad in stucco. The partial-width porch on the main (north) façade has a shed roof and shelters the centered main entrance, which is accessed via a short set of side-facing concrete steps. The porch has a simple metal hand railing. Fenestration consists of double-hung wood-sash windows, replacement sliding windows, and fixed casement multiple-light windows. The volume under the front gable to the left of the main entrance projects slightly, and the window on the gable has decorative wood shutters. There is a brick chimney on the east elevation.

P5b. Description of Photo: (View, date, accession #) Photograph 1: North and west elevations, camera facing southeast, June 15, 2021.

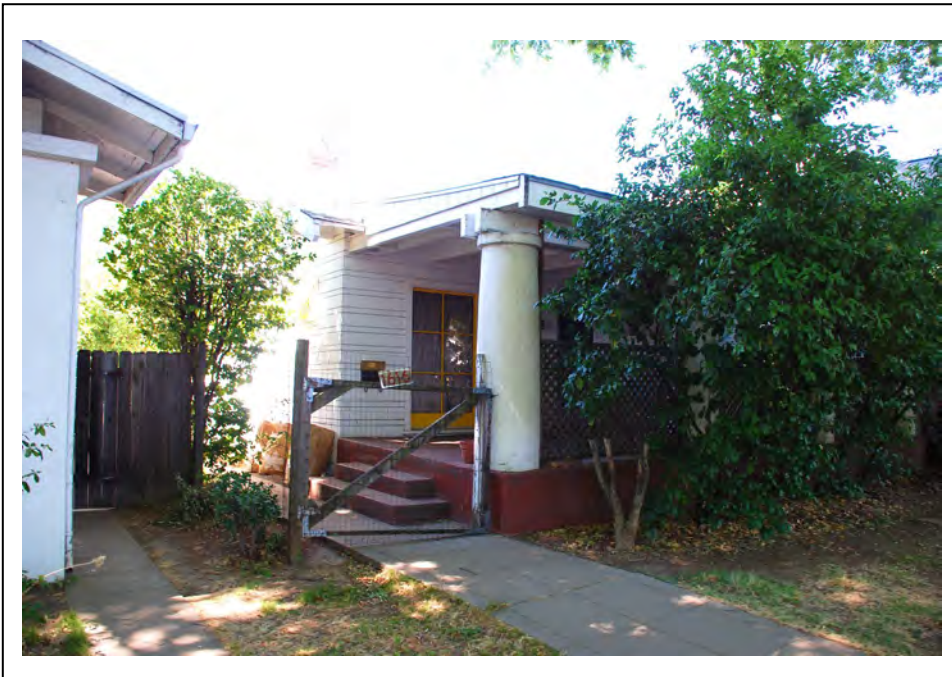
\*P3a. **Description:** (Describe resource and its major elements. Include design, materials, condition, alterations, size, setting, and boundaries)  
The one-story residence has a rectangular plan and medium-pitched side-gabled roof with exposed roof beams. It is clad in horizontal wood drop siding. The projecting full-width porch on the main (north) façade shelters the centered main entrance, which is accessed from the side via a low set of concrete steps. It features a shed roof and is supported at the corners by large round columns with capitals; the porch is screened at the front wood lattice panels. Fenestration consists of casement windows. The main façade features a large fixed window with multiple lights in a rectangular opening to the left of the entrance.

P5b. Description of Photo: (View, date, accession #) Photograph 1: North elevation, camera facing southwest, June 15, 2021.

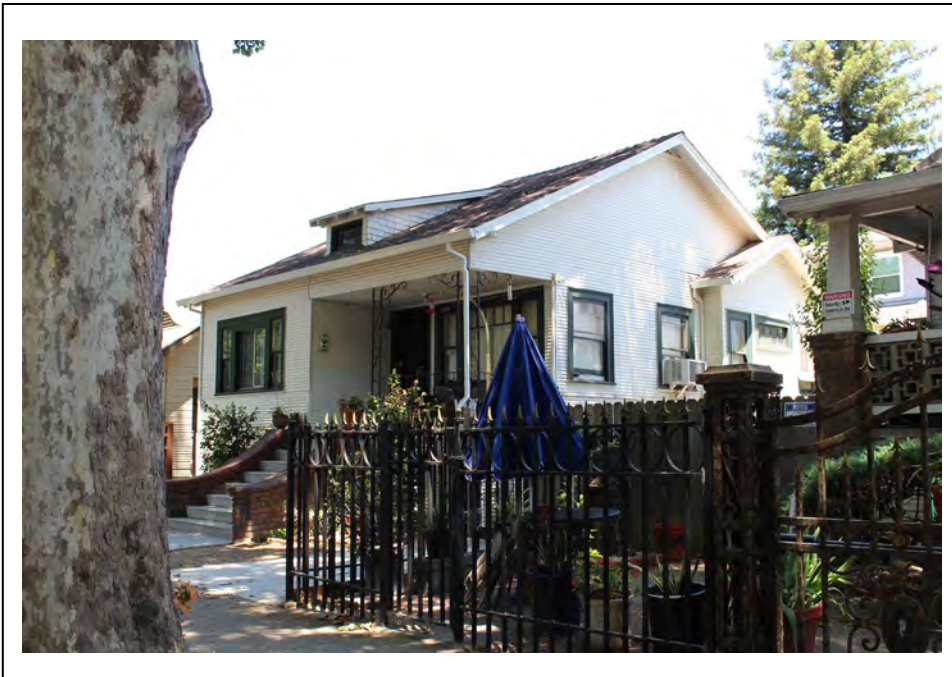
\*P3a. Description: (Describe resource and its major elements. Include design, materials, condition, alterations, size, setting, and boundaries)  
The one-story residence, which exhibits elements of Craftsman architecture, has a rectangular plan and medium-pitched side-gabled roof with small vents on the gable ends. The main (south) façade has a shed-roof dormer fitted with a fixed window and clad in wood shingles. The house is clad in narrow wood clapboard. The partial-width porch on the main façade shelters the centered main entrance, which is fitted with a metal security screen door and is accessed via a wide set of concrete steps with curved brick wing walls. A decorative metal column supports the porch at the corner; the balustrade is metal. Fenestration consists of double-hung wood-sash windows. The main façade features a decorative assemblage of three cottage windows to the right of the entrance. A second assemblage of three windows to the left of the entrance has a replacement sliding aluminum window between two double-hung wood-sash windows.

P5b. Description of Photo: (View, date, accession #) Photograph 1: South and east elevations, camera facing northwest, June 15, 2021.

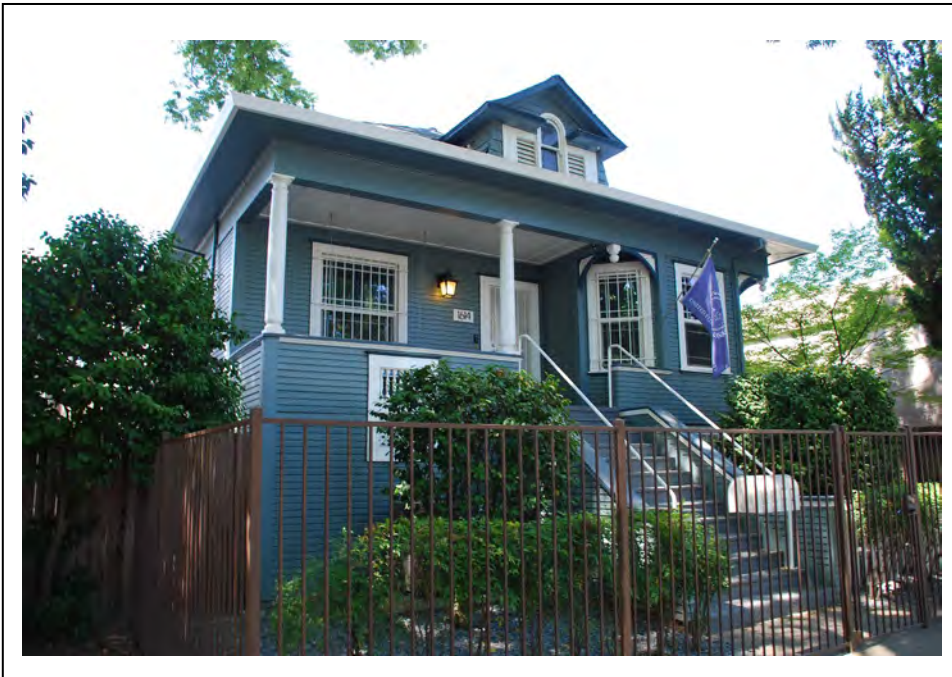
\*P3a. Description: (Describe resource and its major elements. Include design, materials, condition, alterations, size, setting, and boundaries)  
The two-story Four-Square residence sits atop a raised basement and has a rectangular plan and medium-pitched hipped roof. The house is clad in horizontal narrow wood clapboard. The partial-width porch on the main (north) façade shelters the centered main entrance, which has a security screen door and is accessed via a long set of wood steps with wooden wing walls and a metal hand railing. Round wood columns with capitals and bases support the porch at the corner and entrance. Fenestration consists of vinyl replacement windows. The main façade features a cutaway bay window assemblage to the right of the entrance. There is a gable dormer with returns on the main elevation that features two louvered vents on either side of a double-hung wood-sash window with an arched top. The dormer is clad in wood shingles.

P5b. Description of Photo: (View, date, accession #) Photograph 1: North elevation, camera facing southwest, June 15, 2021.

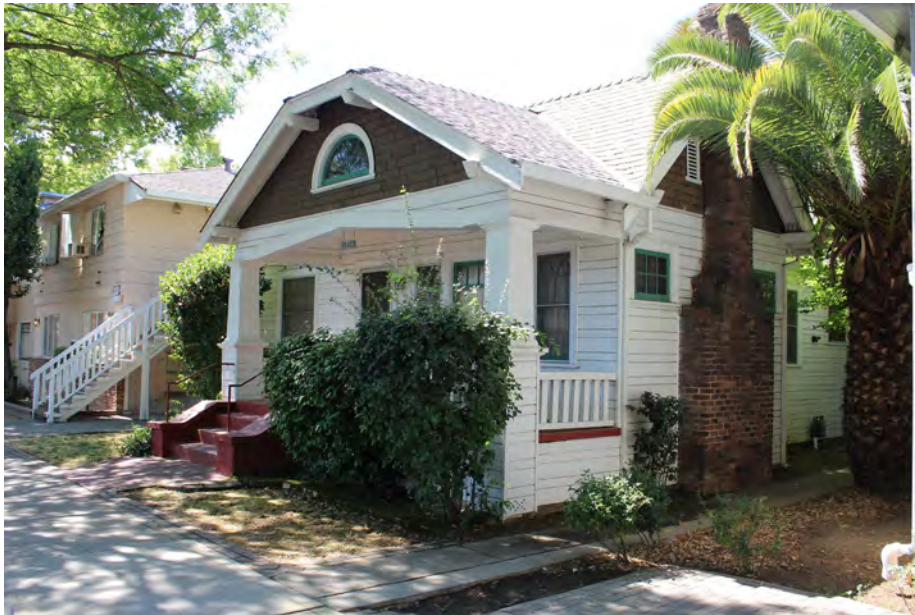
P5b. Description of Photo: (View, date, accession #) Photograph 1: North and west elevations, camera facing southeast, June 15, 2021.

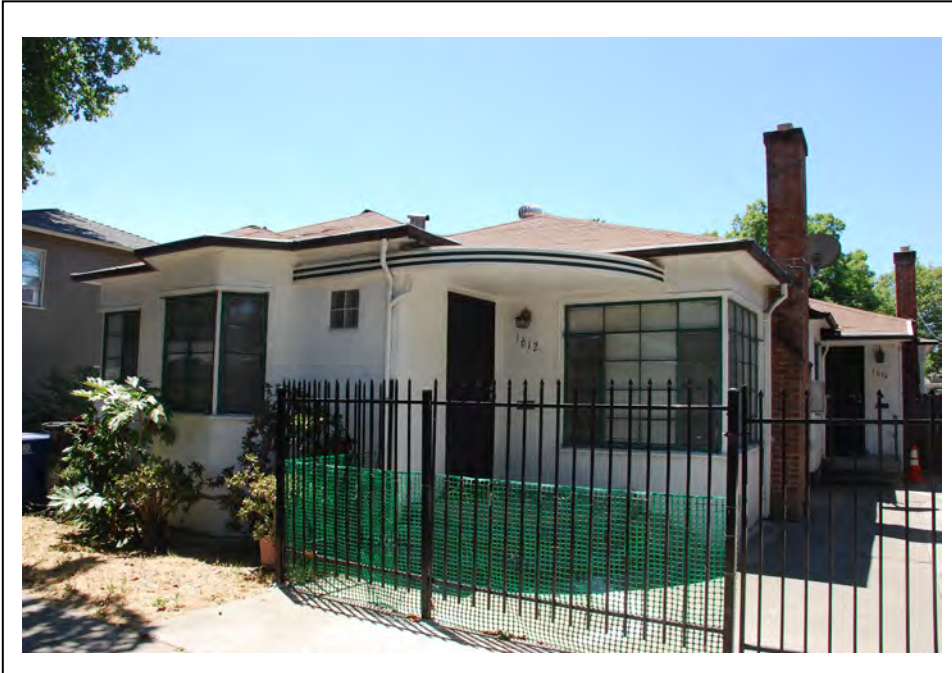
**\*P3a. Description:** (Describe resource and its major elements. Include design, materials, condition, alterations, size, setting, and boundaries)  
The one-story residence, which exhibits elements of Minimal-Traditional architecture, has a roughly rectangular plan and medium-pitched hipped roof. It is clad in stucco. The projecting partial-width porch on the main (north) façade has a flat roof with a curved edge and horizontal grooves. The main entrance is right of center and faces to the side; it has a metal security screen door and is accessed via a wide set of concrete steps. The second entrance on the west façade is fitted with a metal security screen door and is accessed via a short set of concrete steps, which are curved to the outside, mimicking the shape of the roof. Fenestration consists of multi-light casement windows, and there is a bay window to the left of the entrance on the main façade. The second entrance also has a metal security screen door and faces the street; it is located farther back on a projecting volume of the west elevation and accessed by a low set of concrete steps. There are two brick chimneys on the west elevation.

**P5b. Description of Photo:** (View, date, accession #) Photograph 1: North and west elevations, camera facing southeast, June 15, 2021.

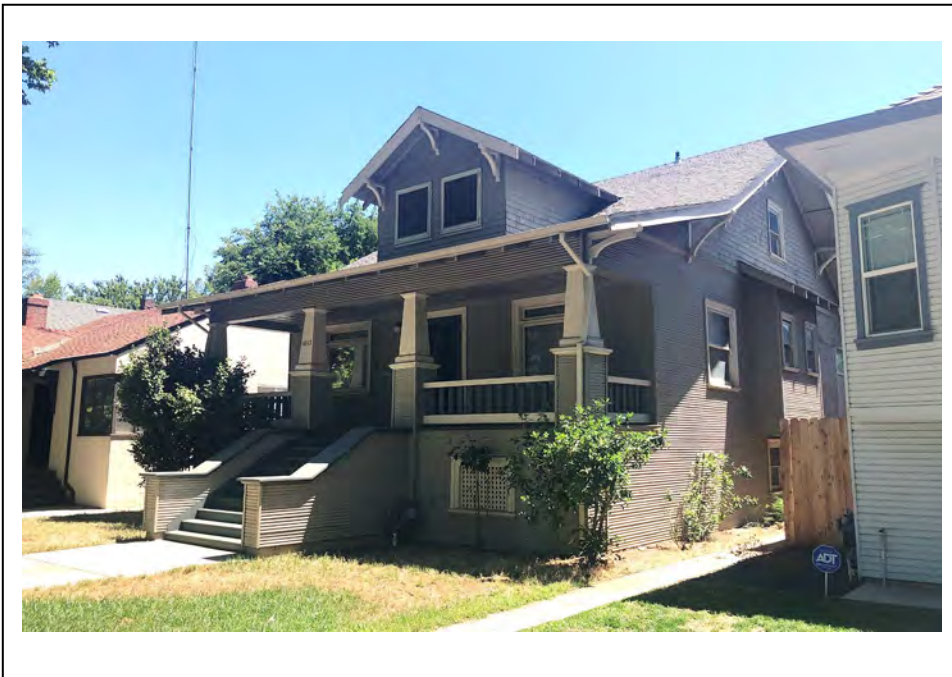
\*P3a. Description: (Describe resource and its major elements. Include design, materials, condition, alterations, size, setting, and boundaries)  
The 1.5-story Craftsman residence sits atop a raised basement and has a rectangular plan. The medium-pitched side-gabled roof has exposed rafter tails and curved knee braces. There is a gable dormer at the center of the main (north) façade with two fixed windows. The dormer and gable faces are clad in shingle, while the rest of the building is clad in narrow horizontal wood clapboard. The full-width porch on the main façade shelters the centered main entrance, which is fitted with a partially glazed paneled wood door and is accessed via a wide set of low wood steps with wood wing walls. Battered wood columns with capitals and bases rest on heavy clapboard piers and support the porch at the corners and entrance; the balustrade is wood. Fenestration consists of double-hung wood-sash windows. The main façade features a picture window on each side of the entrance. There are openings with wood screens on either side of the staircase on the basement level of the main façade. There are small projecting volumes on the first floor of the east and west elevations with windows and shed roofs.

P5b. Description of Photo: (View, date, accession #) Photograph 1: North and west elevations, camera facing southeast, June 15, 2021.

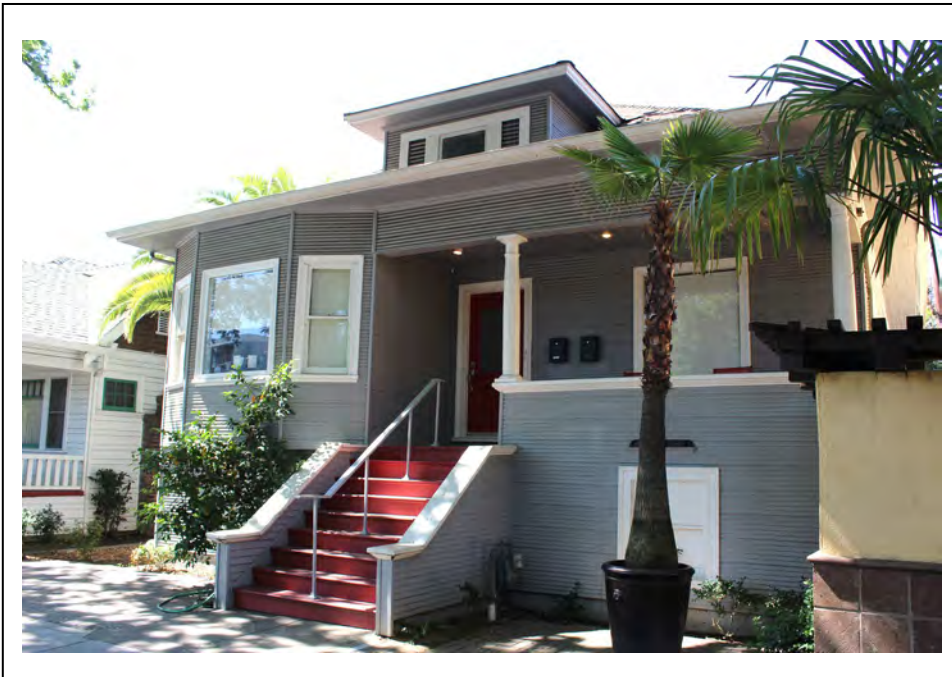
**\*P3a. Description:** (Describe resource and its major elements. Include design, materials, condition, alterations, size, setting, and boundaries)  
The one-story Four-Square residence sits atop a raised basement. It has a rectangular plan and medium-pitched hipped roof. The hipped dormer above the main (north) façade features two louvered vents on either side of a casement window. The building is clad in narrow horizontal wood siding. The partial-width porch on the main façade shelters the centered main entrance, which has a partially glazed paneled wood door and is accessed via a wide set of wood steps with wood wing walls and a central hand rail. Round wood columns with capitals and bases support the porch at the corner and entrance; the balustrade is solid, clad in the same clapboard as the house. Fenestration consists of double-hung wood-sash windows. The main façade features a picture window to the right of the entrance and a cutaway bay window to the left of the entrance.

**P5b. Description of Photo:** (View, date, accession #) Photograph 1: North elevation, camera facing southeast, June 15, 2021.

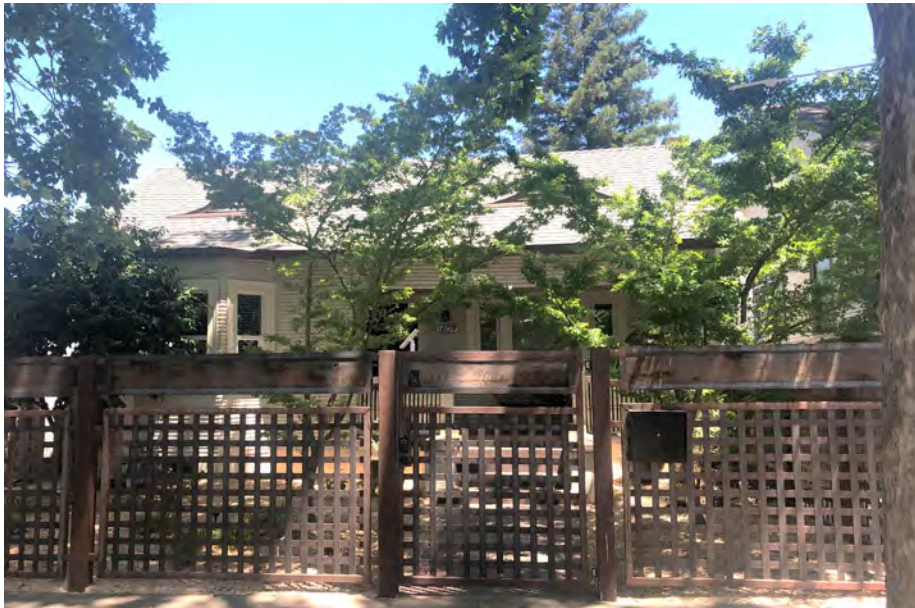
P5b. Description of Photo: (View, date, accession #) Photograph 1: South elevation, camera facing north, June 15, 2021.

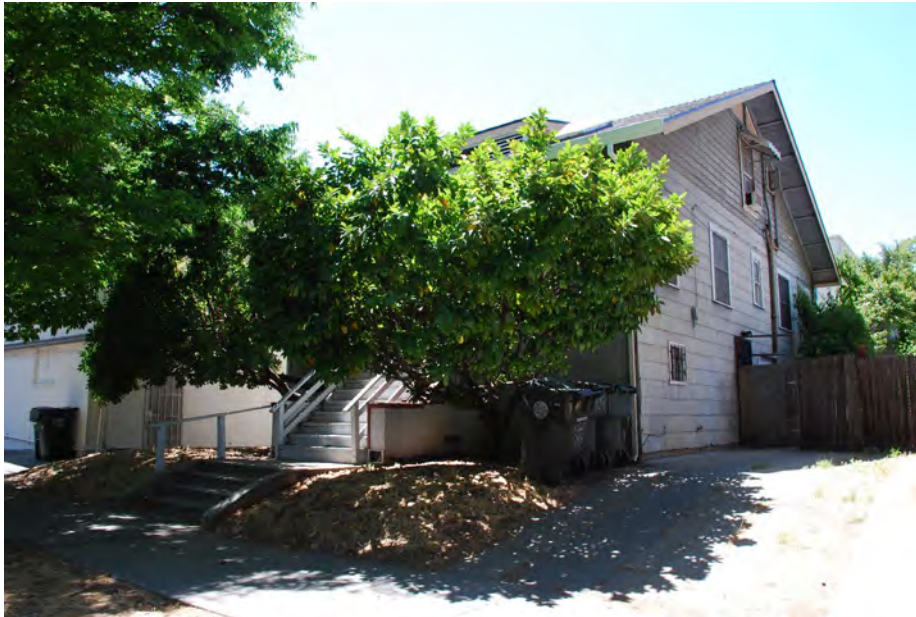
\*P3a. Description: (Describe resource and its major elements. Include design, materials, condition, alterations, size, setting, and boundaries)  
The 1.5-story Craftsman residence sits atop a raised basement and has a rectangular plan and medium-pitched cross-gabled roof. A low gable dormer has a small window flanked by louvered vents. The building is clad in horizontal wood clapboard siding. The centered main entrance on the main (north) façade is fitted with a metal security screen door and is accessed via a tall set of wood steps with a wood balustrade and wing walls. Fenestration consists of double-hung wood-sash windows.

P5b. Description of Photo: (View, date, accession #) Photograph 1: West and north elevations, camera facing northeast, June 15, 2021.

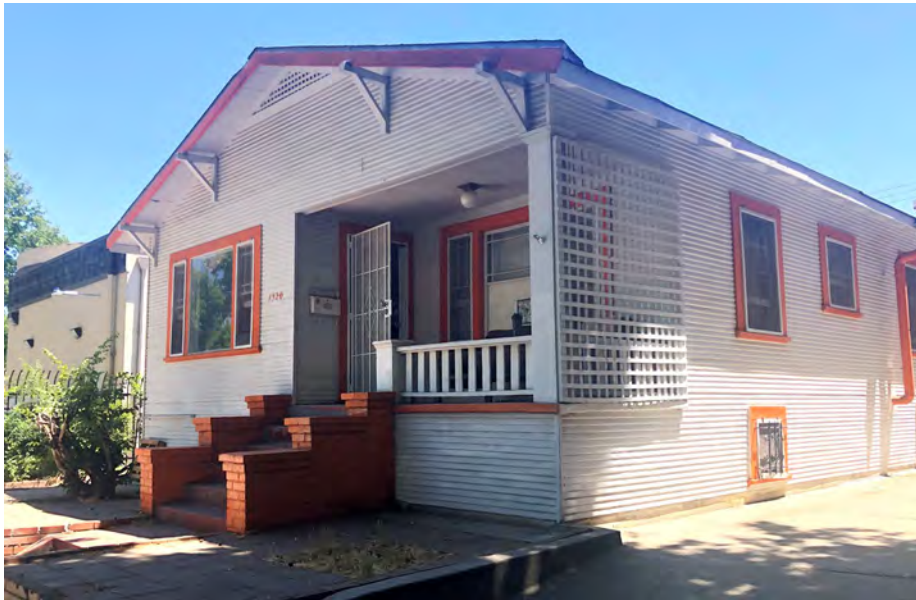
\*P3a. Description: (Describe resource and its major elements. Include design, materials, condition, alterations, size, setting, and boundaries)  
The one-story residence, which exhibits elements of Craftsman architecture, has a rectangular plan and sits atop a raised basement. The medium-pitched front-gabled roof has vents on the gable ends and exposed rafter tails. The building is clad in narrow, horizontal wood clapboard. The partial-width integral porch on the main (north) façade shelters the centered main entrance, which is fitted with a metal security screen door faces to the right. A square wood column with a capital supports the porch at the corners; the balustrade is wood. There is a wooden screen on the right side of the porch. The front steps are concrete with brick wing walls. Fenestration consists of double-hung wood-sash windows in rectangular openings, and the main façade features two decorative assemblages of three cottage windows on either side of the entrance. The front yard is raised and paved with brick.

P5b. Description of Photo: (View, date, accession #) Photograph 1: North and west elevations, camera facing southeast, June 15, 2021.

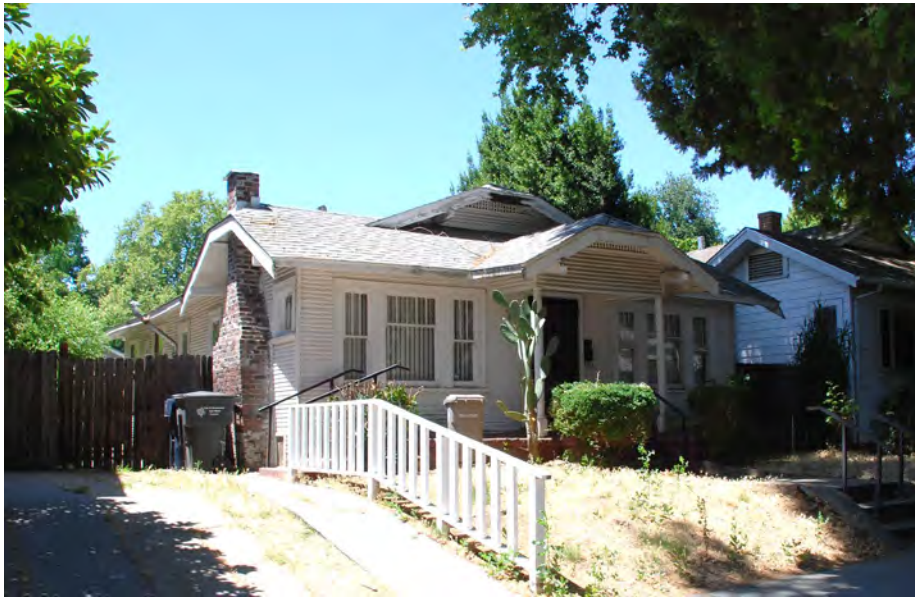
\*P3a. Description: (Describe resource and its major elements. Include design, materials, condition, alterations, size, setting, and boundaries)  
The one-story Craftsman-Bungalow residence has a rectangular plan and medium-pitched hip-on-gable roof with vents on the gable ends and exposed roof beams. It is clad in horizontal wood clapboard. The projecting partial-width porch on the main (north) façade shelters the centered main entrance, which has a metal security screen door and is accessed via a wide set of concrete steps with a metal handrail. Another set of steps leads to the porch from the driveway to the left. Round wood columns with capitals and bases support the porch at the corners. Fenestration consists of double-hung wood-sash windows. The main façade features two decorative assemblages of three cottage windows on either side of the entrance. There is a brick chimney on the east elevation.

P5b. Description of Photo: (View, date, accession #) Photograph 1: North and east elevations, camera facing southwest, June 15, 2021.

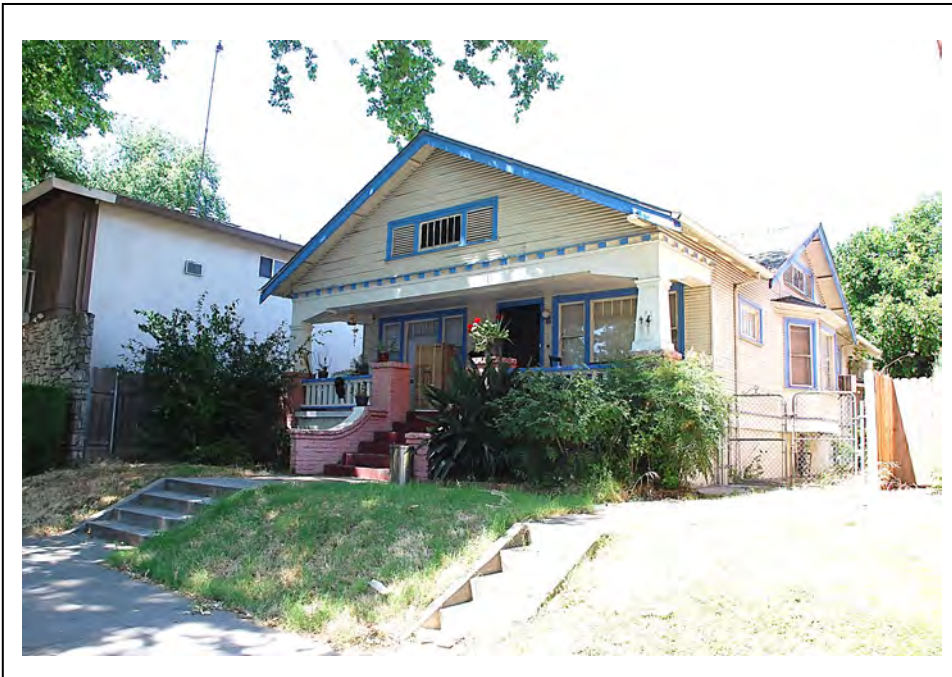
P5b. Description of Photo: (View, date, accession #) Photograph 1: South and east elevations, camera facing northwest, June 15, 2021.

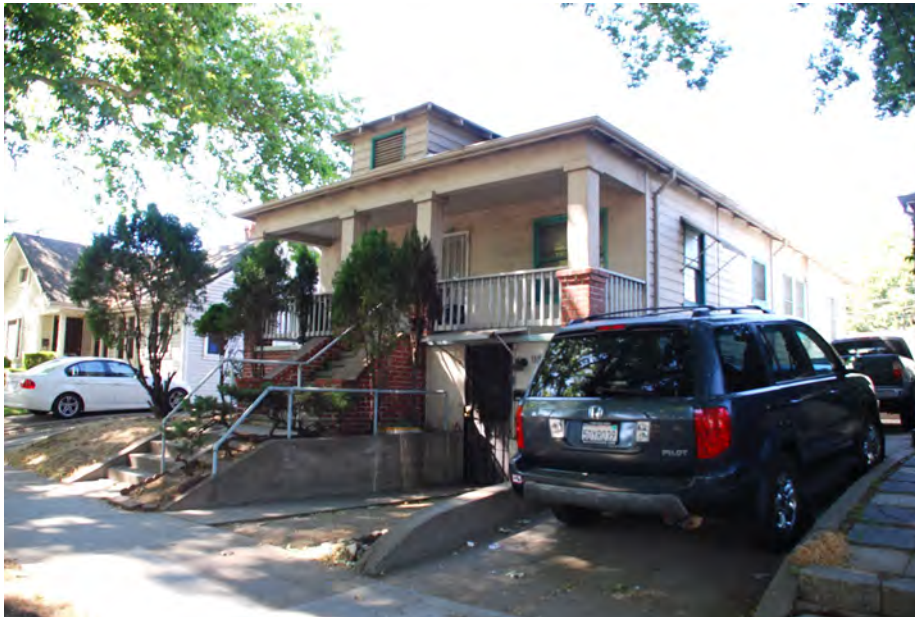
**\*P3a. Description:** (Describe resource and its major elements. Include design, materials, condition, alterations, size, setting, and boundaries)  
The 1.5-story American Four-Square residence has a rectangular plan and sits above a raised basement. It has a medium-pitch hipped roof with a hipped dormer and exposed rafter tails. The hipped dormer features a louvered vent and exposed rafter tails. The house is clad in textured stucco and horizontal wood drop siding. The full-width integral porch on the main (south) façade shelters the centered main entrance, which is fitted with a metal security screen door. The porch is accessed via a wide set of concrete steps with brick wing walls. Heavy square wood columns with capitals support the porch at the corners and entrance, and rest on heavy brick piers; the balustrade is an open wood railing. A secondary entrance to the right of the steps at the basement level is sheltered by an awning and is fitted with a metal security screen door. Fenestration consists of double-hung wood-sash windows in rectangular openings. There is a brick chimney on the west elevation. A narrow driveway at the west of the house leads to a single garage just behind the house. It has a hipped roof with exposed rafter tails and double doors that open from the center in the vehicle opening.

**P5b. Description of Photo:** (View, date, accession #) Photograph 1: West and south elevations, camera facing northwest, June 15, 2021.

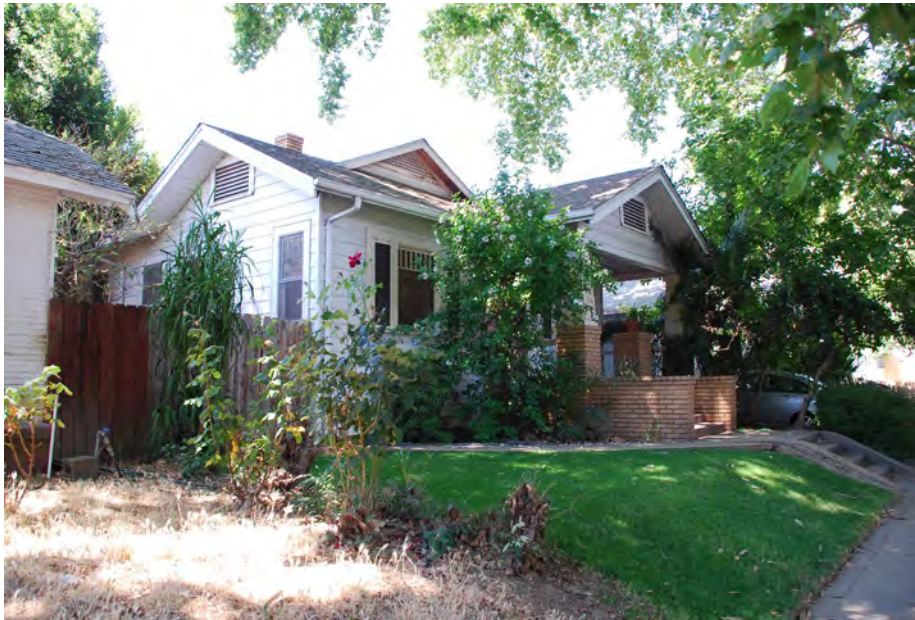
**P5b. Description of Photo:** (View, date, accession #) Photograph 1: East and north elevations, camera facing southwest, June 15, 2021.

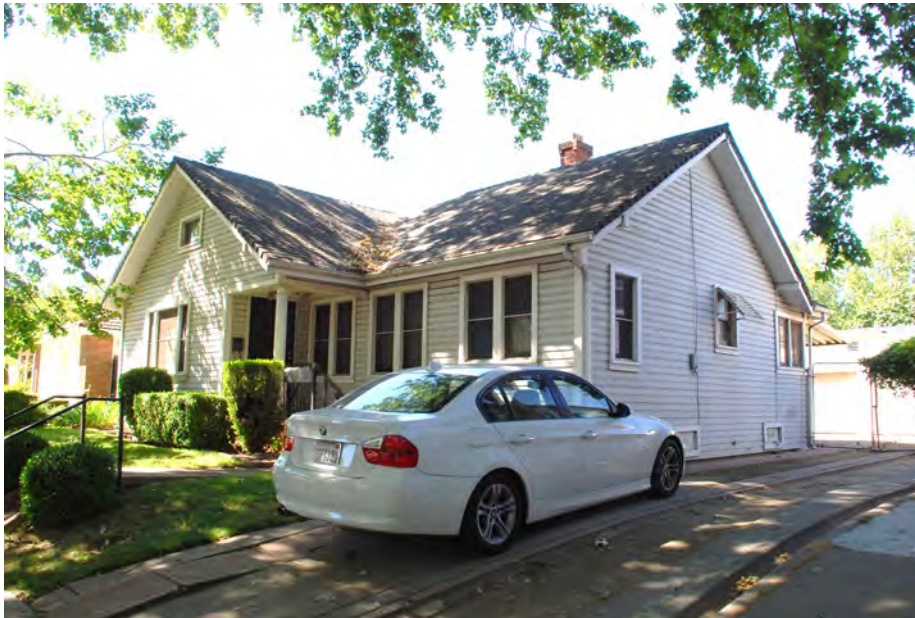
**\*P3a. Description:** (Describe resource and its major elements. Include design, materials, condition, alterations, size, setting, and boundaries)  
The one-story residence, which exhibits elements of Craftsman architecture, has an L-shaped plan and medium-pitched cross-gabled roof with exposed roof beams. It is clad in wood drop siding. The partial-width porch on the main (south) façade shelters the main entrance, which faces east rather than facing the street and is fitted with a metal security screen door. It is accessed via a set of concrete steps. A Tuscan column supports the porch at the corner; the balustrade is metal. Fenestration consists of double-hung wood-sash windows in rectangular openings. A secondary dwelling at the rear of the main house has similar roof form and materials with a rectangular plan and screen porch at its northeast corner. A small single garage along Victorian Alley has stucco cladding and a wood door that opens upward.

P5b. Description of Photo: (View, date, accession #) Photograph 1: South and east elevations, camera facing northwest, June 15, 2021.

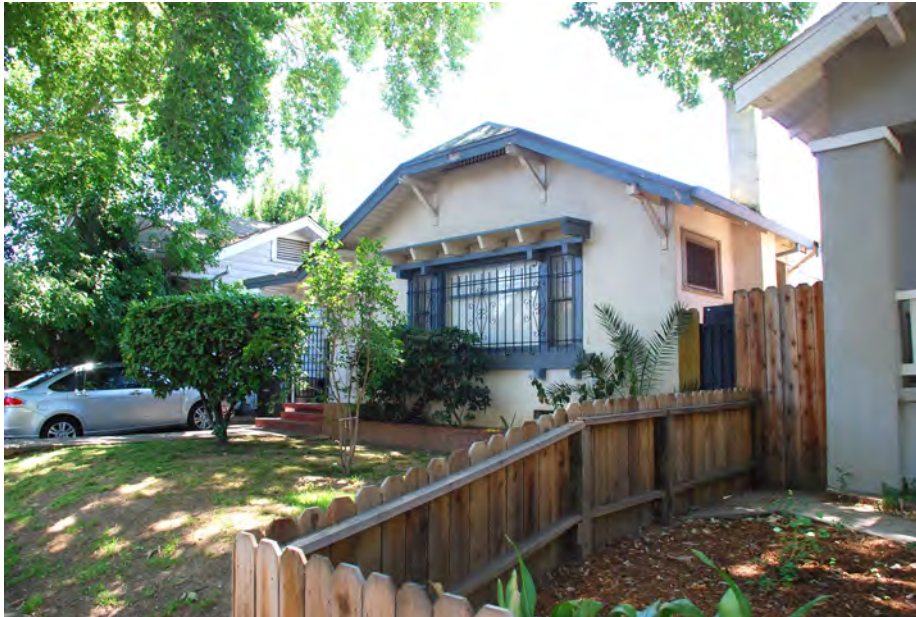
\*P3a. Description: (Describe resource and its major elements. Include design, materials, condition, alterations, size, setting, and boundaries)  
The one-story residence, which exhibits elements of Craftsman architecture, has a rectangular plan and medium-pitched jerkin head roof with knee braces. It is clad in stucco. The partial-width porch on the main (north) façade shelters the main entrance, which is left of center and has a metal security screen door. It is accessed via a wide set of concrete steps. A metal pole supports the porch at the corner. The main façade features an assemblage of three windows to the right of the entrance with a wooden awning above it.

P5b. Description of Photo: (View, date, accession #) Photograph 1: North and west elevations, camera facing southeast, June 15, 2021.

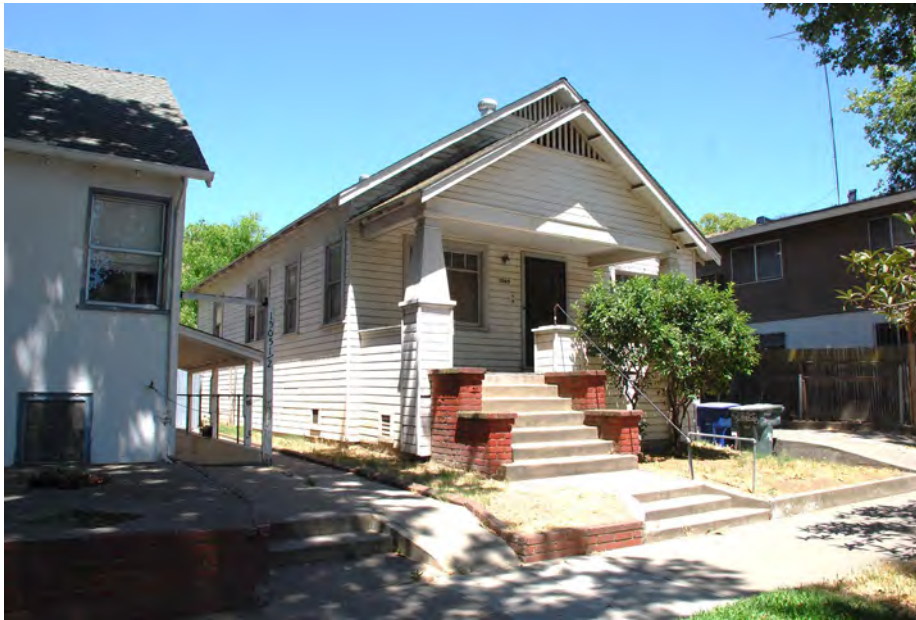
\*P3a. Description: (Describe resource and its major elements. Include design, materials, condition, alterations, size, setting, and boundaries)  
The one-story Craftsman residence sits atop a raised basement and has a rectangular plan. The medium-pitched front-gabled roof has vents on the gable ends. It is clad in horizontal wood clapboard. The projecting partial-width porch on the main (south) façade shelters the centered main entrance, which is fitted with a metal security screen door. The wide front steps are concrete with brick wing walls. Battered wood columns with capitals and bases support the porch at the corners and rest on heavy clapboard piers; the balustrade is solid. Fenestration consists of double-hung wood-sash windows. The main façade features two fixed cottage windows on either side of the entrance.

P5b. Description of Photo: (View, date, accession #) Photograph 1: West and south elevations, camera facing northeast, June 15, 2021.

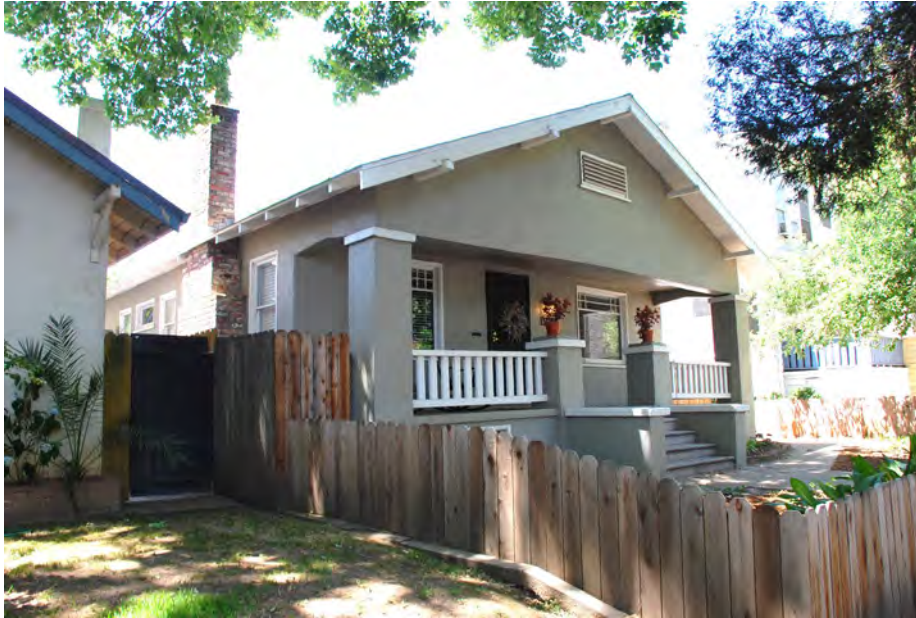
\*P3a. Description: (Describe resource and its major elements. Include design, materials, condition, alterations, size, setting, and boundaries)  
The one-story Craftsman residence sits atop a raised basement and has a rectangular plan. The medium-pitched front-gabled roof has louvered vents on the gable ends and exposed roof beams and rafter tails. The building is clad in stucco. The full-width porch on the main (north) façade shelters the centered main entrance, which has a metal security screen door and is accessed via a wide set of concrete steps with flat stucco wing walls. Square stucco columns with capitals support the porch at the corners; the balustrade is wood. Fenestration consists of double-hung wood-sash windows. The main façade features two cottage picture windows on either side of the entrance. There is a brick chimney on the east elevation.

P5b. Description of Photo: (View, date, accession #) Photograph 1: East and north elevations, camera facing southwest, June 15, 2021.

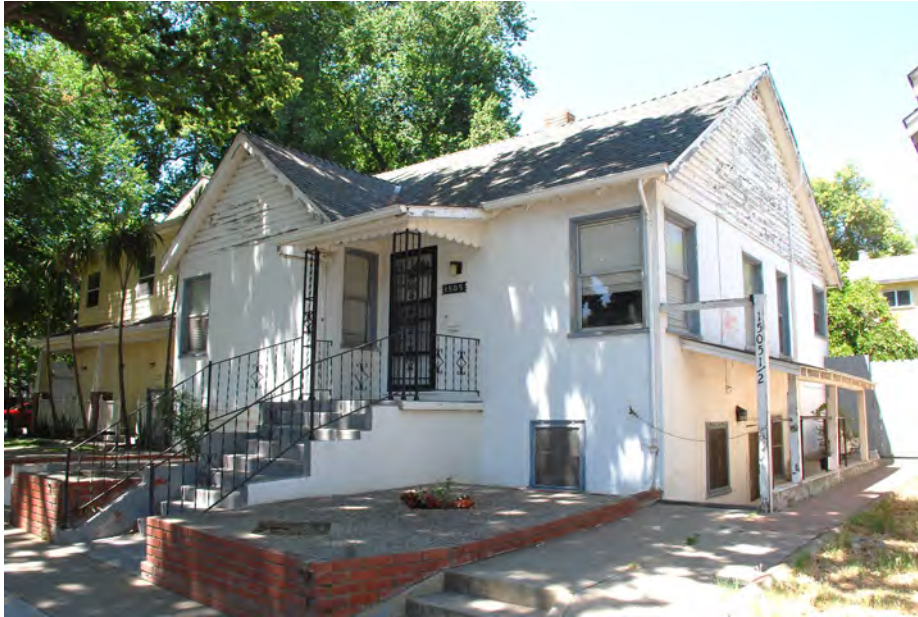
\*P3a. Description: (Describe resource and its major elements. Include design, materials, condition, alterations, size, setting, and boundaries) The one-story residence, which exhibits elements of Minimal Traditional architecture, has a rectangular plan and sits atop a raised basement. The medium-pitched cross-gabled roof has small round vents on the gable ends and exposed rafter tails. Gable ends are clad in horizontal wood clapboard; the rest of the house is clad in stucco. The projecting partial-width porch on the main (south) façade has a shed roof and shelters the centered main entrance, which has a partially glazed paneled wood door and is accessed via a long set of concrete steps. Decorative metal columns support the porch at the corners; the balustrade of the staircase and porch is metal with decorative accents. Fenestration consists of double-hung wood-sash windows. There is a garage with a metal roll-up door at the basement level of the house, accessed by a driveway that slopes downward from the street.

P5b. Description of Photo: (View, date, accession #) Photograph 1: South and east elevations, camera facing northwest, June 15, 2021.
