State of California – The Resources Agency  
DEPARTMENT OF PARKS AND RECREATION  
PRIMARY RECORD

\*Resource Name or # (Assigned by recorder) 2209 14<sup>th</sup> Street

c. Address 2209 14<sup>th</sup> Street City Sacramento Zip 95818

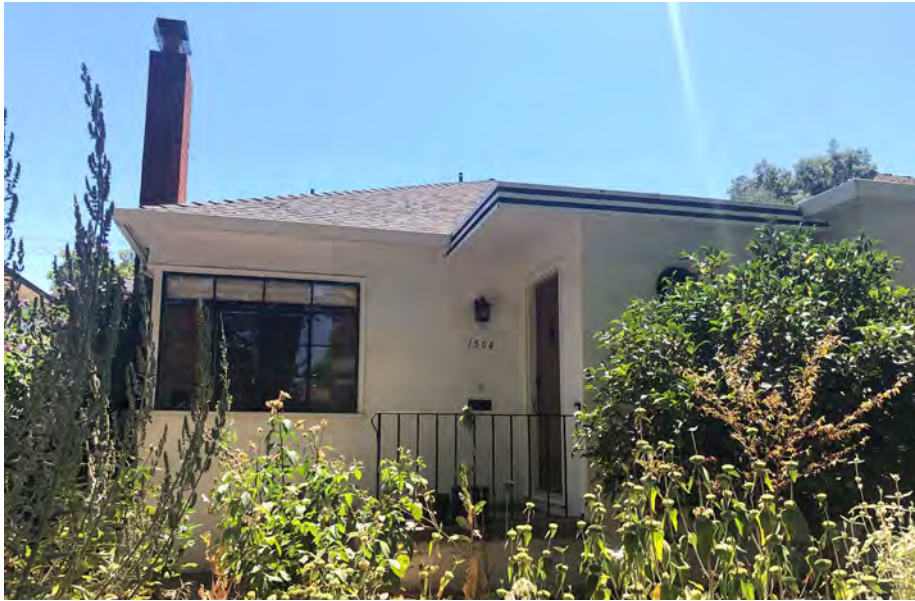
P5b. Description of Photo: (View, date, accession #) Photograph 1: North elevation, camera facing south, June 15, 2021.

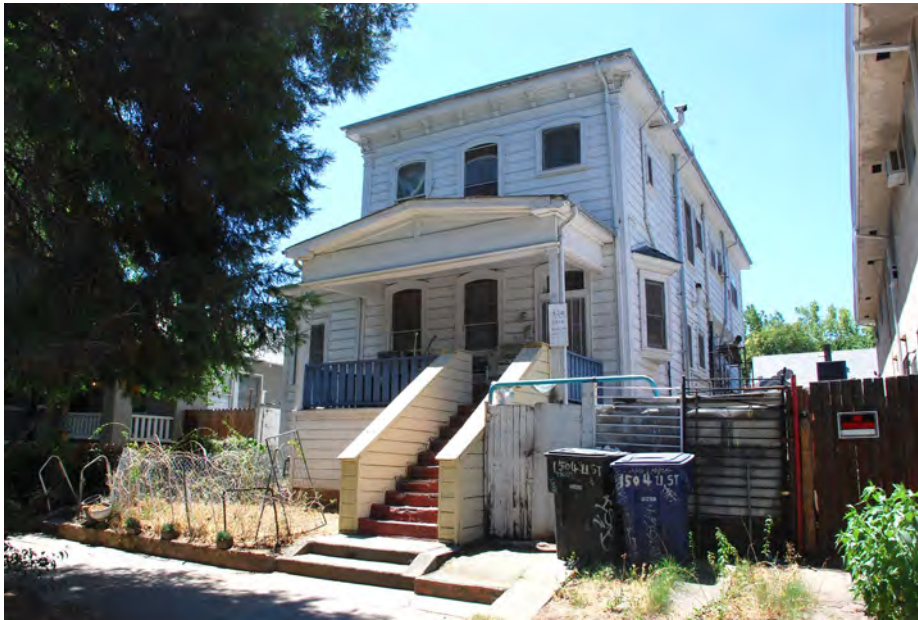
P5b. Description of Photo: (View, date, accession #) Photograph 1: North and west elevations, camera facing southeast, June 15, 2021.

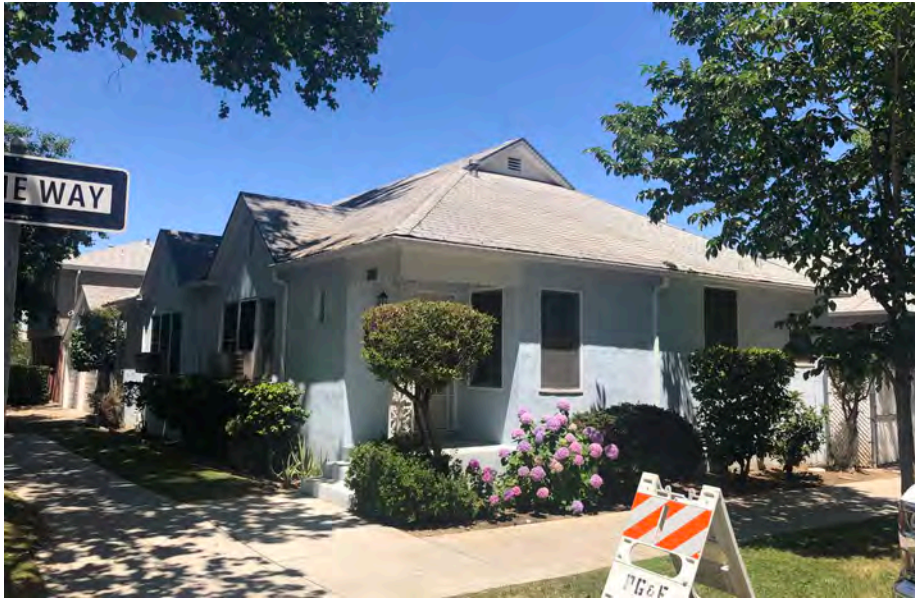
**P5b. Description of Photo:** (View, date, accession #) Photograph 1: South and east elevations, camera facing northwest, June 15, 2021.

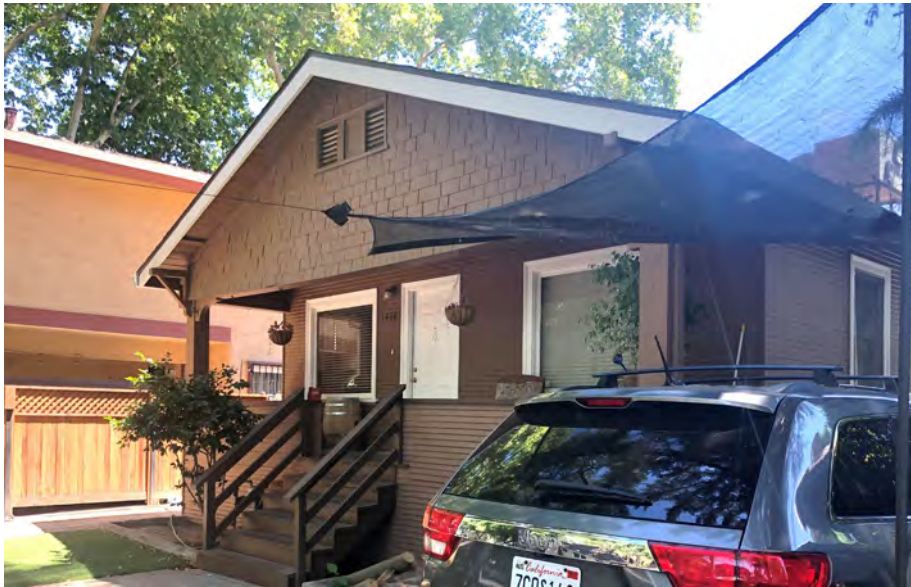
P5b. Description of Photo: (View, date, accession #) Photograph 1: North and west elevations, camera facing southeast, June 15, 2021.

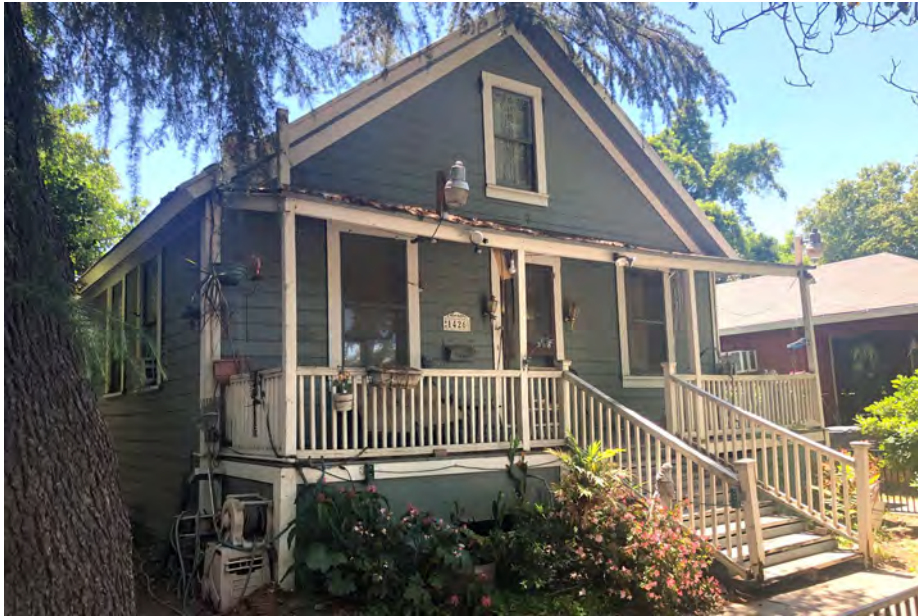
P5b. Description of Photo: (View, date, accession #) Photograph 1: East and north elevations, camera facing southwest, June 15, 2021.

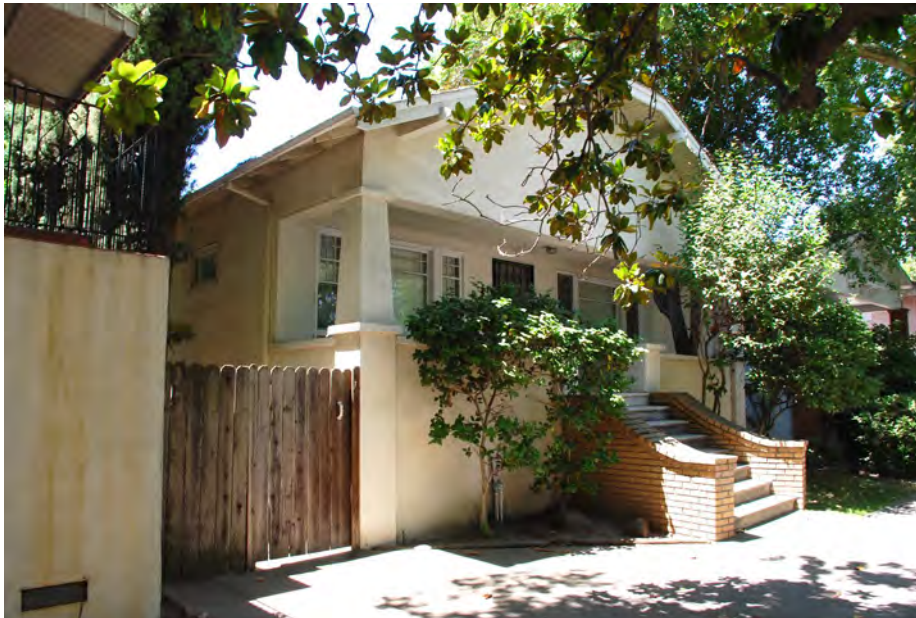
P5b. Description of Photo: (View, date, accession #) Photograph 1: West and south elevations, camera facing southwest, June 15, 2021.

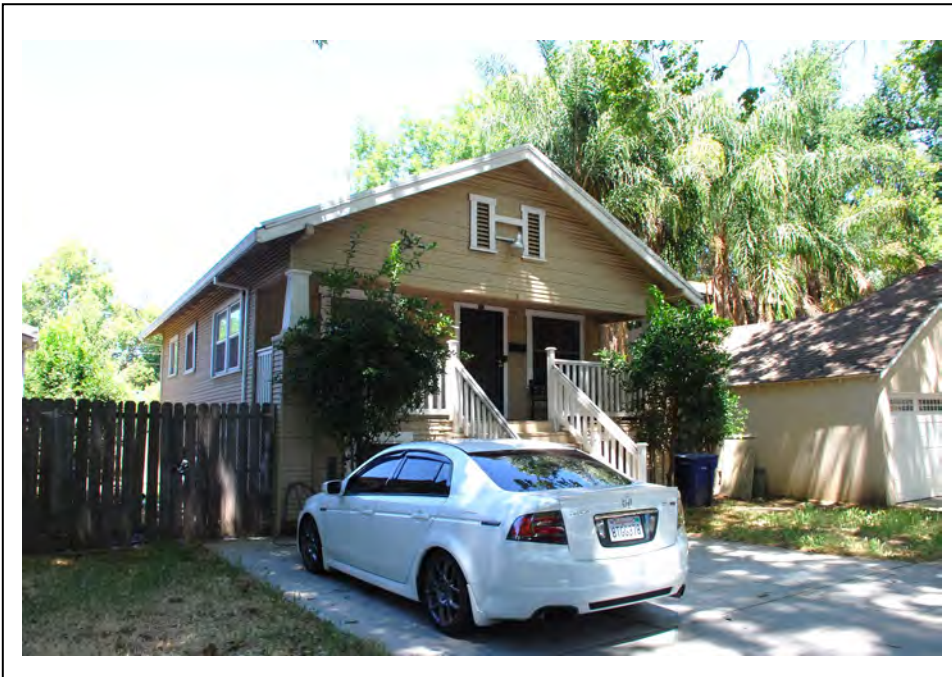
P5b. Description of Photo: (View, date, accession #) Photograph 1: West and south elevations, camera facing northeast, June 15, 2021.

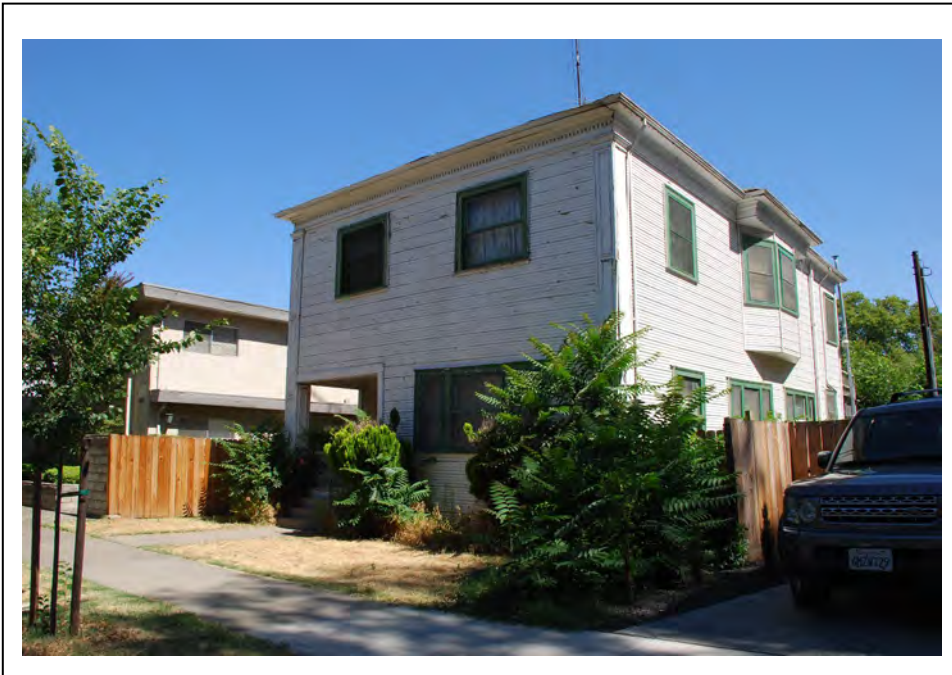
**P5b. Description of Photo:** (View, date, accession #) Photograph 1: South and east elevations, camera facing northwest, June 15, 2021.

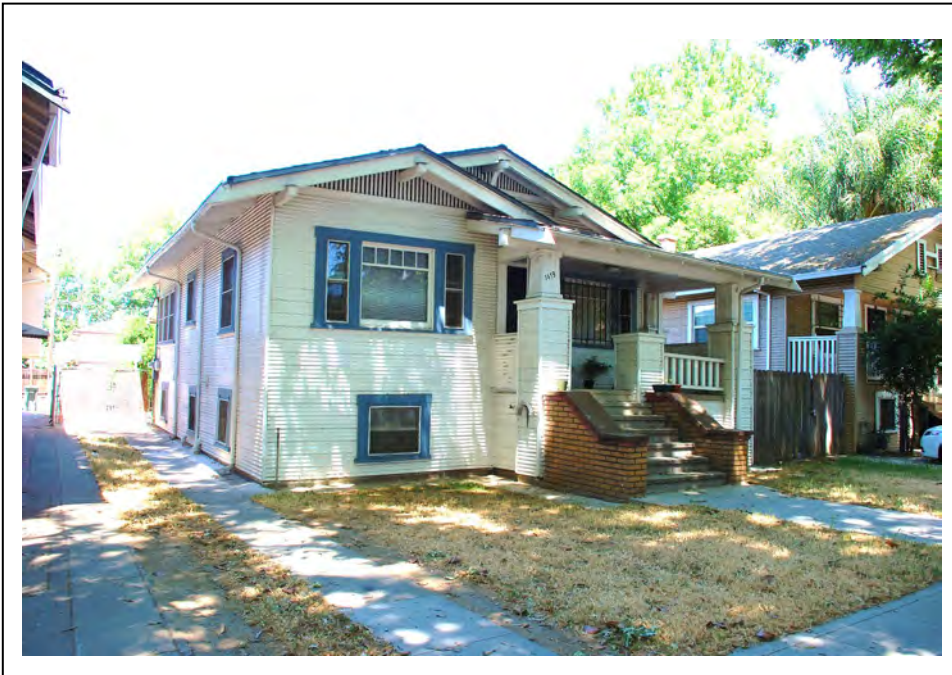
\*P3a. Description: (Describe resource and its major elements. Include design, materials, condition, alterations, size, setting, and boundaries)  
The one-story Craftsman residence has roughly rectangular plan and a raised basement. The medium-pitched gable roof has vents on the gable ends and exposed roof beams. The building is clad in narrow, horizontal wood clapboard. The recessed partial-width porch on the main (south) façade has a slightly projecting shed roof. The centered main entrance is fitted with a metal security screen door. Square wood columns with capitals and bases support the porch at the corners and rest on heavy clapboard piers; the balustrade is wood. The wide concrete steps have brick wing walls. Fenestration consists of double-hung wood-sash windows in rectangular openings. The main façade features two decorative assemblages of three cottage windows on either side of the entrance.

P5b. Description of Photo: (View, date, accession #) Photograph 1: West and south elevations, camera facing northeast, June 15, 2021.

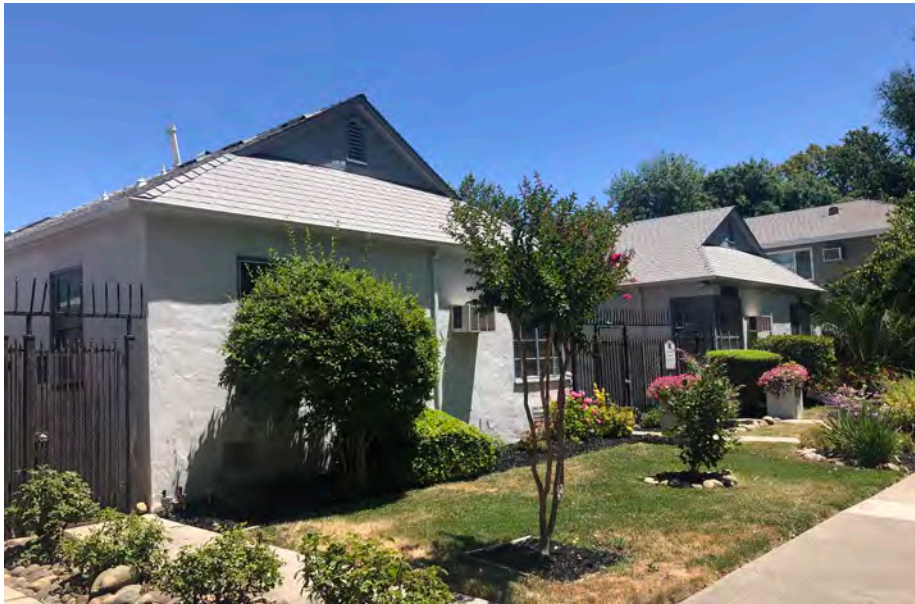
**\*P3a. Description:** (Describe resource and its major elements. Include design, materials, condition, alterations, size, setting, and boundaries)  
This property includes seven buildings arrayed around a landscaped central courtyard: six square buildings that face each other in two rows, and a larger rectangular building at the rear that faces toward the street. The six one-story residences, which exhibit elements of courtyard apartment architecture, have medium-pitched gable-on-hip roofs with louvered vents on the gable ends. Gable ends are clad in horizontal wood siding; the rest of each house is clad in stucco. Projecting partial-width porches with shed roofs shelter the entrances, which have metal security screen doors and are accessed via sets of concrete steps. Square columns support the porches at the corners. Fenestration is varied; the main façades on the south elevations feature decorative assemblages of multiple-pain casement windows. The rear building is cross-gabled and has a large arched entryway lined with brick.

P5b. Description of Photo: (View, date, accession #) Photograph 1: West and south elevations, camera facing northeast, June 15, 2021.

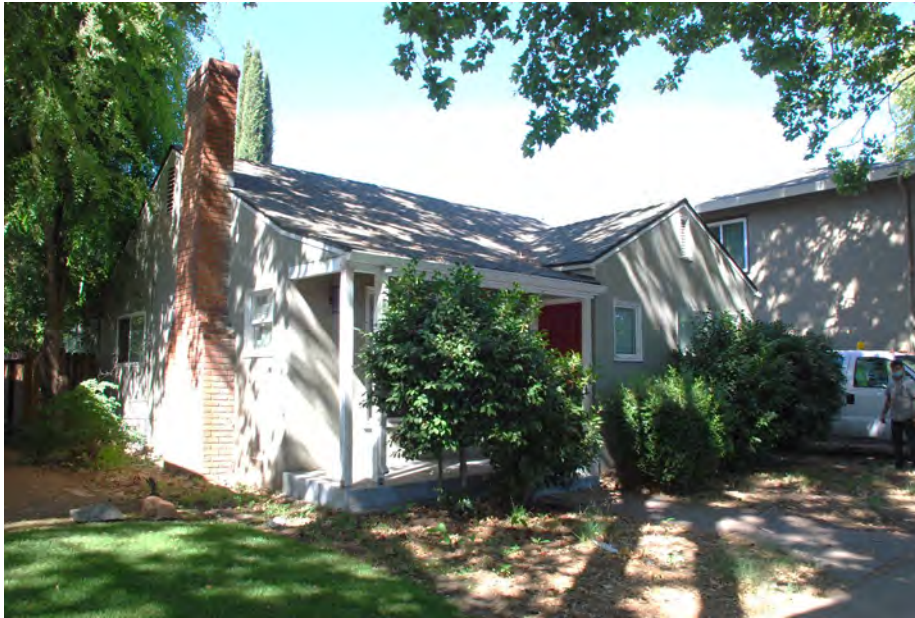
\*P3a. Description: (Describe resource and its major elements. Include design, materials, condition, alterations, size, setting, and boundaries)  
The one-story residence, which exhibits elements of Minimal-Traditional architecture, has a rectangular plan and medium-pitched cross-gabled roof with louvered vents on the gable ends and no eaves. It is clad in stucco. The projecting partial-width porch on the main (south) façade has a shed roof that shelters the centered main entrance, which is fitted with a paneled wood door. It is accessed via a low set of concrete steps. Square wood posts support the porch at the corners. Fenestration consists of vinyl replacement windows in vertical openings. The main façade features a picture window to the left of the entrance. There is a chimney on the west elevation.

P5b. Description of Photo: (View, date, accession #) Photograph 1: West and south elevations, camera facing northeast, June 15, 2021.

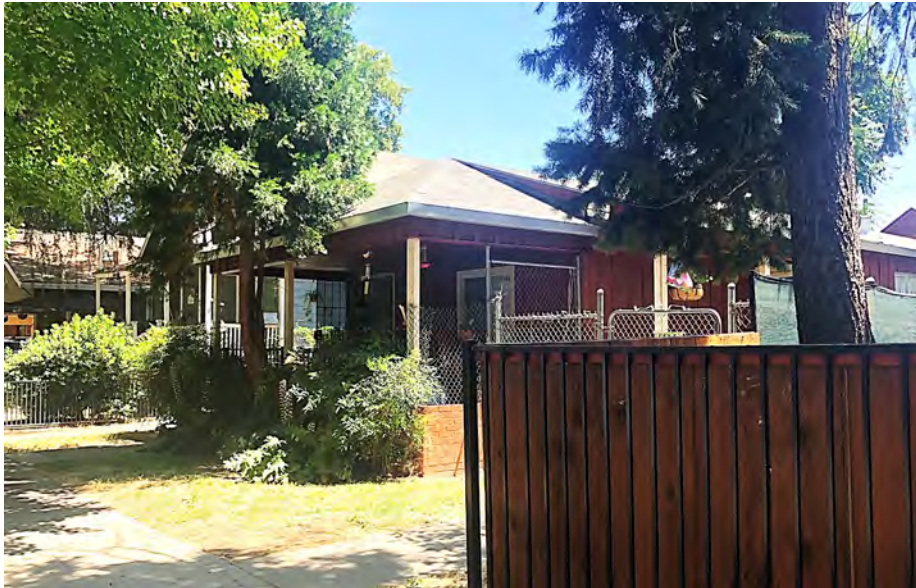
\*P3a. Description: (Describe resource and its major elements. Include design, materials, condition, alterations, size, setting, and boundaries) The one-story residence, has a rectangular plan and medium-pitched hipped roof. It is clad in vertical board and batten siding. The full-width porch on the main (north) façade shelters the main entrance, which is left of center and has a security screen door. Square wood columns support the porch at the corners; the balustrade is metal. It has a low, wide set of concrete steps. Fenestration consists of sliding aluminum-sash windows.

P5b. Description of Photo: (View, date, accession #) Photograph 1: North and west elevations, camera facing southeast, June 15, 2021.

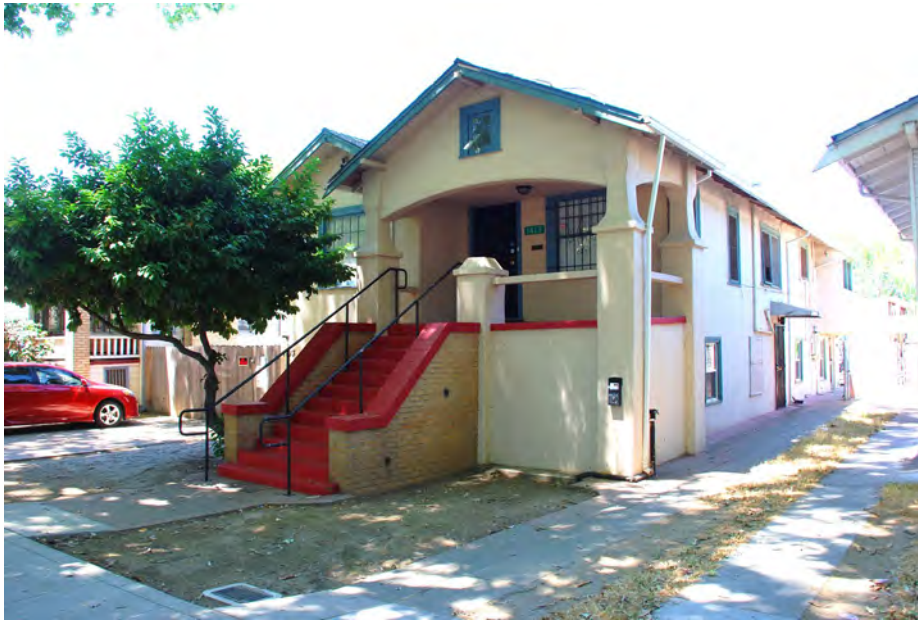
\*P3a. Description: (Describe resource and its major elements. Include design, materials, condition, alterations, size, setting, and boundaries)  
The one-story residence, which exhibits elements of Craftsman architecture, has a rectangular plan and medium-pitched front-gabled roof with exposed roof beams. It sits atop a raised basement and is clad in stucco. The partial-width porch on the main (south) façade shelters the centered main entrance, which is fitted with a metal security screen door. It is accessed via a wide set of concrete steps with brick wing walls and metal hand rails. Square stucco columns support the porch at the corners; the balustrade is wood. Fenestration consists of double-hung wood-sash windows in rectangular openings. The main façade features two decorative assemblages of three cottage windows on either side of the entrance.

P5b. Description of Photo: (View, date, accession #) Photograph 1: South and east elevations, camera facing northwest, June 15, 2021.

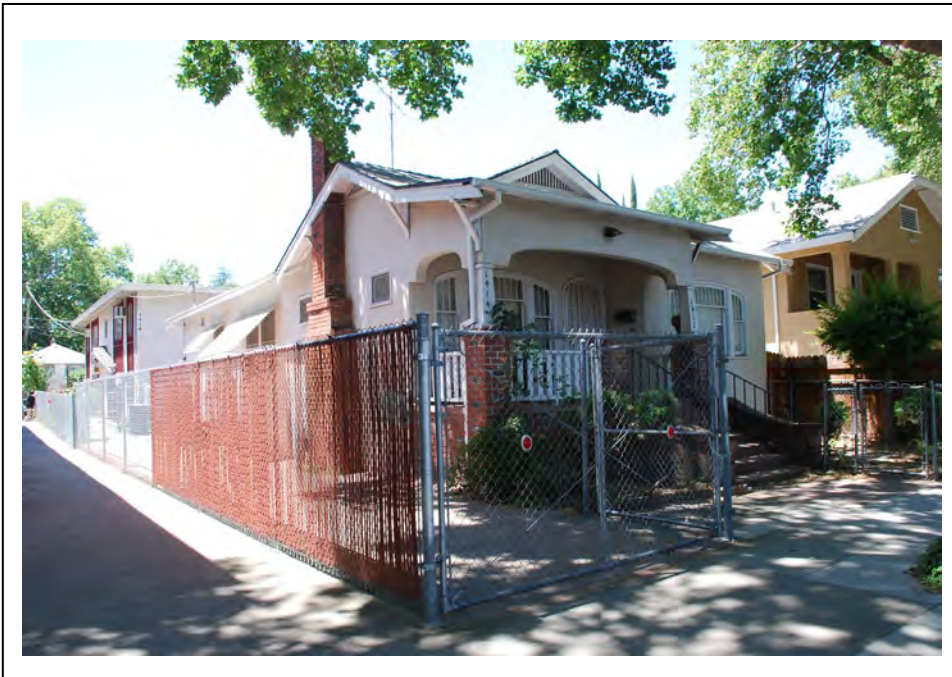
**P5b. Description of Photo:** (View, date, accession #) Photograph 1: East and north elevations, camera facing southwest, June 15, 2021.

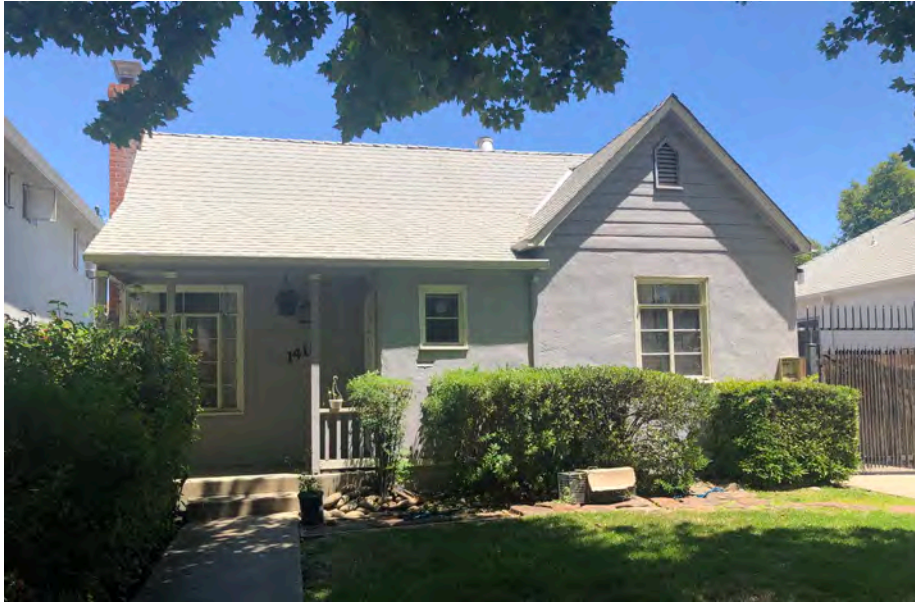
\*P3a. Description: (Describe resource and its major elements. Include design, materials, condition, alterations, size, setting, and boundaries)  
The one-story residence, which exhibits elements of Tudor architecture, has a rectangular plan and steeply-pitched cross-gabled roof with exposed roof beams. Gable ends, which face south and east, are clad in horizontal wood clapboard and have louvered vents. The rest of the house is clad in stucco. The partial-width porch on the main (south) façade shelters the main entrance, which is left of center and has a metal security screen door. It is accessed via a pair of concrete steps. Square wood columns with capitals support the porch at the corners; the balustrade is wood. Fenestration primarily consists of multiple-light casement windows. There is a brick chimney on the west elevation.

P5b. Description of Photo: (View, date, accession #) Photograph 1: South elevation, camera facing north, June 15, 2021.

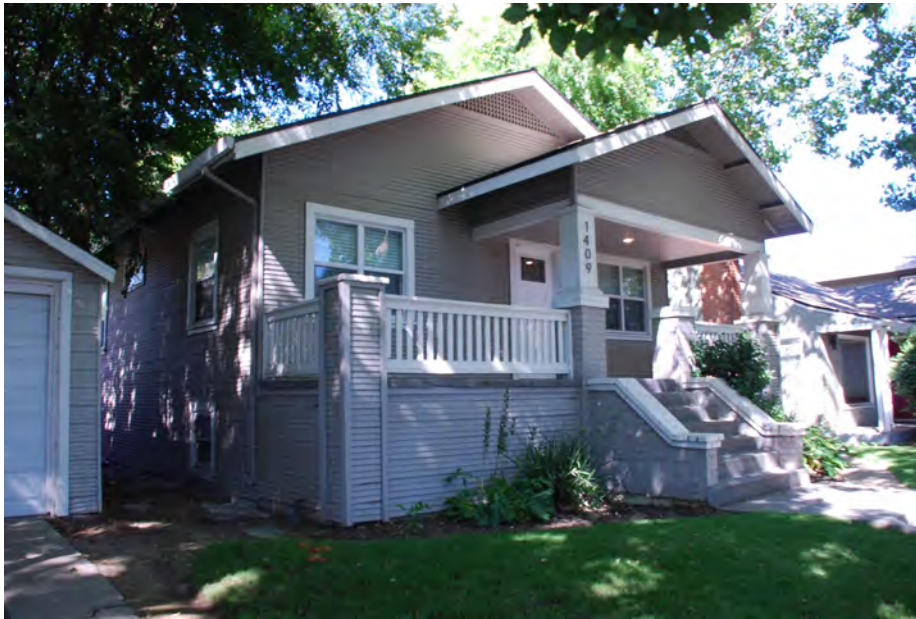
The one-story Craftsman residence sits atop a raised basement and has a rectangular plan and medium-pitched gable roof with vents on the gable ends and exposed roof beams. It is clad in narrow wood clapboard. The projecting partial-width porch on the main (south) façade shelters the centered main entrance, which is fitted with a partially glazed replacement wood door. The original porch at the east side of the main façade has been extended with an unsheltered deck to the west. It is accessed via a wide set of concrete steps with brick wing walls. Square wood columns with capitals and bases support the porch at the corners and rest on heavy brick and clapboard piers; the balustrade is an open wood railing. Fenestration consists of replacement windows. A Hollywood-style driveway to the west of the house leads to a small single garage with gabled roof and metal roll-up door.

P5b. Description of Photo: (View, date, accession #) Photograph 1: West and south elevations, camera facing northeast, June 15, 2021.

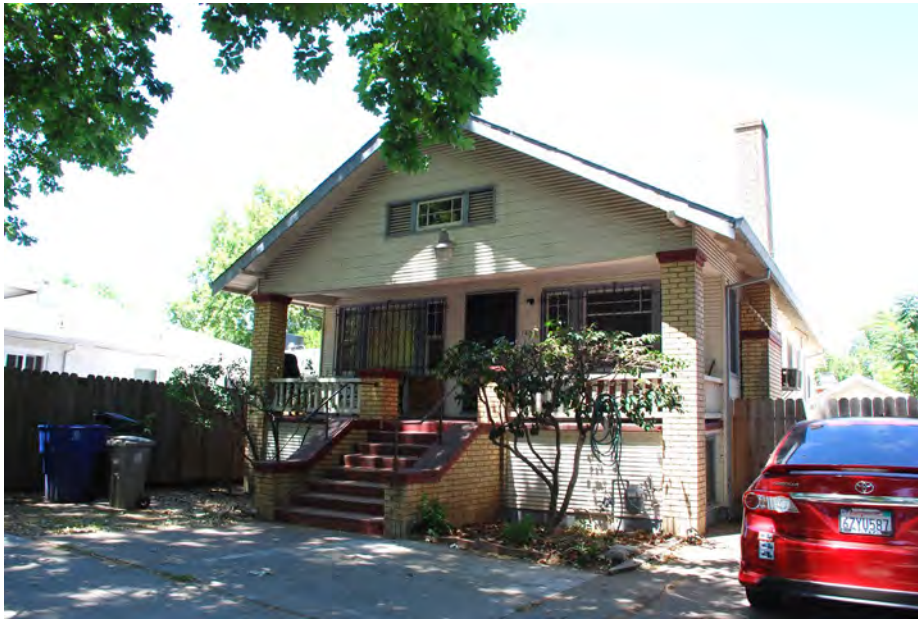
\*P3a. **Description:** (Describe resource and its major elements. Include design, materials, condition, alterations, size, setting, and boundaries)  
The one-story Craftsman residence sits atop a raised crawlspace and has a rectangular plan. Its medium-pitch gabled roof has louvered vents flanking a diminutive window on the gable ends and exposed rafter tails. The house is clad in narrow wood clapboard. The full-width integral porch on the main (south) façade shelters the centered main entrance, which is fitted with a metal security screen door and is accessed via a wide set of concrete steps. Heavy square brick columns/piers support the porch at the corners; the balustrade is a simple wood railing. Fenestration consists of double-hung wood-sash windows. The main façade features two decorative assemblages of three cottage windows on either side of the entrance. There is a tall brick chimney on the east elevation. A narrow driveway east of the house leads to a single garage with front-gabled roof at the rear of the property.

P5b. Description of Photo: (View, date, accession #) Photograph 1: South and west elevations, camera facing northwest, June 15, 2021.

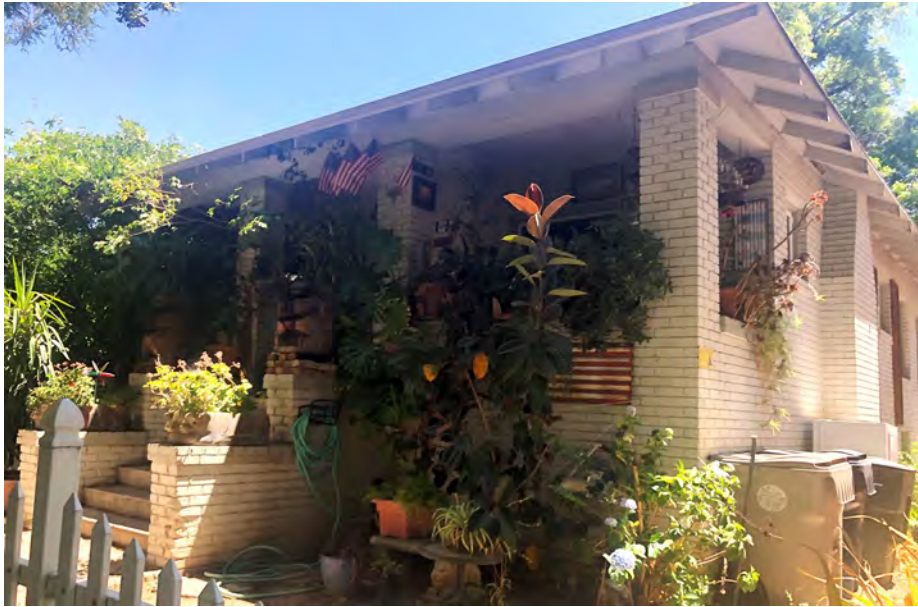
\*P3a. Description: (Describe resource and its major elements. Include design, materials, condition, alterations, size, setting, and boundaries)  
The one-story Craftsman residence has a rectangular plan and medium-pitch hipped roof with exposed rafter tails. It is clad in brick. The full-width integral porch on the main (north) façade shelters the centered main entrance, which is fitted with a metal security screen door. The porch is accessed via a set of concrete steps with brick wing walls. Heavy square brick columns support the porch at the corners and entrance; they rest on the solid brick balustrade. Fenestration consists of double-hung wood-sash windows.

P5b. Description of Photo: (View, date, accession #) Photograph 1: North and west elevations, camera facing southeast, June 15, 2021.

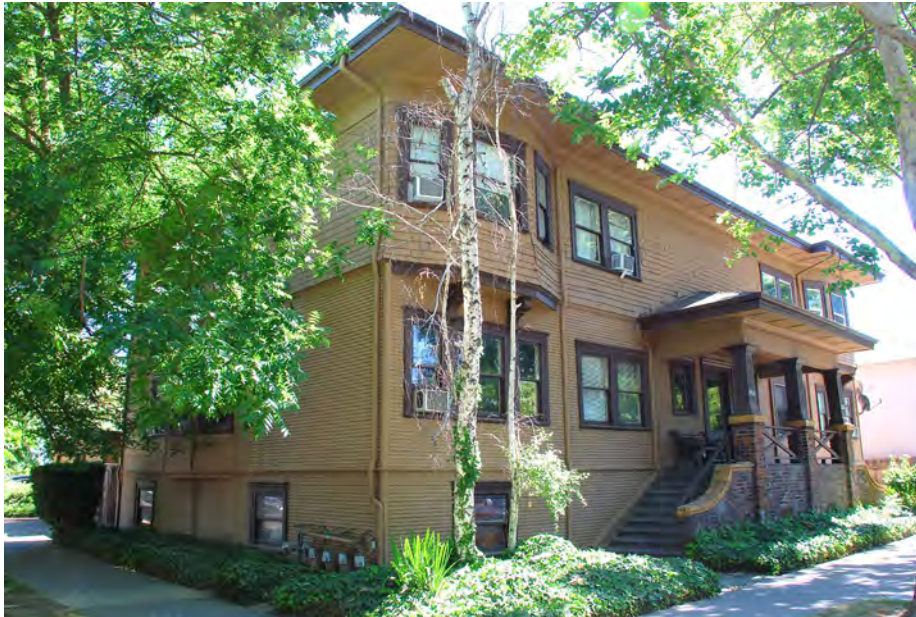
\*P3a. Description: (Describe resource and its major elements. Include design, materials, condition, alterations, size, setting, and boundaries)  
The two-story Prairie building has a raised foundation, a rectangular plan, and a low-pitched hipped roof. The first story is clad in narrow horizontal wood siding and the second story is clad in wood shingle. There is a projecting partial-width one-story porch on the main (south) façade with a hipped roof and dentil molding. Side-facing stairs access the porch from each side, and square wood columns with capitals and bases support the porch at the front. They rest on heavy brick piers, and the brick wing walls of the porch curves along the staircases. The stairs and porch have wooden balustrades, with wooden X's along the porch. The main entrance has a wide glazed wood door flanked by decorative cottage windows. Elsewhere fenestration consists of wide double-hung wood-sash windows. There are shallow, wide bay windows on the second floor at each corner of the main façade, and the roof projects slightly over each. On the center of the east and west elevations are two stories of shallow, wide bay windows, and above them are hipped dormers with no windows. There is a one-story garage with two metal roll-up doors behind the building to the north; it is accessed from 14<sup>th</sup> Street.

P5b. Description of Photo: (View, date, accession #) Photograph 1: West and south elevations, camera facing northeast, June 15, 2021.

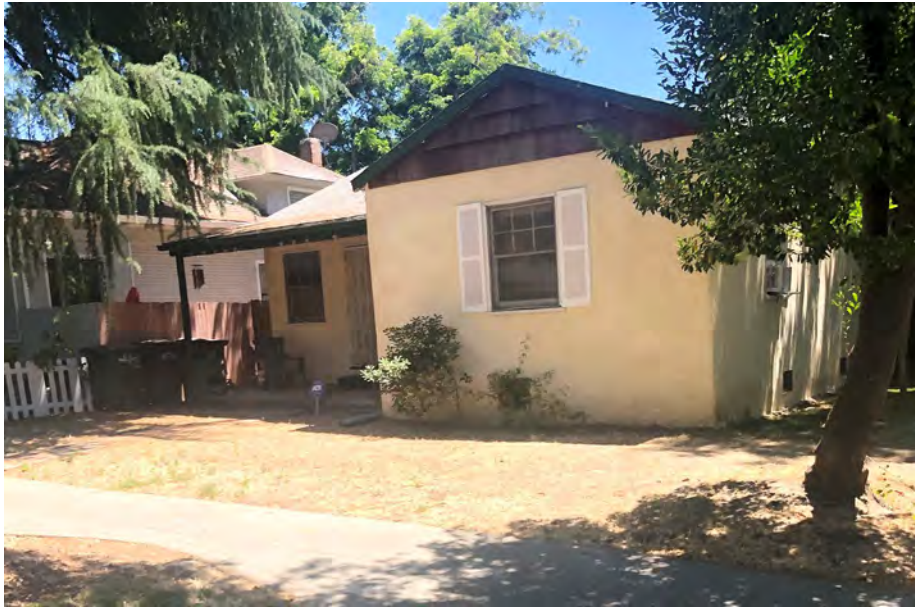
\*P3a. Description: (Describe resource and its major elements. Include design, materials, condition, alterations, size, setting, and boundaries)  
The one-story residence, which exhibits elements of Minimal-Traditional architecture, has an L-shape plan and medium-pitched gable roof with exposed rafter tails. Gable ends are clad in wood shingle; the rest of the house is clad in stucco. The projecting partial-width porch on the main (north) façade has a shed roof and shelters the main entrance, which is left of center and is fitted with a metal security screen door and is accessed via a set of concrete steps. A square wood column supports the porch at the corner. Fenestration consists of double-hung wood-sash windows with multiple-pained upper lights.

P5b. Description of Photo: (View, date, accession #) Photograph 1: North and west elevations, camera facing northeast, June 15, 2021.

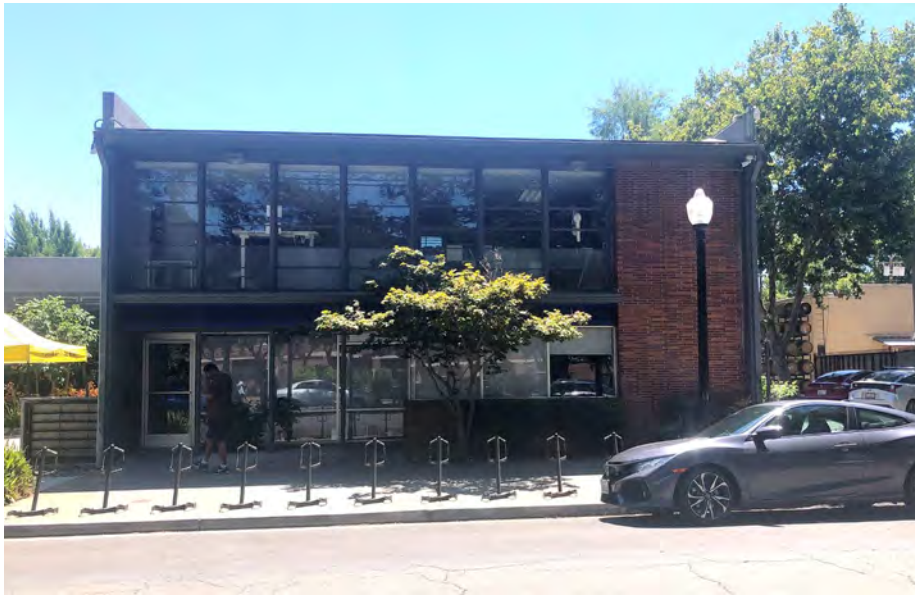
\*P3a. Description: (Describe resource and its major elements. Include design, materials, condition, alterations, size, setting, and boundaries)  
The Midcentury-Modern commercial building has a roughly L-shaped plan with a flat roof. There is a two-story volume at the west adjacent to V Street and a one-story volume at the southeast along Victorian Alley. The northeast corner of the property is an open courtyard. The building is constructed of concrete masonry units, and east, west, and south elevations are nearly blank except for a large vehicle opening on the south and clerestory windows on the west. The north façades of both building volumes features nearly continuous ribbon bands of windows with decorative brick at either end. Heavy, flat awnings sheltered the main façade. There are large murals on the east façades.

P5b. Description of Photo: (View, date, accession #) Photograph 1: North elevation, camera facing south, June 15, 2021.

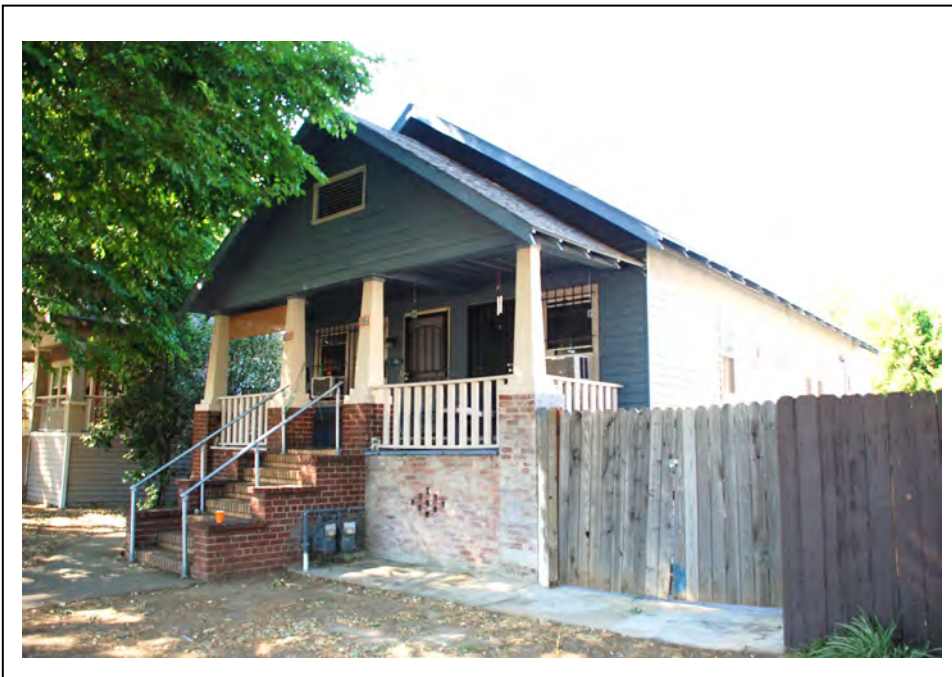
P5b. Description of Photo: (View, date, accession #) Photograph 1: South and east elevations, camera facing northwest, June 15, 2021.

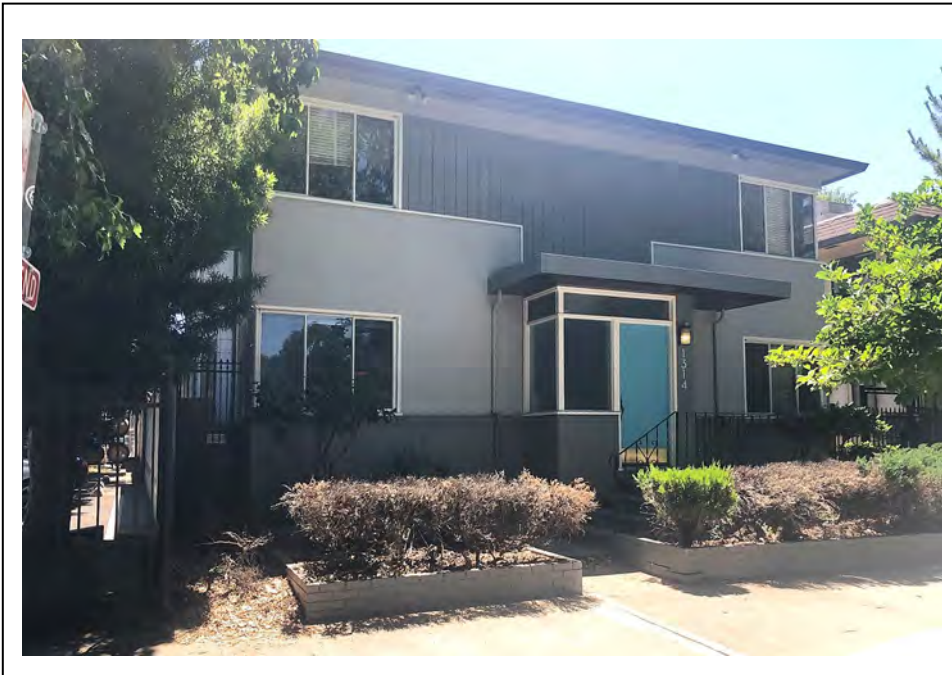
\*P3a. Description: (Describe resource and its major elements. Include design, materials, condition, alterations, size, setting, and boundaries)  
The Midcentury-Modern apartment building has a rectangular plan and very low-pitch hipped roof with wide eaves. It is clad in stucco with decorative wood trim on the main (north) façade arranged in a geometric pattern. The lower wall on the main façade has decorative brick trim; planters and a small front yard constructed of the same material. The projecting flat awning on the main façade shelters an entrance, which is fitted with a flat wood door and has an assemblage of side lights and transoms; it is accessed via a wide set of concrete steps with a simple metal handrail. Fenestration consists of steel casement windows. There is a large, one-story garage building at the rear of the property; is accessed via Victorian Alley.

P5b. Description of Photo: (View, date, accession #) Photograph 1: North elevation, camera facing southwest, June 15, 2021.

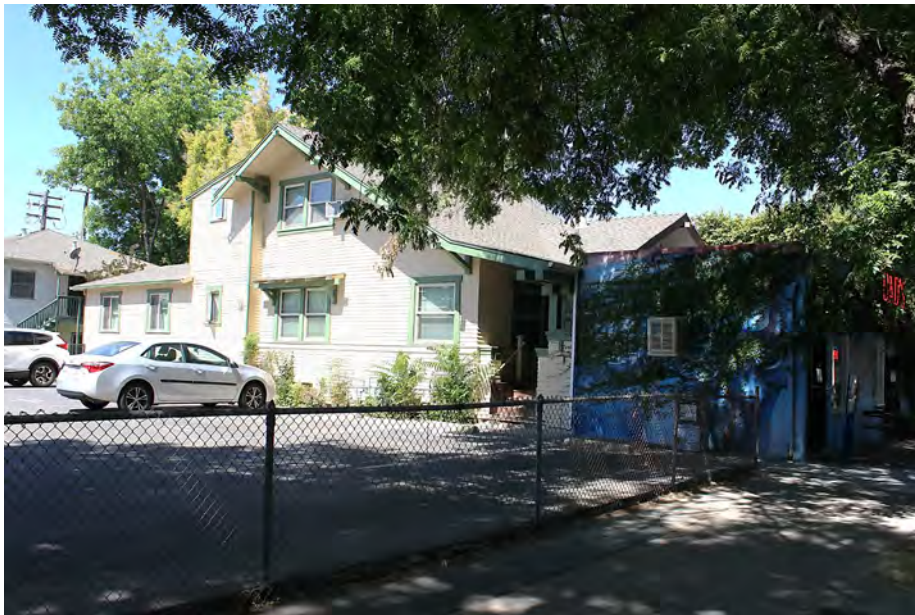
\*P3a. Description: (Describe resource and its major elements. Include design, materials, condition, alterations, size, setting, and boundaries)  
The parcel contains two buildings, a two-story residence and a one-story commercial building directly in front of the house. The house has a rectangular plan and is clad in narrow horizontal wood siding. The roof, which is cross-gabled over the two-story main volume of the house, has triangular knee braces and wide overhanging eaves; a one-story volume at the rear has a hipped roof. There is a full-width porch on the main (north) façade which shelters the entrance that is accessed from the side via a set of wood steps. Square wood columns support the porch at the corners. Fenestration consists of wide double-hung wood-sash windows with decorative upper lights, many in pairs. The commercial building is attached to the porch of the house. It has a rectangular plan and flat roof. It is clad in stucco. There is a slightly projecting full-width awning on length of the main (north) façade that features horizontal grooves characteristic of Streamline Moderne. It shelters the two entrances, which are both fitted with metal security screen doors. Fenestration consists of storefront picture windows and double-hung wood sash windows. There is a neon sign and a mural on the main elevation advertising the sandwich business that occupies the building.

P5b. Description of Photo: (View, date, accession #) Photograph 1: East and north elevations, camera facing southwest, June 15, 2021.

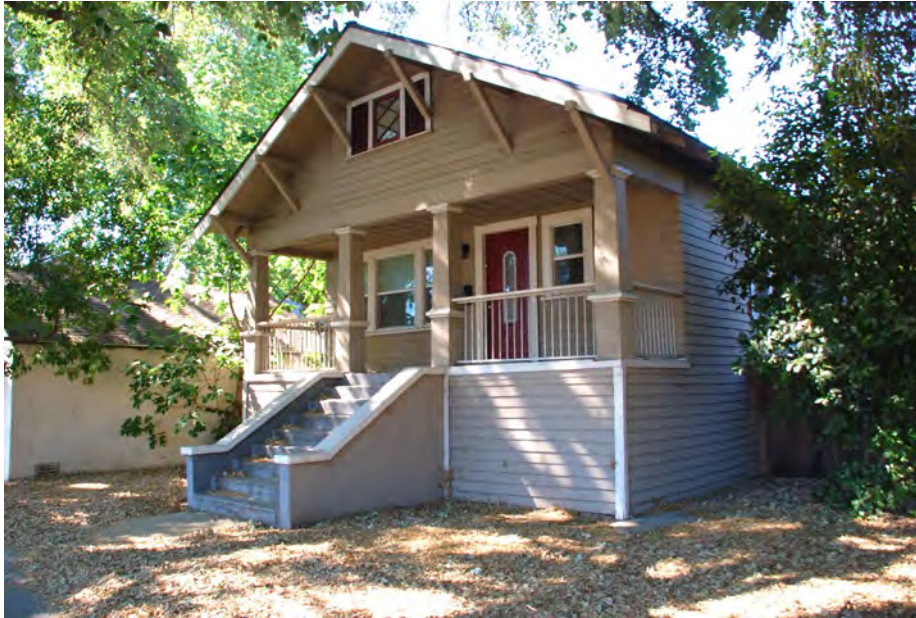
\*P3a. Description: (Describe resource and its major elements. Include design, materials, condition, alterations, size, setting, and boundaries)  
The 1.5-story Craftsman residence sits atop a raised basement and has a rectangular plan and medium-pitched gable roof with exposed roof beams and knee braces. The main façade gable end features a decorative window with louvered vents on either side. The house is clad in wood lap siding. The integral full-width porch on the main (south) façade shelters the main entrance, which is right of center and has a partially glazed replacement door. It is accessed via a wide set of concrete steps with concrete wing walls. Battered wood columns with capitals and bases support the porch and the balustrade is wood with thin balusters. Fenestration consists of vinyl replacement windows. A garage with gabled roof is accessed via Victorian Alley.

P5b. Description of Photo: (View, date, accession #) Photograph 1: South and east elevations, camera facing northwest, June 15, 2021.

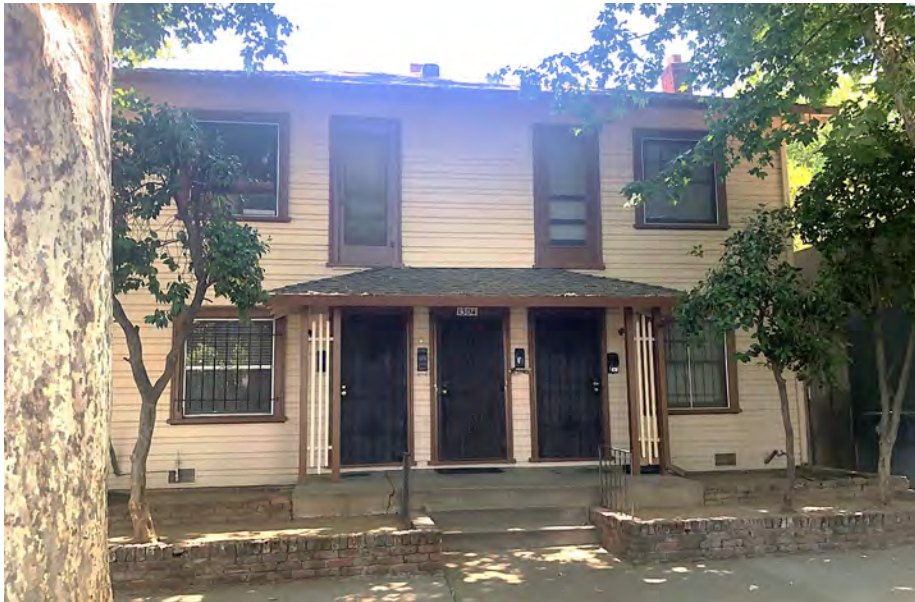
\*P3a. Description: (Describe resource and its major elements. Include design, materials, condition, alterations, size, setting, and boundaries)  
The two-story residence, which exhibits elements of Prairie architecture, has an L-shaped plan and medium-pitched hipped roof with exposed rafter tails. It is clad in variable-width horizontal wood siding. The projecting partial-width porch on the main (north) façade shelters the three centered main entrances, which are fitted with metal security screen doors and are accessed via a wide set of concrete steps. Doubled wood posts connected by simple decorative trim support the porch at the corners. There are two additional entrances on the second story that are fitted with wood screen doors; they apparently originally led to a balcony but are above the hipped roof to the entrance porch. Fenestration consists of double-hung wood-sash windows with divided upper lights and replacement aluminum sliding-sash windows.

P5b. Description of Photo: (View, date, accession #) Photograph 1: North elevation, camera facing south, June 15, 2021.

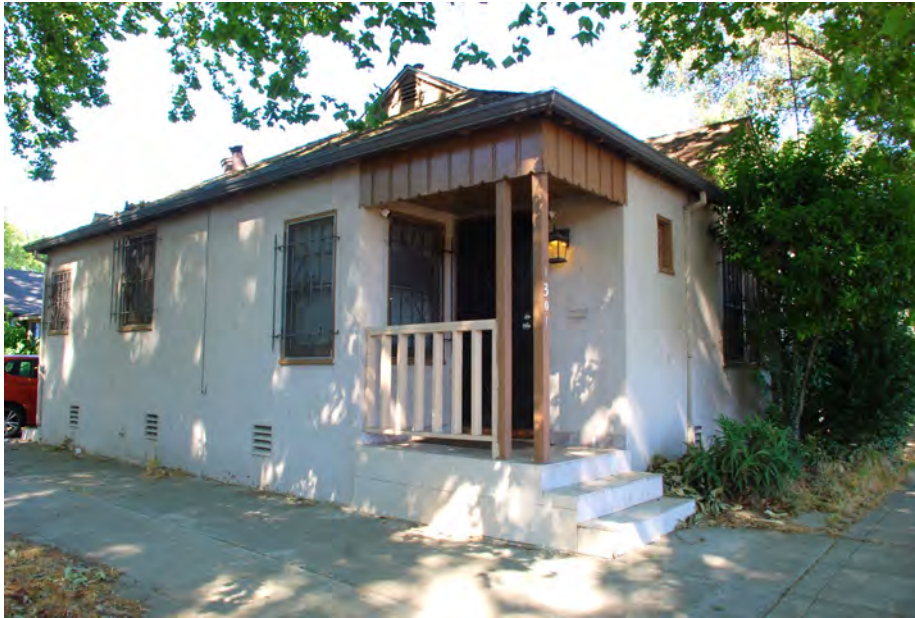
**P5b. Description of Photo:** (View, date, accession #) Photograph 1: West and south elevations, camera facing northeast, June 15, 2021.

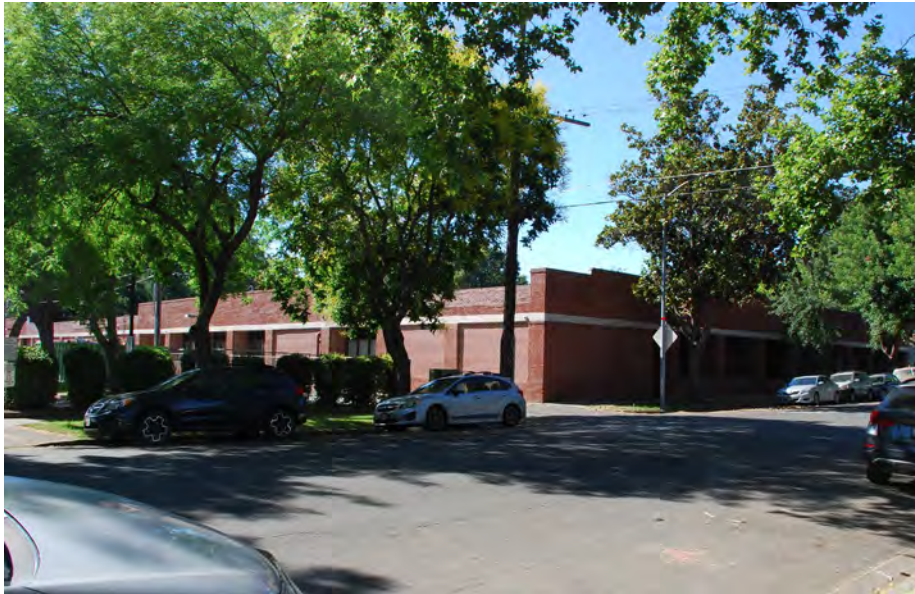
P5b. Description of Photo: (View, date, accession #) Photograph 1: East and north elevations, camera facing northwest, photograph taken June 15, 2021.

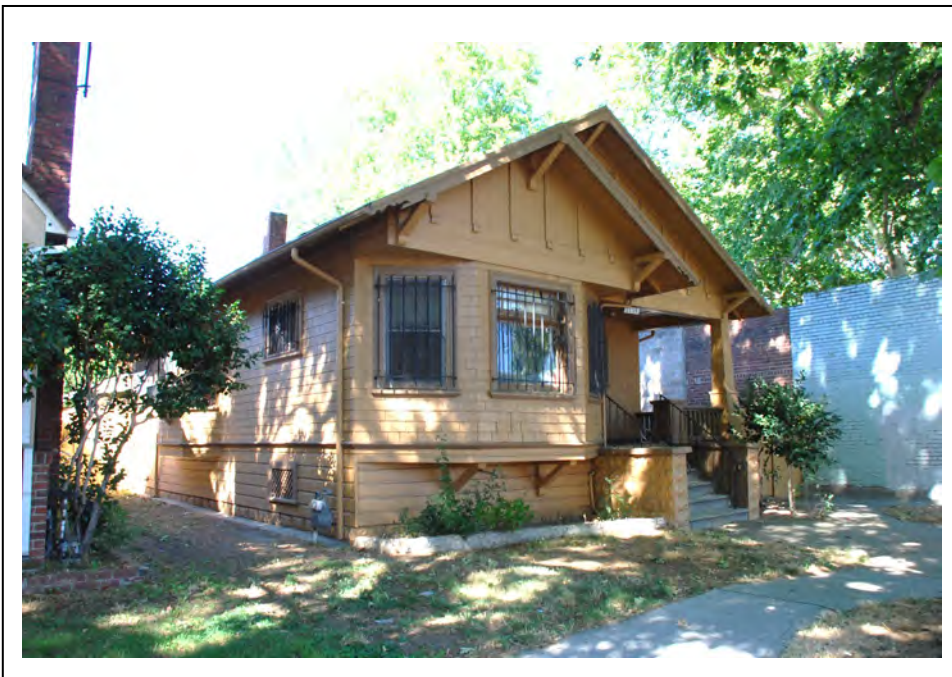
P5b. Description of Photo: (View, date, accession #) Photograph 1: West and south elevations, camera facing northeast, June 15, 2021.

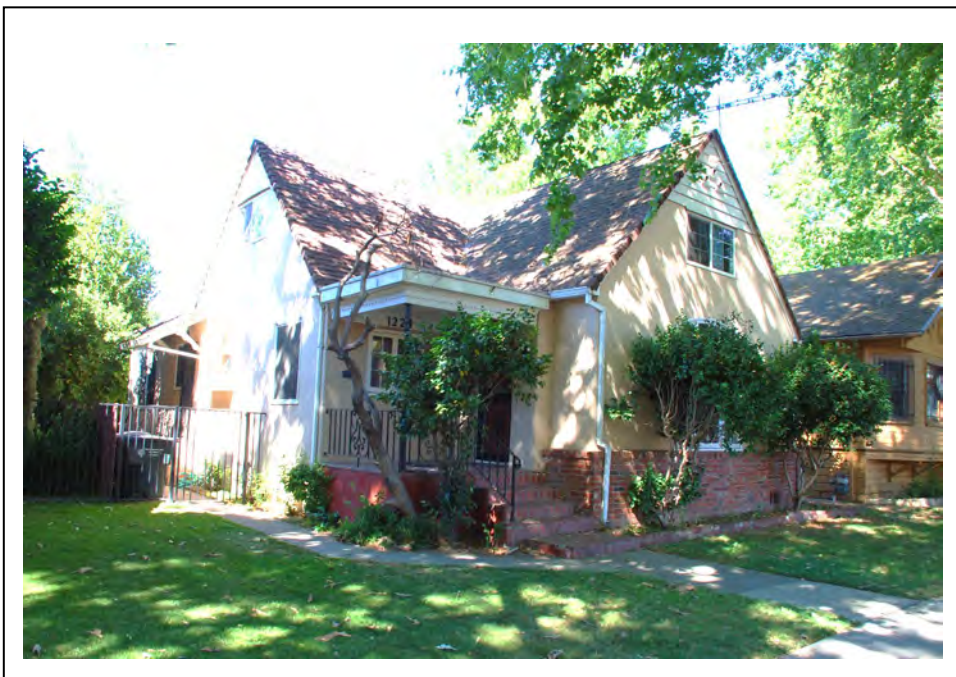
P5b. Description of Photo: (View, date, accession #) Photograph 1: West and south elevations, camera facing northeast, June 15, 2021.
