State of California – The Resources Agency  
DEPARTMENT OF PARKS AND RECREATION  
PRIMARY RECORD

\*Resource Name or # (Assigned by recorder) 2209 14<sup>th</sup> Street

c. Address 2209 14<sup>th</sup> Street City Sacramento Zip 95818

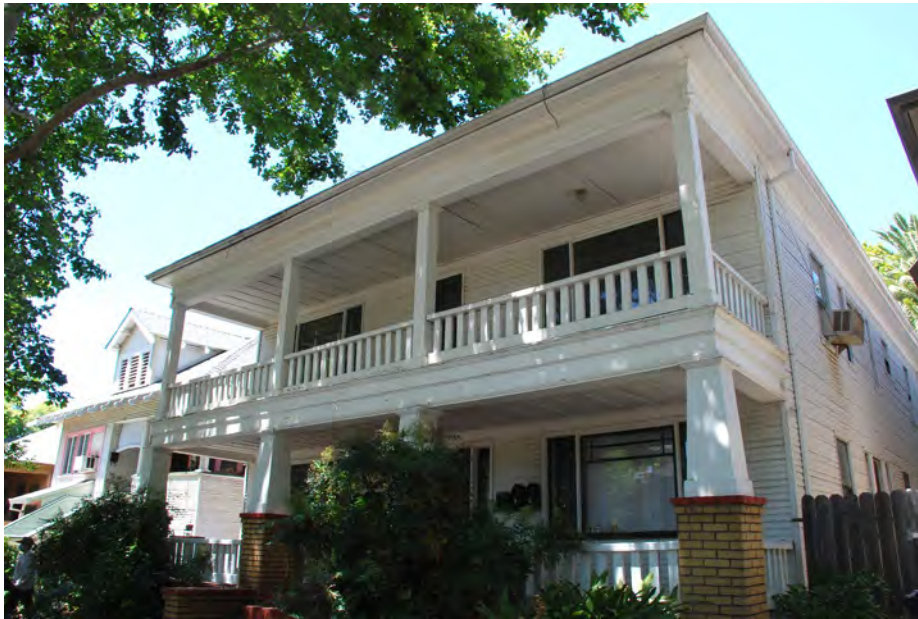
P5b. Description of Photo: (View, date, accession #) Photograph 1: South and east elevations, camera facing northwest, June 15, 2021.

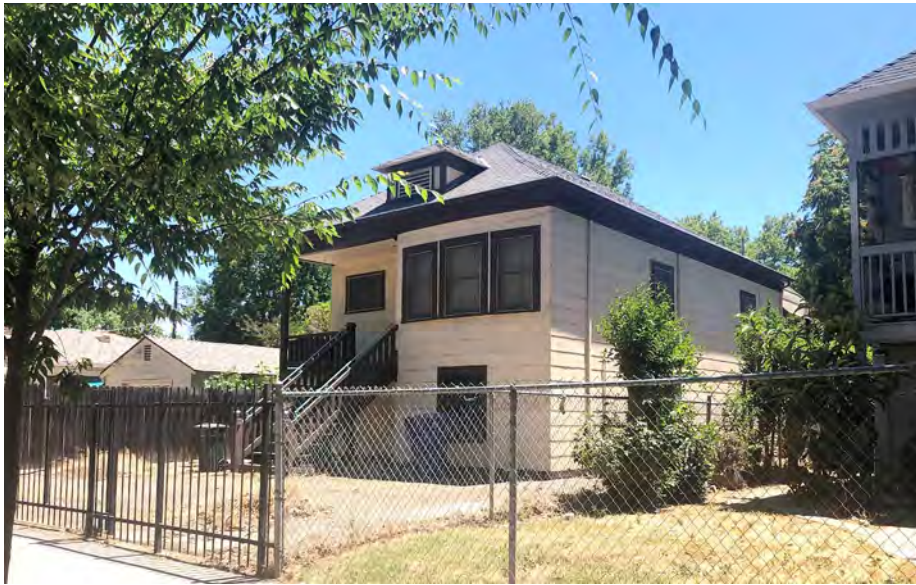
P5b. Description of Photo: (View, date, accession #) Photograph 1: North and west elevations, camera facing southeast, June 15, 2021.

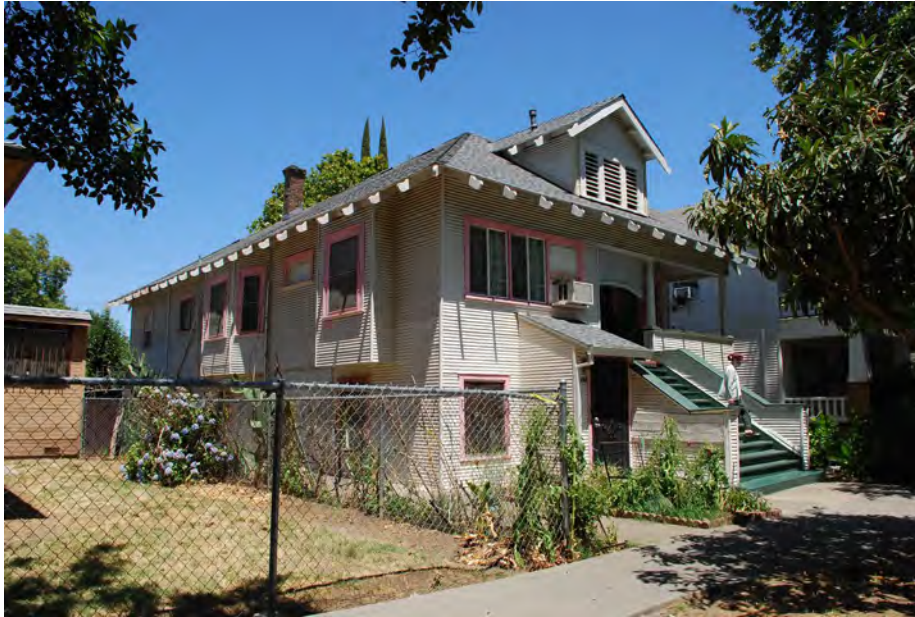
P5b. Description of Photo: (View, date, accession #) Photograph 1: West and south elevations, camera facing northeast, June 15, 2021.

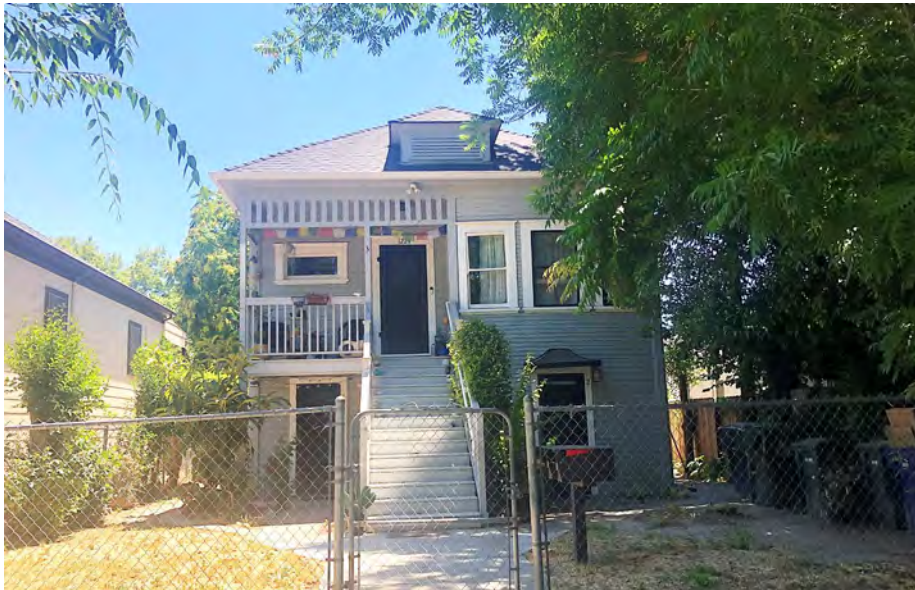
P5b. Description of Photo: (View, date, accession #) Photograph 1: North elevation, camera facing south, June 15, 2021.

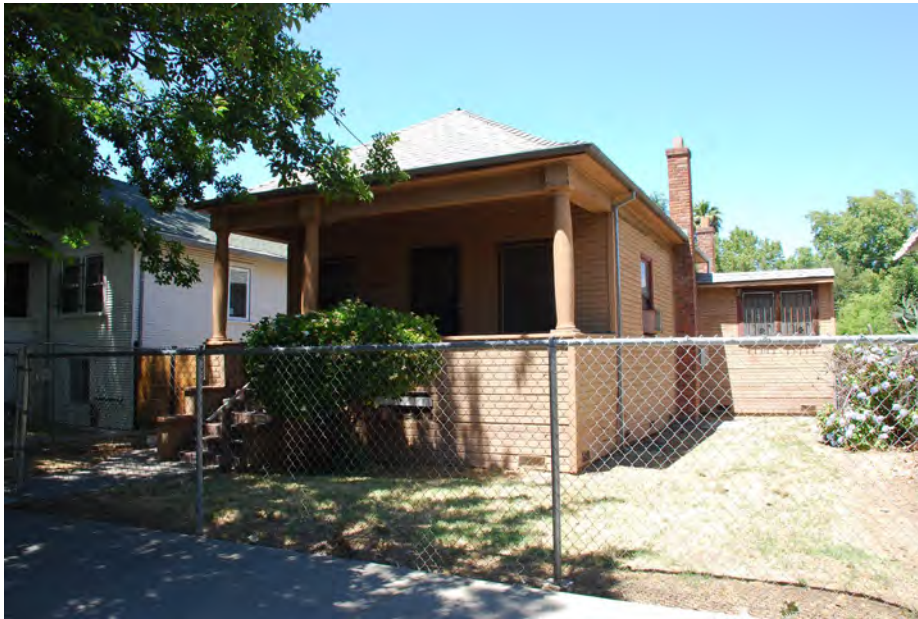
P5b. Description of Photo: (View, date, accession #) Photograph 1: North and east elevations, camera facing northwest, June 15, 2021.

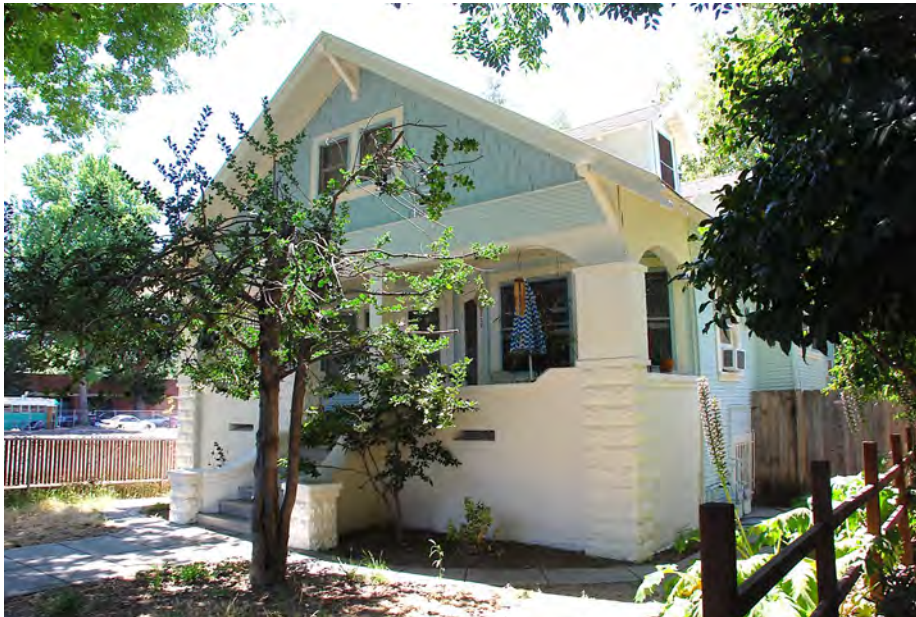
**P5b. Description of Photo:** (View, date, accession #) Photograph 1: West and south elevations, camera facing southeast, June 15, 2021.

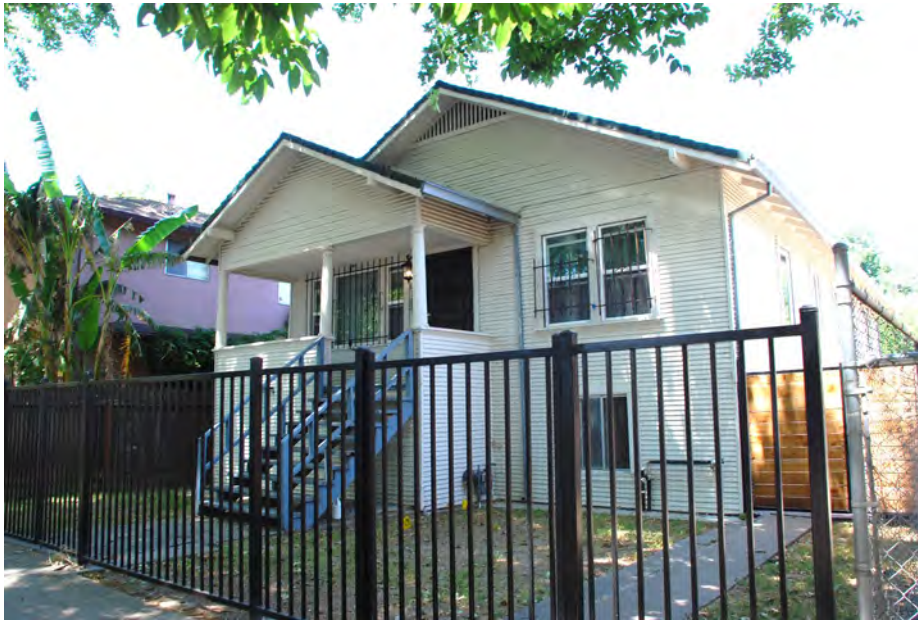
**\*P3a. Description:** (Describe resource and its major elements. Include design, materials, condition, alterations, size, setting, and boundaries)  
The one-story residence, which exhibits elements of Craftsman architecture, sits atop a raised basement and has a rectangular plan and medium-pitch front-gabled roof with wood vents on the gable ends and exposed roof beams. It is clad in narrow wood clapboard. The projecting partial-width porch on the main (south) façade shelters the centered main entrance, which is fitted with a metal security screen door and is accessed via a set of wood steps with simple wood hand rails. Tuscan columns with capitals and bases support the porch at the corners and entrance; they rest on the solid clapboard balustrade. Fenestration consists of vinyl replacement windows. The main façade features a decorative assemblage of three cottage windows to the left of the entrance.

P5b. Description of Photo: (View, date, accession #) Photograph 1: South and east elevations, camera facing northwest, June 15, 2021.

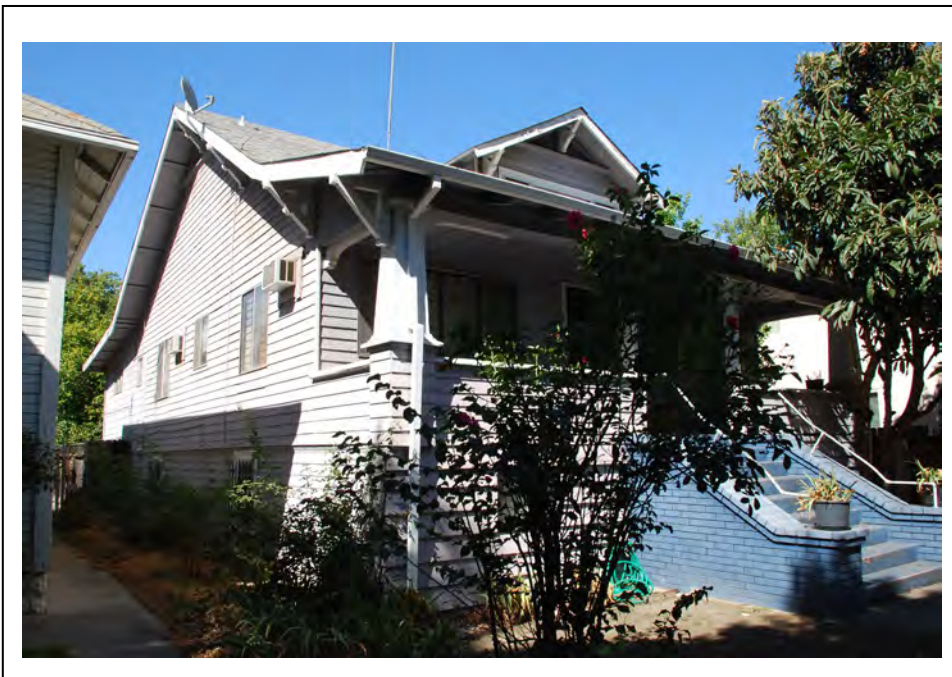
\*P3a. Description: (Describe resource and its major elements. Include design, materials, condition, alterations, size, setting, and boundaries)  
The 1.5-story Craftsman residence has a rectangular plan and medium-pitch gabled roof with flared eaves and a gabled dormer. The primary roof and Dorma both have exposed roof beams and knee braces. The dormer features a fixed window with diamond-shaped panes flanked by louvered vents. The house is clad in wood lap siding. The full-width integral porch on the main (south) façade shelters the centered main entrance, which is fitted with a metal security screen door. The wide set of concrete steps as brick wing walls with decorative caps. There are heavy battered columns at the corners of the porch with slender square columns with capitals and bases at the entry. They rest on the solid balustrade. Fenestration consists of replacement aluminum sliding-sash windows. A large garage accessed via Victorian Alley has a low-pitch shed roof, vertical-groove plywood siding, and three roll-up vehicle doors.

P5b. Description of Photo: (View, date, accession #) Photograph 1: West and south elevations, camera facing northeast, June 15, 2021.

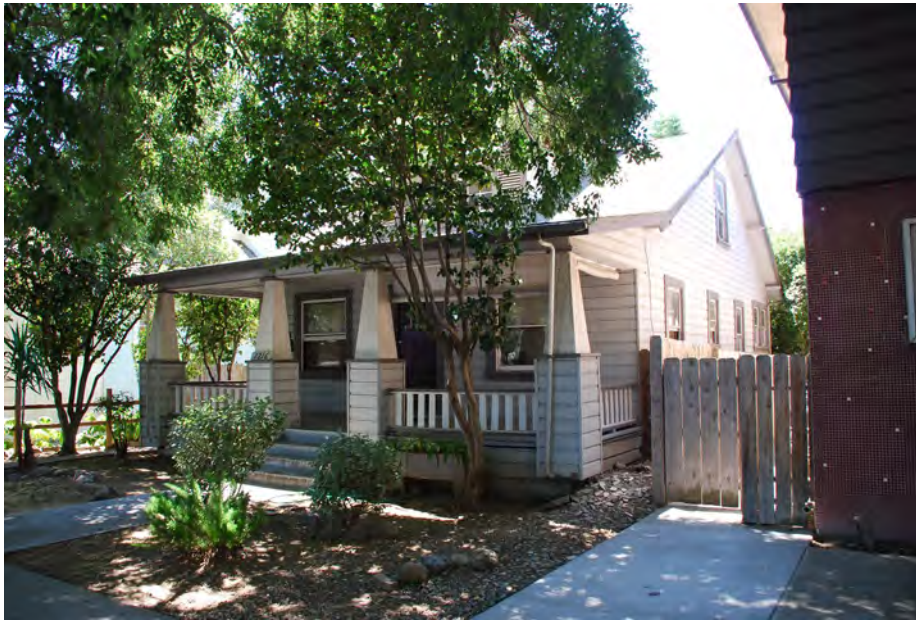
P5b. Description of Photo: (View, date, accession #) Photograph 1: North and west elevations, camera facing southeast, June 15, 2021.

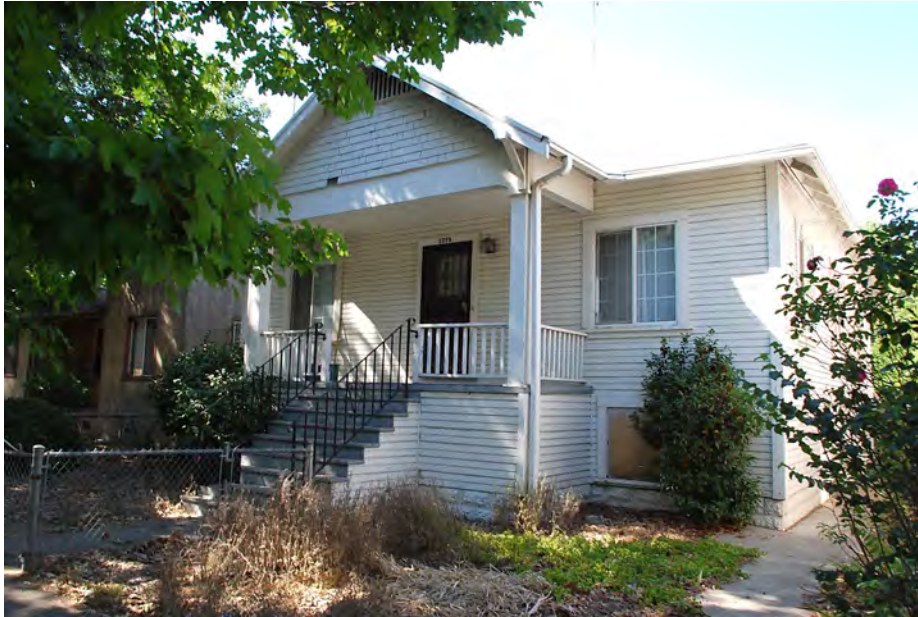
\*P3a. Description: (Describe resource and its major elements. Include design, materials, condition, alterations, size, setting, and boundaries)  
The one-story residence, which exhibits elements of Craftsman architecture, sits atop a raised basement and has an irregular plan. Its gable-on-hip roof has vents on the gable ends and exposed rafter tails. Gable ends are clad in wood shingles; the house is clad in narrow horizontal wood siding. The projecting partial-width porch on the main (south) façade shelters the centered main entrance, which has a partially glazed paneled wood door and is accessed via a wide set of wood steps. Square wood columns with simple capitals and bases support the porch at the corners; the balustrade is wood and stair rail metal. Fenestration consists of replacement horizontal sliding-sash windows with interior muntins. A triple garage at the rear of the property has a double-hipped roof with exposed rafter tails and three roll-up vehicle doors. It is accessed via Victorian Alley.

P5b. Description of Photo: (View, date, accession #) Photograph 1: South and east elevations, camera facing northwest, June 15, 2021.

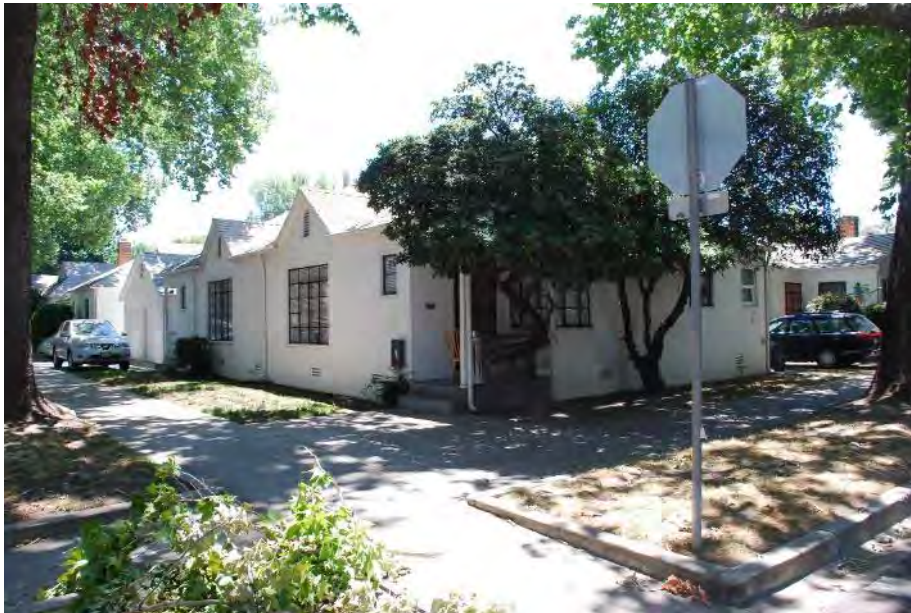
**P5b. Description of Photo:** (View, date, accession #) Photograph 1: North and west elevations, camera facing southeast, June 15, 2021.

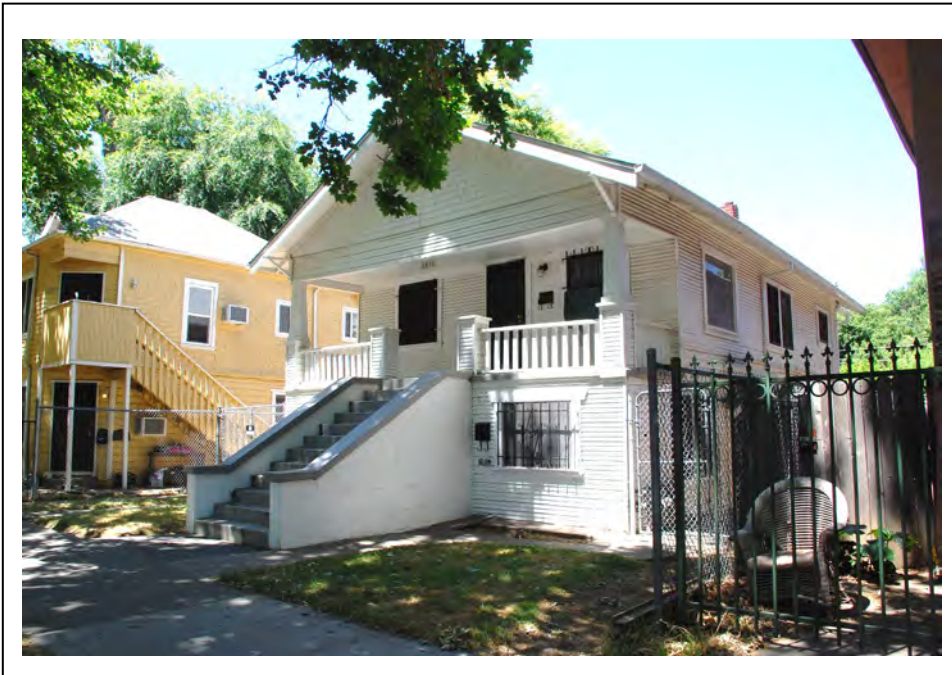
\*P3a. Description: (Describe resource and its major elements. Include design, materials, condition, alterations, size, setting, and boundaries)  
The one-story Craftsman residence sits atop a raised basement and has a rectangular plan and medium-pitched gable roof. There are wooden vents on the gable ends with knee braces and exposed rafter tails. Gable ends are clad in wood shingles; the remainder of the house is clad in narrow wood clapboard. The full-width porch on the main (south) façade shelters the main entrance, which is slightly right of center and has a metal security screen door. It is accessed via a tall set of concrete steps with rusticated concrete wing walls. Battered wood columns with capitals and bases support the porch at the corners and rest on clapboard piers; the balustrade is a simple wood railing. Fenestration consists of replacement windows and picture windows.

P5b. Description of Photo: (View, date, accession #) Photograph 1: South and east elevations, camera facing northwest, June 15, 2021.

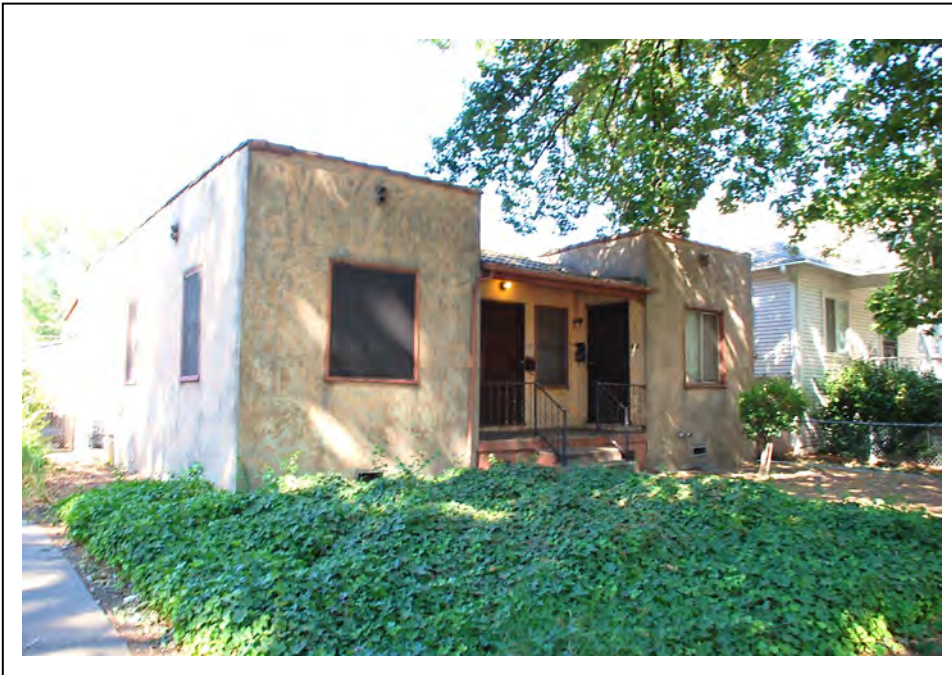
**\*P3a. Description:** (Describe resource and its major elements. Include design, materials, condition, alterations, size, setting, and boundaries)  
The one-story Spanish-Revival duplex has a rectangular plan and flat hipped roof with decorative clay tile at the edges. It is clad in textured stucco. There are decorative clay tile vents on the upper walls. The recessed partial-width porch on the main (south) façade has a shed clay tile roof and shelters the two entrances, which are fitted with metal security screen doors that are accessed via a low set of concrete steps; balustrade is metal. Fenestration consists of double-hung wood-sash windows and replacement aluminum sliding sash window. The property lacks a driveway. There is a corrugated metal garage/barn with a centered vehicle door at the rear of the property along Victorian Alley.

P5b. Description of Photo: (View, date, accession #) Photograph 1: West and south elevations, camera facing northeast, June 15, 2021.

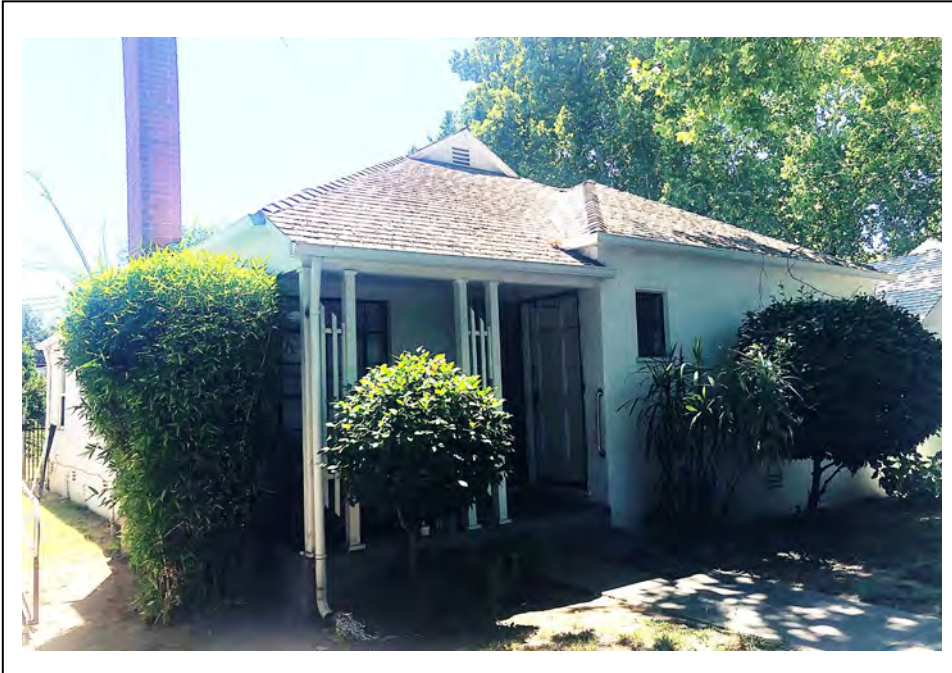
P5b. Description of Photo: (View, date, accession #) Photograph 1: North elevation, camera facing southwest, June 15, 2021.

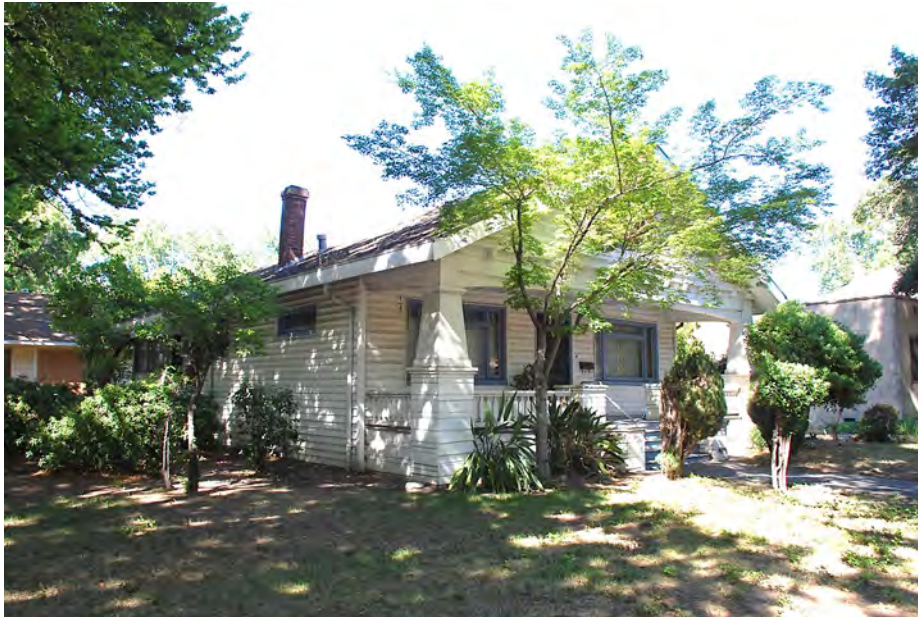
\*P3a. Description: (Describe resource and its major elements. Include design, materials, condition, alterations, size, setting, and boundaries)  
The one-story Craftsman residence has a rectangular plan and medium-pitch gabled roof with vents on the gable ends and medium eaves. The house is clad in replacement aluminum siding. The main (south) gable end features small paired divided-light windows. The full-width integral porch on the main façade shelters the centered main entrance, which has a partially glazed paneled wood door and is accessed via a wide set of wood steps. Heavy battered wood columns with capitals and bases support the porch at the corners and rest on heavy piers clad in wood siding; the balustrade is wood. Fenestration consists of double-hung wood-sash windows. The main façade features two decorative assemblages of three cottage windows on either side of the entrance. A corbelled chimney projects from the west side of the roof; there is a similar chimney on the east elevation. A narrow driveway east of the house leads to a single garage at the rear of the property. It is rectangular in plan with natural wood siding and partially-glazed carriage house doors that open from the center.

P5b. Description of Photo: (View, date, accession #) Photograph 1: West and south elevations, camera facing northeast, June 15, 2021.

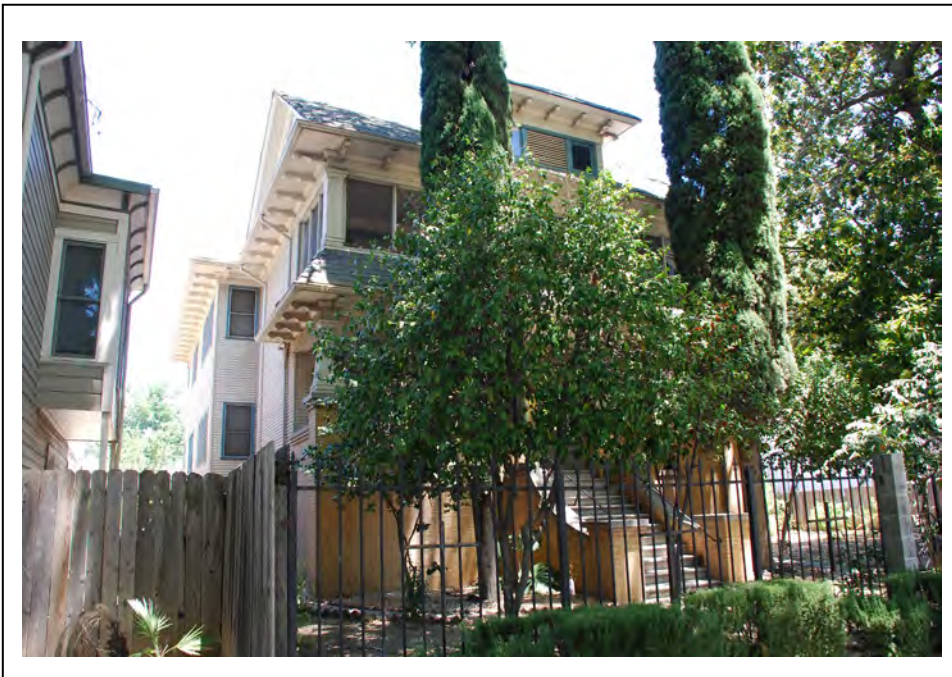
\*P3a. Description: (Describe resource and its major elements. Include design, materials, condition, alterations, size, setting, and boundaries)  
The 2.5-story residence has a rectangular plan and medium-pitched gable-on-hip roof with boxed eaves and shaped applied rafter tails. The building exhibits elements of Craftsman architecture along with the massing and emphasis on verticality associated with late Queen Anne architecture. It is clad in narrow lapped wood siding with wood shingle at the gable ends. Fenestration consists of double-hung wood-sash windows. A decorative dormer at the main (south) large façade has a hipped roof with eave details that match the main roof and small square windows flanking a louvered vent. The full-width second-floor porch is supported by squat square columns at the corners and is screened. The first-floor porch has a hipped roof that projects below the upper porch. The centered main entrance is fitted with a partially glazed paneled wood door and accessed via a tall set of concrete steps. Battered wood columns with capitals and bases rest on heavy brick piers; the balustrade is also brick, with a corbelled cap. Entrance steps are flanked by brick wing walls with heavy piers and curved caps. The double lot has a large yard to the east of and behind the house but no driveway or garage.

P5b. Description of Photo: (View, date, accession #) Photograph 1: West and south elevations, camera facing northeast, June 15, 2021.

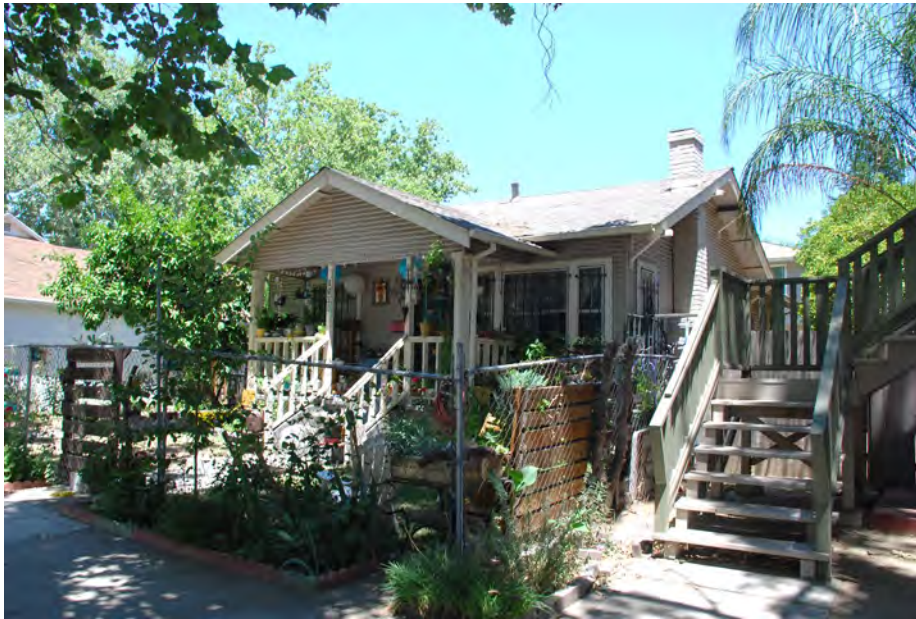
\*P3a. Description: (Describe resource and its major elements. Include design, materials, condition, alterations, size, setting, and boundaries)  
The one-story residence, which exhibits elements of Craftsman architecture, has a rectangular plan and medium-pitch cross-gabled roof with exposed roof beams. It is clad in narrow wood clapboard. The projecting partial-width porch on the main (south) façade shelters the centered main entrance, which is fitted with a metal security door and is accessed via a set of concrete steps. Simple square wood posts support the porch at the corners and entrance; the balustrade is an open wood railing. Fenestration consists of double-hung wood-sash windows. There is a corbelled brick chimney on the east elevation. There is a two-story apartment building behind the residence. It is rectangular in plan with a hipped roof and lacks references to Craftsman architecture. A parking area at the rear of the property is accessed via Victorian Alley.

P5b. Description of Photo: (View, date, accession #) Photograph 1: South and east elevations, camera facing northwest, June 15, 2021.

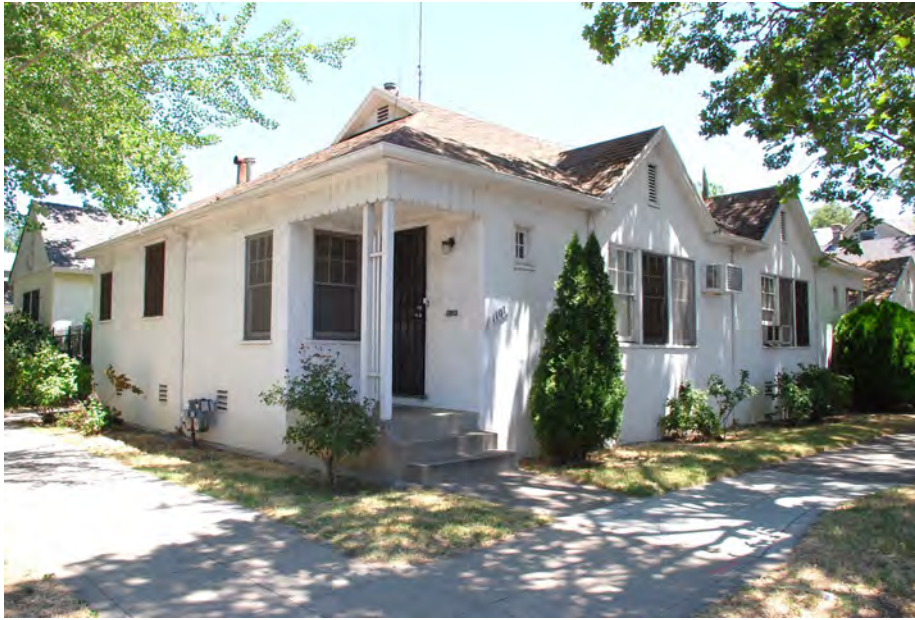
\*P3a. Description: (Describe resource and its major elements. Include design, materials, condition, alterations, size, setting, and boundaries)  
The one-story duplex, which exhibits elements of Minimal-Traditional architecture, has a rectangular plan and medium-pitched gable-on-hip roof with louvered vents on the gable ends and with narrow eaves. It is clad in stucco. The partial-width porches on the main (south) façade shelter the entrance, which are fitted with metal security screen doors and are accessed via low sets of concrete steps. Porches feature scalloped trim and square wood columns support the porches at the corners. Fenestration consists of double-hung wood-sash windows with divided upper lights. A double garage at the rear of the property is accessed via Victorian Alley. It has a front-gabled roof and stucco cladding with two metal roll-up vehicle doors. The duplex is similar to a large grouping of residential buildings about a block away near V and 12th Streets. All the buildings feature very similar architecture and plans; they appear to have been developed as a group in the late 1930s and early 1940s by local contractor Tony Brazil.

P5b. Description of Photo: (View, date, accession #) Photograph 1: West and south elevations, camera facing northeast, June 15, 2021.

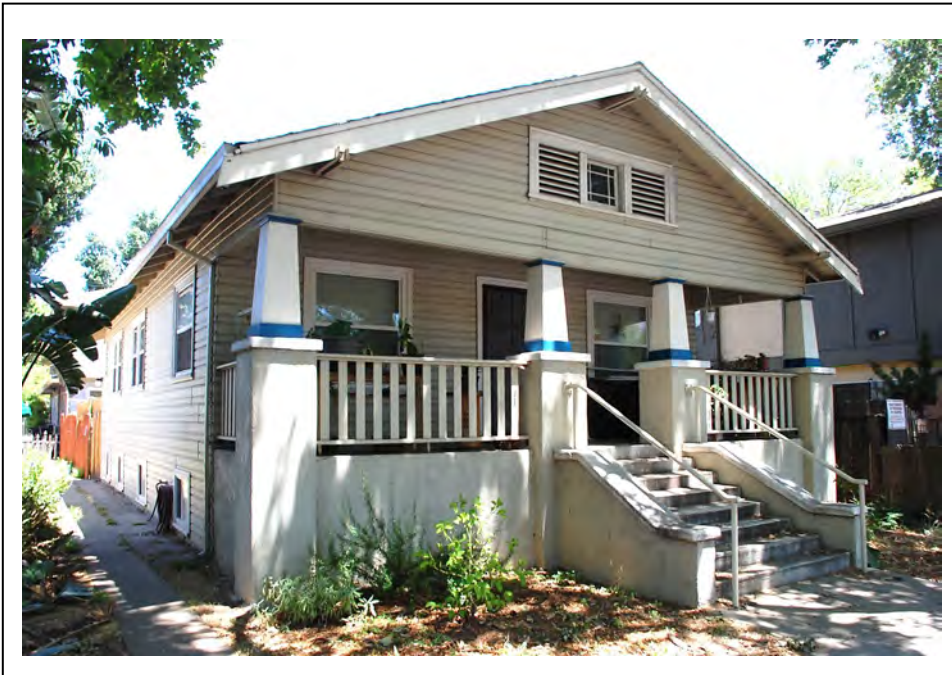
**\*P3a. Description:** (Describe resource and its major elements. Include design, materials, condition, alterations, size, setting, and boundaries)  
The one-story Craftsman residence sits atop a raised basement and has a rectangular plan and medium-pitch gabled roof with exposed purlins and rafter tails. The gable end features a decorative fixed window with two louvered vents on either side. The building is clad in variable-width horizontal wood siding. The full-width integral porch on the main (south) façade shelters the centered main entrance, which is fitted with a metal security screen door and is accessed via a wide set of concrete steps. Battered wood columns with capitals and bases support the porch at the corners and entrance and rest on heavy stucco piers; the balustrade is a simple wood railing. Fenestration consists of double-hung wood-sash windows.

**P5b. Description of Photo:** (View, date, accession #) Photograph 1: West and south elevations, camera facing northeast, June 15, 2021.

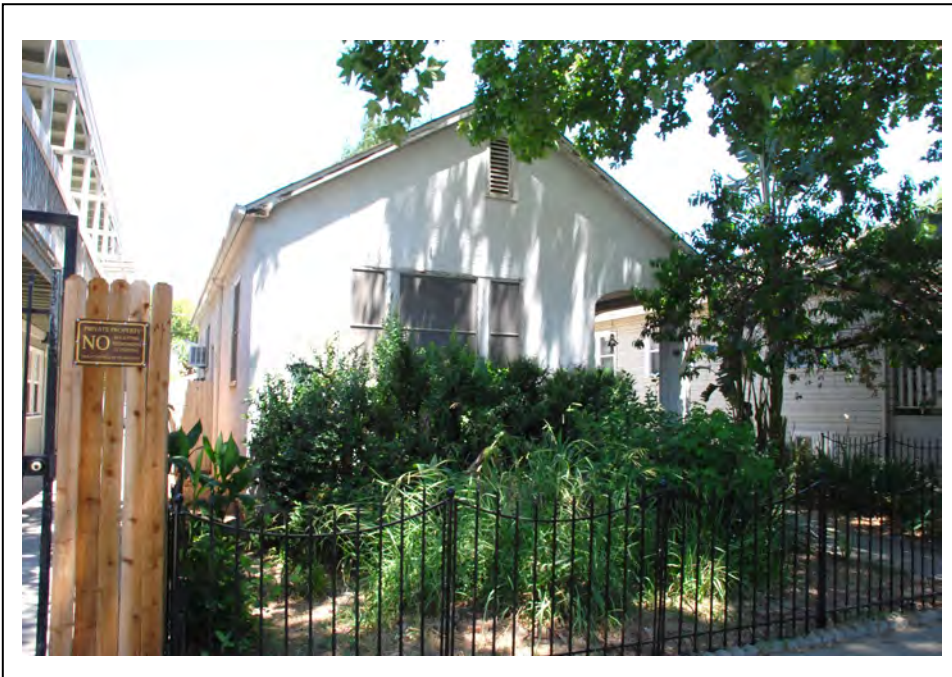
**\*P3a. Description:** (Describe resource and its major elements. Include design, materials, condition, alterations, size, setting, and boundaries)  
The one-story residence, which exhibits elements of Tudor architecture, has a rectangular plan and medium-pitch gabled roof with louvered vents on the gable ends and boxed eaves. It is clad in stucco. The partial-width integral porch on the main (south) façade shelters the main entrance, which is at the southeast corner of the house and is accessed via a low set of concrete steps. A heavy square column supports the porch at the corner; porch openings are arched. Fenestration consists of double-hung wood-sash windows. The main façade features an assemblage of three windows to the left of the entrance.

P5b. Description of Photo: (View, date, accession #) Photograph 1: West and south elevations, camera facing northeast, June 15, 2021.

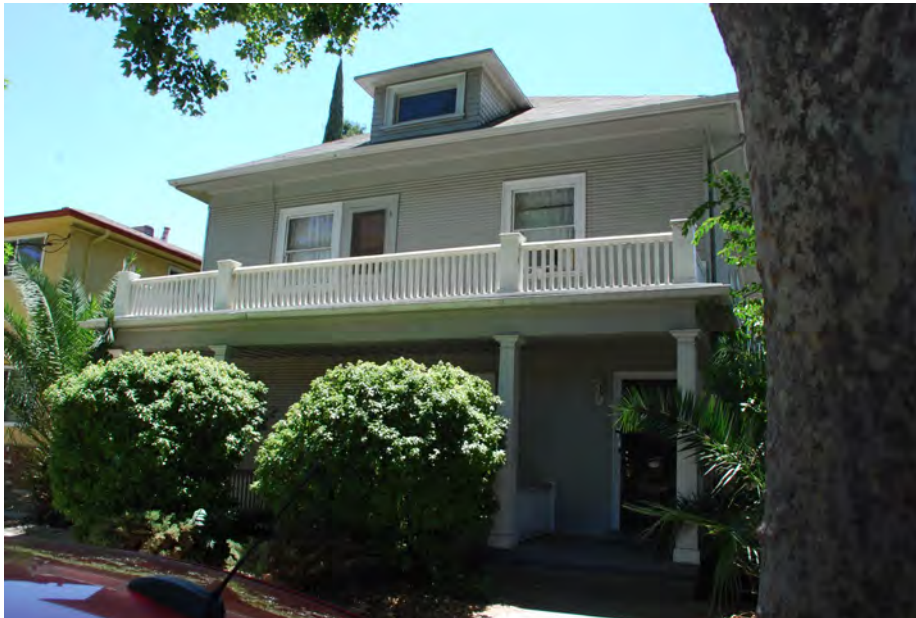
**\*P3a. Description:** (Describe resource and its major elements. Include design, materials, condition, alterations, size, setting, and boundaries)  
The two-story American Four-Square residence has a rectangular plan and medium-pitched hipped roof with hipped dormers and medium eaves. Dormers are clad in shingles; the balance of the house is clad in narrow horizontal wood siding. A projecting full-width porch/balcony on the main (north) façade shelters the main entrances on the first story, which have partially glazed paneled wood doors and are accessed via low sets of concrete steps. The second story entrance to the balcony sits left of center and is fitted with a partially glazed paneled wood door. Square wood columns with capitals and bases support the balcony at the corners and entrances; the balustrade is wood. Fenestration consists of double-hung wood-sash windows in short rectangular openings.

**P5b. Description of Photo:** (View, date, accession #) Photograph 1: North elevation, camera facing south, June 15, 2021.

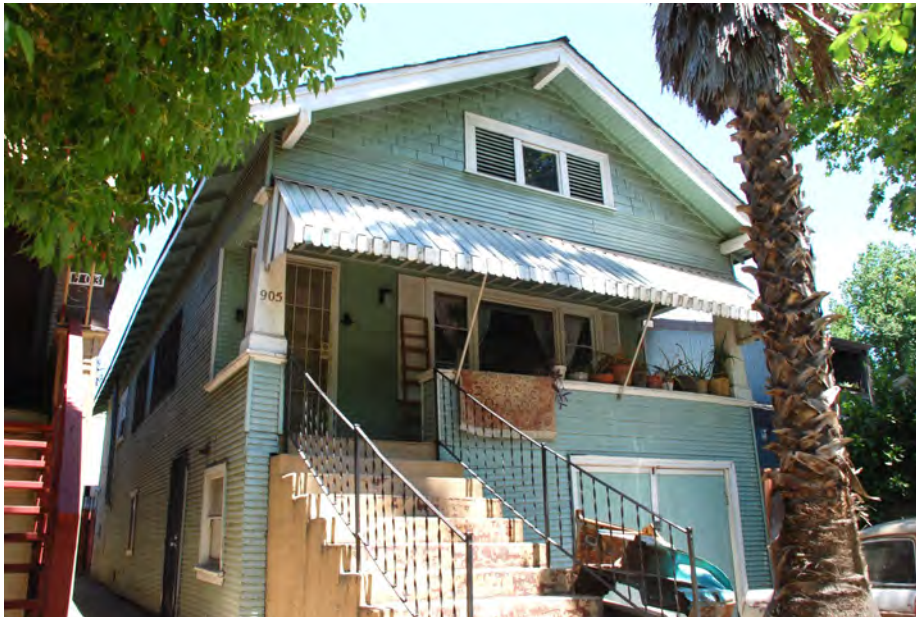
\*P3a. Description: (Describe resource and its major elements. Include design, materials, condition, alterations, size, setting, and boundaries)  
The 1.5-story residence, which exhibits elements of Craftsman architecture, sits atop a raised basement and has a rectangular plan. The medium-pitch gabled roof has exposed purlins and rafter tails. The gable end is clad in wood shingles and features a fixed window with louvered vents on either side; elsewhere, the building is clad in narrow horizontal wood clapboard. The full-width porch on the main (south) façade shelters the main entrance, which is left of center and is accessed via a wide set of concrete steps with metal handrails. Battered wood columns with capitals and bases support the porch at the corners and rest on the solid balustrade, clad in the same clapboard as the house. There is a projecting full-width awning connected to the porch. Fenestration consists of a combination of vinyl and double-hung wood-sash windows. The main façade features a decorative assemblage of three windows flanked by shutters to the right of the entrance. A short driveway on the east side of the parcel leads to a basement garage with double doors that open outward. This building is identical to the house next door at 903 W Street except that its stairs are at the west of the main façade.

P5b. Description of Photo: (View, date, accession #) Photograph 1: West and south elevations, camera facing northeast, June 15, 2021.

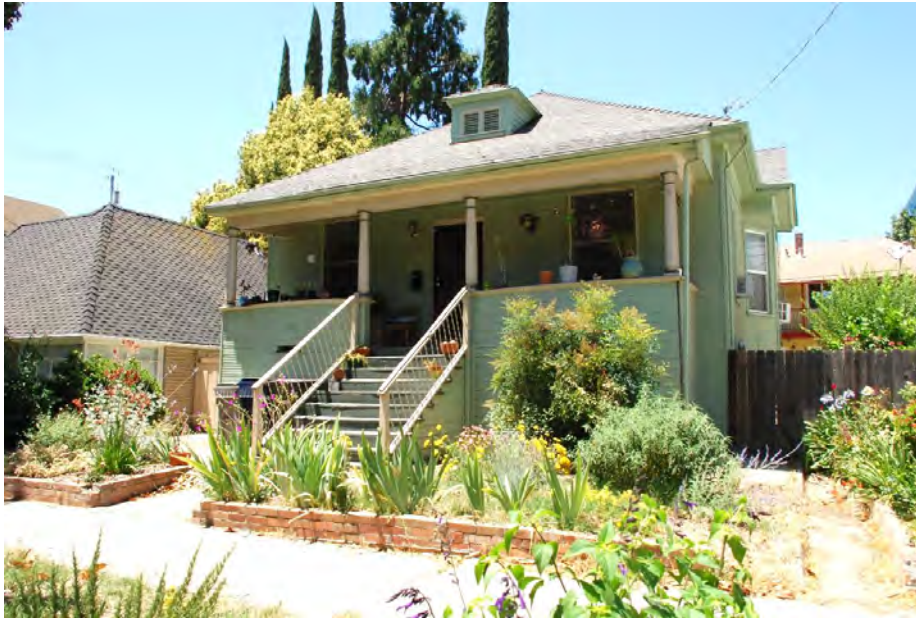
**\*P3a. Description:** (Describe resource and its major elements. Include design, materials, condition, alterations, size, setting, and boundaries)  
The 1.5-story American foursquare residence sits atop a raised basement and has a rectangular plan. It has a medium-pitched hipped roof with a hipped dormer and narrow boxed eaves. Its hipped dormer has two louvered vents. The house is clad in wood clapboard. The integral full-width porch on the main (east) façade shelters the centered main entrance, which is fitted with a metal security screen door and accessed via a wide set of wood steps. Tuscan columns support the porch at the corners and entrance; they rest on the solid clapboard balustrade. Fenestration consists of vinyl replacement windows in rectangular openings.

**P5b. Description of Photo:** (View, date, accession #) Photograph 1: East elevation, camera facing southwest, June 15, 2021.

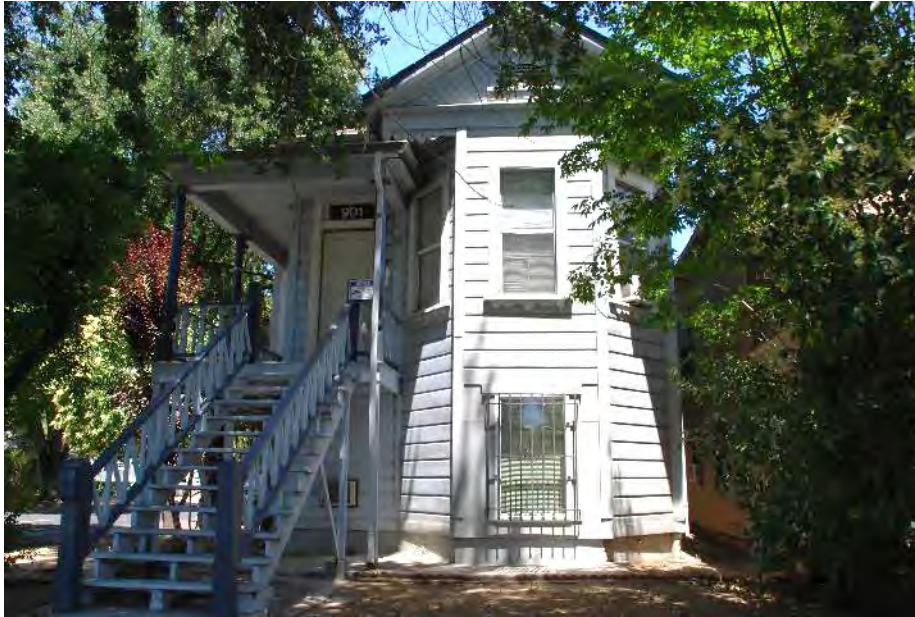
\*P3a. Description: (Describe resource and its major elements. Include design, materials, condition, alterations, size, setting, and boundaries)  
The one-story residence, which exhibits elements of Queen Anne architecture, has a roughly rectangular plan and medium-pitch gable-on-hip roof. It sits atop a raised basement. The gable end has a decorative louvered vent and is clad in fishscale shingle; elsewhere, the house is clad in horizontal wood drop siding. The partial-width porch on the main (south) façade shelters the main entrance, which is left of center and has a paneled wood door and transom. The porch wraps around the southwest corner of the building and is accessed via a tall set of wood steps. Turned posts with capitals and bases support the porch's hipped at the corners; the balustrade is wood with turned balusters. Fenestration consists of replacement windows in rectangular openings with decorative window casings. The main façade features a cutaway bay window with scrolled trim on the projecting volume to the right of the entrance.

P5b. Description of Photo: (View, date, accession #) Photograph 1: South elevation, camera facing north, June 15, 2021.
